**EXECUTIVE SUMMARY OF INVESTIGATION REPORT INTO
TRAIN COLLISION AT JOO KOON STATION WESTBOUND PLATFORM
ON 15 NOVEMBER 2017 (“INCIDENT”)**

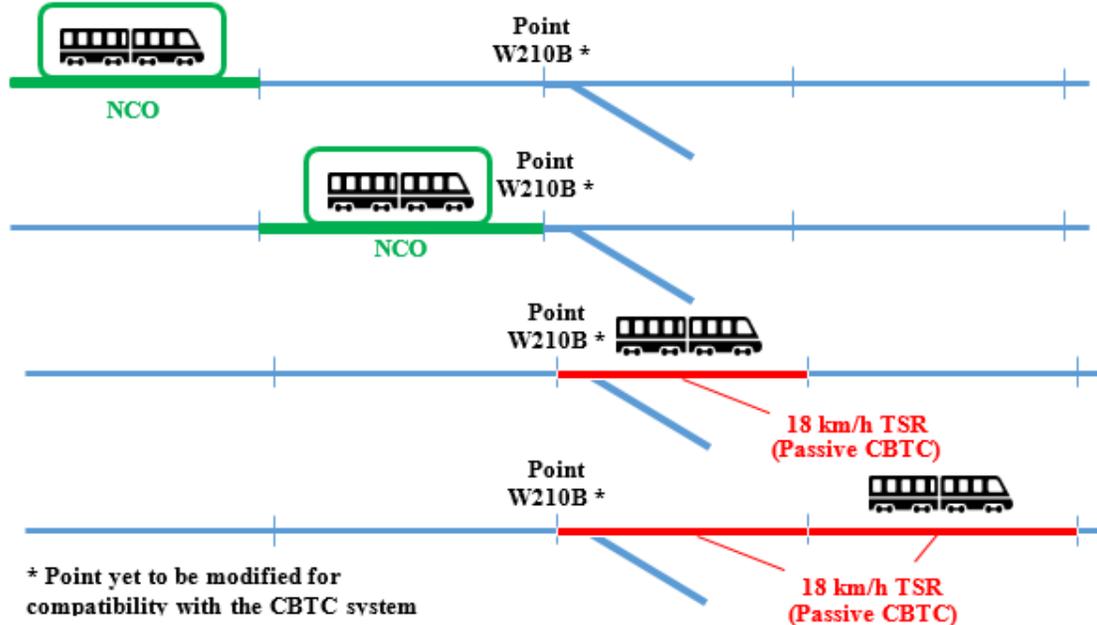
3. However, the NCO protective “bubble” was inadvertently disabled² when Train 3535/3536 passed over an existing trackside device (a track point labelled W210B located west of Clementi station) which had yet to be modified for compatibility with the CBTC system. From that moment onwards, each track circuit block that Train 3535/3536 entered automatically imposed a Temporary Speed Restriction (TSR) of 18 kilometres per hour (km/h). This is illustrated in **Figure 1** below. However, this did not affect the operation of Train 3535/3536 as it continued to travel eastbound towards Pasir Ris MRT station under the full control and protection of the legacy signalling system. After reaching Pasir Ris MRT station, Train 3535/3536 turned back westbound to Pioneer MRT station.

Figure 1: Sequence of events leading to disabling of the NCO protective “bubble” and imposing of TSR under CBTC passive mode operations

12. Thales completed the circuit modification at point W210B on 16 November 2017. Thales will also modify the software logic to ensure propagation of the NCO protective “bubble” across points regardless of the status of the point for both the CBTC active and passive modes. This will prevent future disabling of the NCO protective “bubble”.

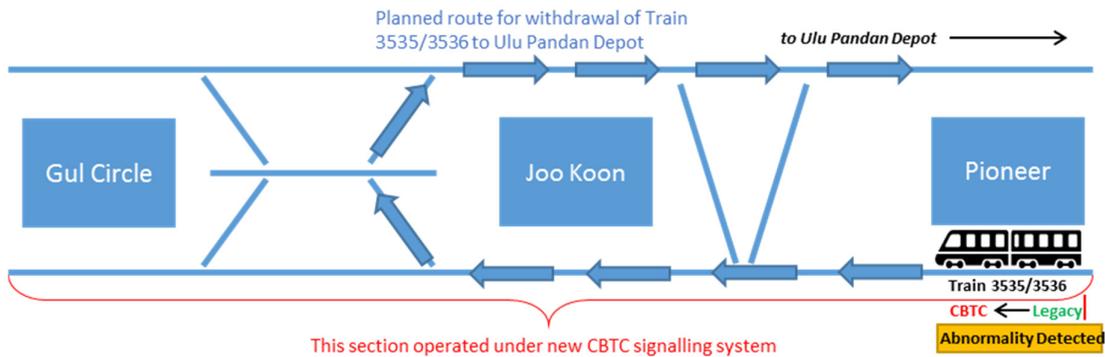
4. Pioneer MRT station is where westbound trains transition from operating on the legacy signalling system on the EWL to operating on the new CBTC signalling system on the Tuas West Extension (TWE), and vice versa for eastbound trains. When Train 3535/3536 arrived at Pioneer MRT station at about 8.03am, it transitioned to operating on the new CBTC signalling system. However, due to the abnormal condition that had developed on the train-borne CBTC signalling equipment, Train 3535/3536 was prevented by the CBTC system from travelling in Automatic Mode (AM). As a result of this abnormality, SMRT's Operations Control Centre made the decision to withdraw Train 3535/3536 from service via a centre siding after Joo Koon MRT station to Ulu Pandan Depot as shown in **Figure 2** below. To accomplish this, Train 3535/3536 was first routed in Restricted Manual (RM) mode to the Joo Koon westbound platform, where the passengers could be de-trained. In RM mode, the train's speed is limited to 18 km/h by the CBTC system.

Figure 2: Legacy to CBTC transition at Pioneer and planned route for withdrawal of Train 3535/3536 to Ulu Pandan Depot

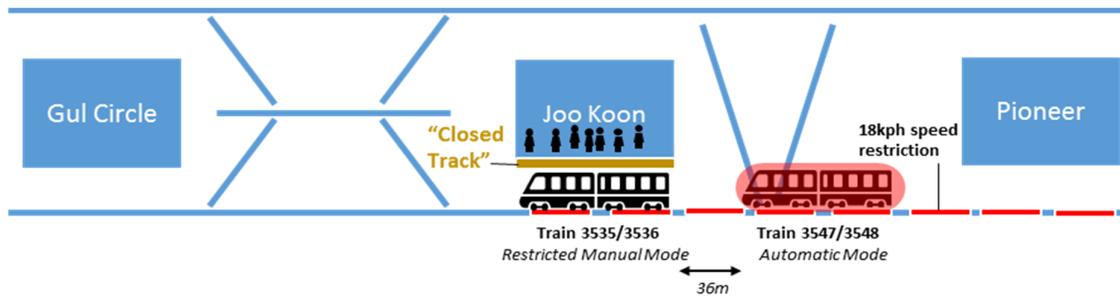
6. When Train 3535/3536 arrived at Joo Koon westbound platform, the platform screen doors had to be opened manually with the Emergency Screen Door Control to allow passengers to de-train. This process created a “Closed Track” protection around Joo Koon westbound platform which prevented trains from entering or leaving the platform. As a result of the “Closed Track” protection, the following train, Train 3547/3548 came to a stop approximately 36 metres from the Joo Koon westbound platform tail-wall. This is illustrated in **Figure 3** below.

Figure 3: Creation of “Closed Track” protection at Joo Koon westbound platform

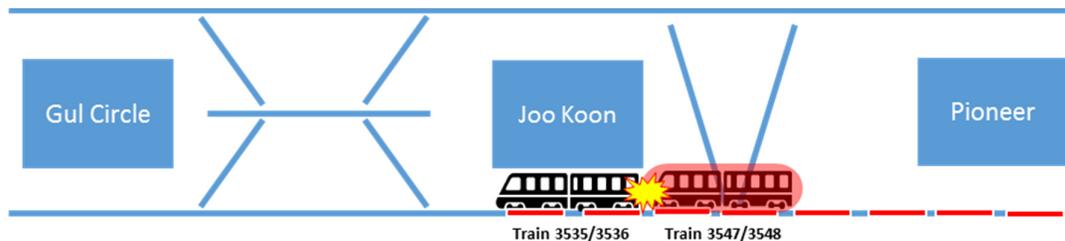
7. Once passengers had de-trained from Train 3535/3536, the platform screen doors were manually closed, and the “Closed Track” protection around the platform was lifted to allow Train 3535/3536 to move off. As the NCO protective “bubble” on Train 3535/3536 had earlier been inadvertently disabled, Train 3547/3548 could not detect the presence of Train 3535/3536 ahead, and moved forward in AM (but restricted to 18 km/h due to the TSRs invoked by Train 3535/3536). At 8.20am, Train 3547/3548 collided with the rear of Train 3535/3536 before the latter could depart from Joo Koon westbound platform, as shown in **Figure 4** below.

Figure 4: Lifting of “Closed Track” protection at Joo Koon MRT Station and collision
