REPORT ON POWER DISRUPTION ON NORTH-SOUTH AND EAST-WEST LINES (NSEWL) AND CIRCLE LINE (CCL) ON 14 OCTOBER 2020 (“INCIDENT”)

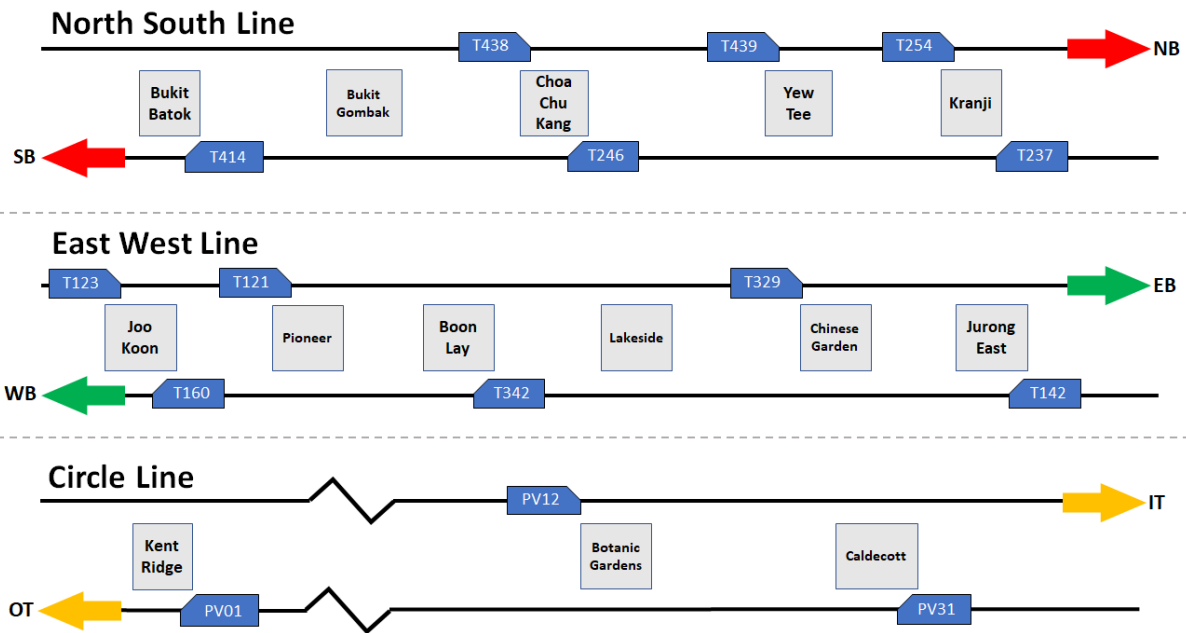
Figure 1: Location of Stalled Trains on NSEWL and CCL (Not to Scale)

4. At 7.34pm, a second 22kV power outage occurred, which affected train services on the CCL between Serangoon (CSER) and HarbourFront (CHBF) stations. Three trains were stalled in the tunnels with commuters on board (See Figure 1). Trains were turned around at CSER and Tai Seng stations towards Stadium station to continue service on the unaffected sectors of CCL.

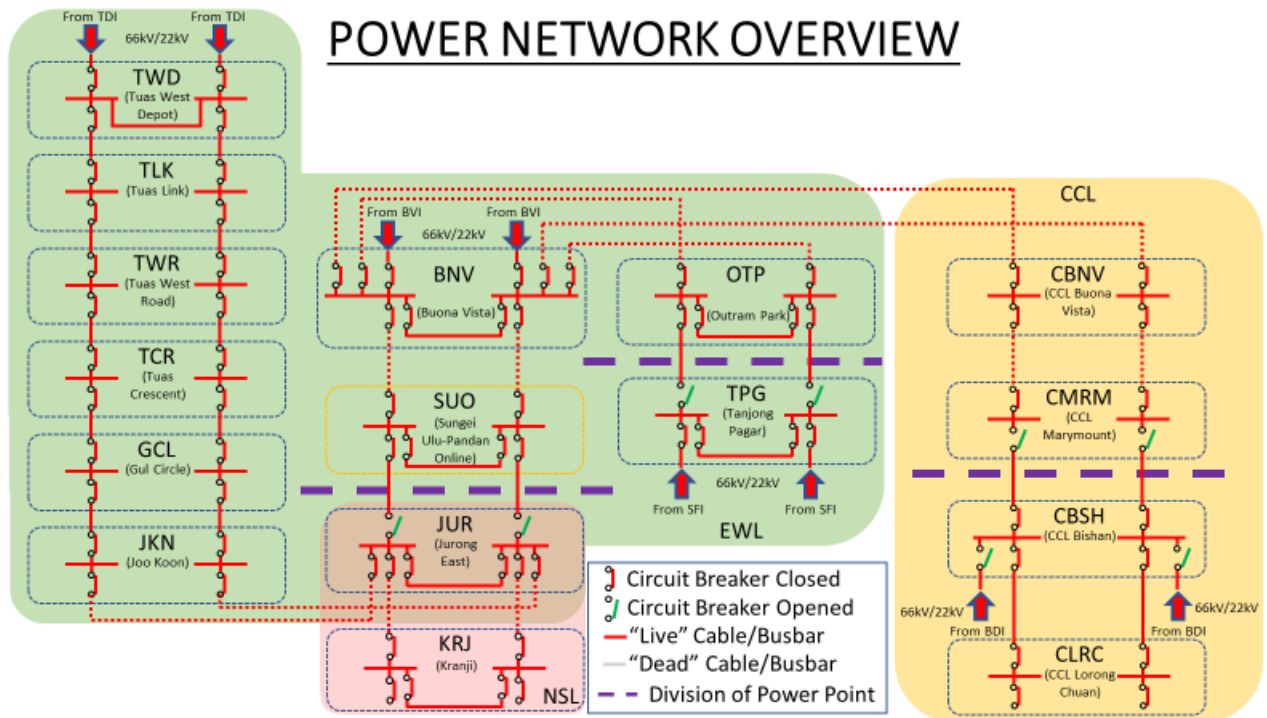
Figure 4: Schematic Power Diagram of Affected Areas on 14 Oct

16. A set of faulty 22kV cables between TLK and Tuas West Road (TWR) stations activated the primary protection, which is designed to trip open and “lock-out”¹ the 22kV breakers at TLK (breaker HL304) and TWR (breaker HL303). (See Figure 4). However, the 22kV breaker at TWR (breaker HL303) failed. This activated the secondary protection which tripped open and “locked-out” a 22kV breaker at Tuas West Depot (TWD) (breaker HL302).

This cut off the 22kV power supply from the Tuas Depot Intake (TDI) substation affecting the NSEWL from TWR to JUR and JUR to KRJ.

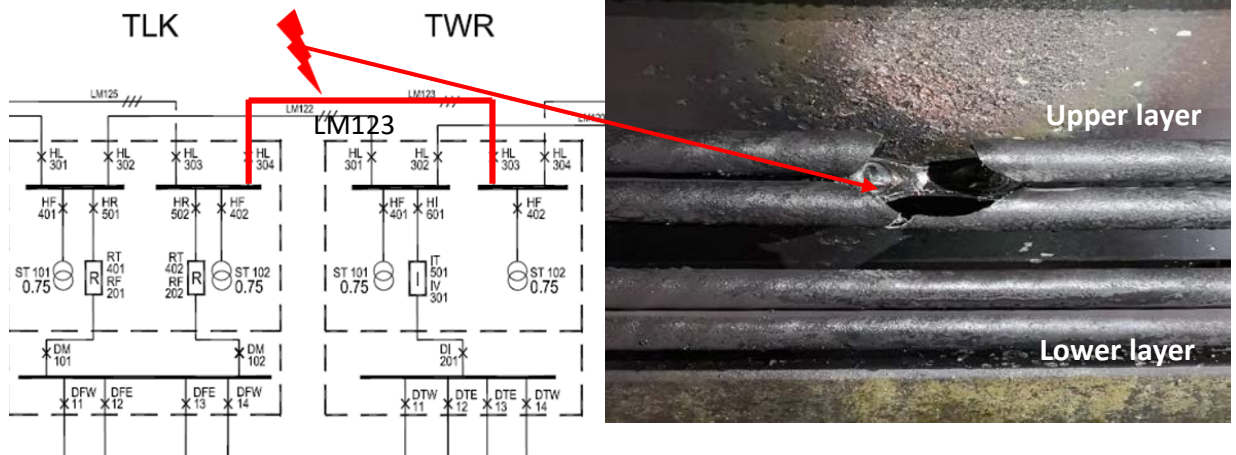
Picture 1: Burnt 22kV Cables

17. Site investigations conducted during engineering hours found that the 22kV cables on the upper layer were burnt through (refer to [Picture 1](#)). Measurements carried out indicated that there were short circuits between the three 22kV cables on the upper layer that led to high fault current burning through the cables at the fault location. This occurred at about 500m from TLK. A trip coil in the 22kV breaker at TWR (breaker HL303) was also found to have melted (refer to [Picture 2](#)). As a result, the TWR 22 kV breaker (breaker HL303) failed to operate and to isolate the faulty cables.

22kV cables found burnt at 500m away from Tuas Link (TLK) Station

22. Rectification works on the faulty cables between TLK and TWR were carried out and completed over two nights (16 and 17 October 2020). The trip coil for the 22kV breaker at TWR (breaker HL303) was immediately replaced and tested during the engineering hours of the incident night.

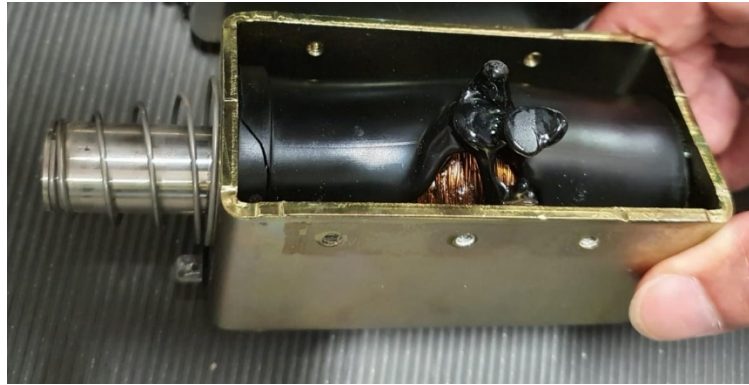
Picture 2: Melted 22kV Breaker Trip Coil

26. Prior to the 14 Oct 2020 incident, this failure mode of the 22kV breaker trip coil had not been encountered at TWE. Alstom has sent the faulty 22kV breaker trip coils at TWR (breaker HL303) and TWD for forensic examinations.

27. While the cable replacement is in progress, to provide assurance, Alstom will be replacing all TWE 22kV breaker trip coils². LTA will implement weekend Early Closures from November 2020 to accelerate the trip coil replacement works and completed by end 2020.

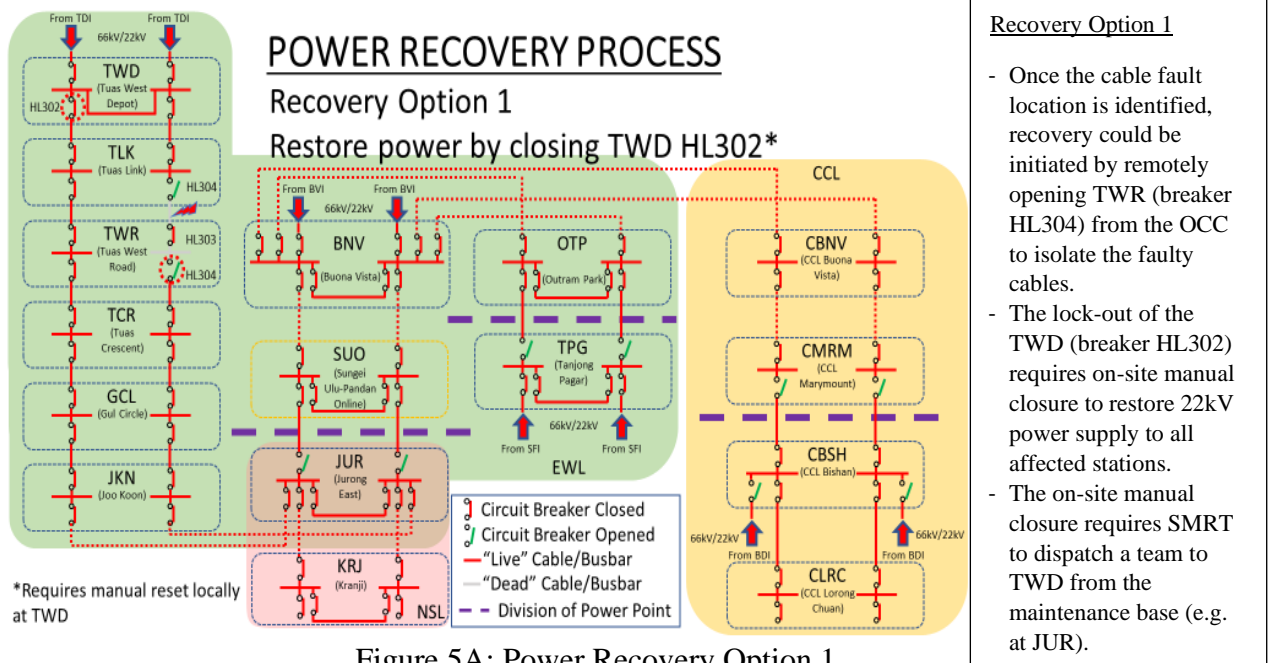
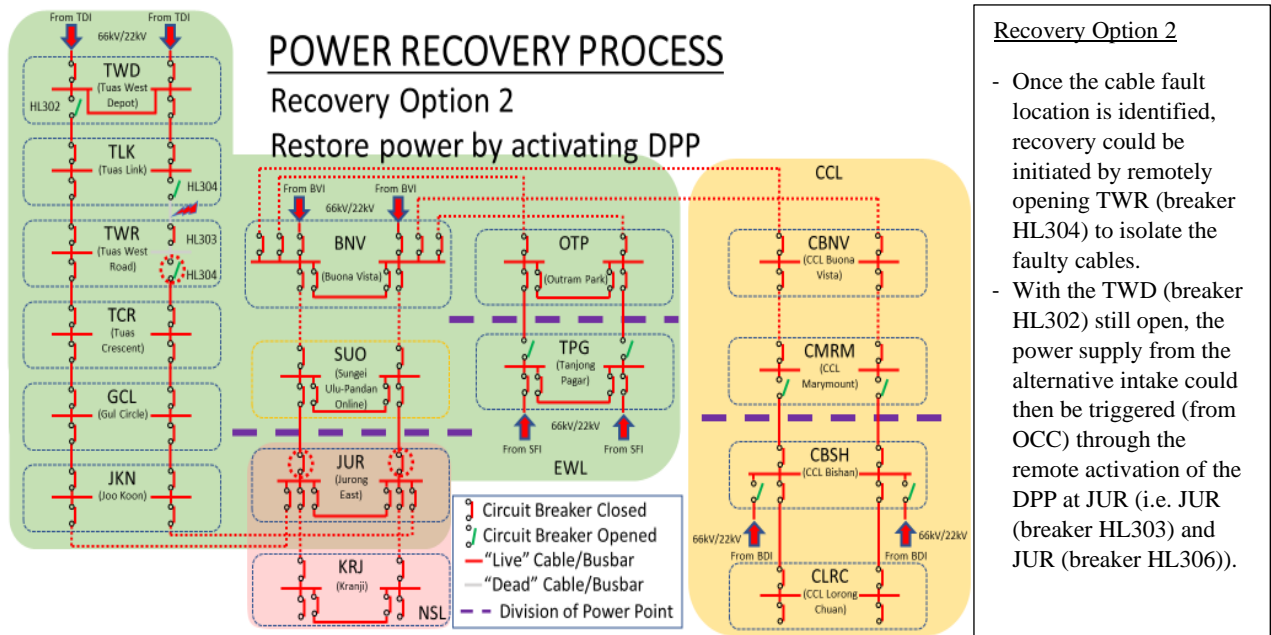
Figure 5B: Power Recovery Option 2

19. Based on the investigation findings, SMRT initially tried to reset the breaker at TWD (breaker HL302) in line with Recovery Option 1 to restore power from TDI. However, this did not work as the cable fault between TLK and TWR was not isolated. SMRT then decided to activate the DPP operation (Recovery Option 2) to draw power from the alternate intake sub-station located at Buona Vista (BVI). This action caused a voltage dip at BVI.

20. The protection devices at BVI were activated in response to a voltage dip. As BVI also serves the CCL, this caused the CCL power outage. If the faulty cables had been isolated, the CCL outage could have been avoided and power restored to the affected TWE stations.

32. SMRT will review their power recovery SOP. In the interim period, whilst the cables are being replaced, SMRT will increase their monitoring of the functional health of the trip coils and conduct more frequent functional tests of their 22kV breakers.

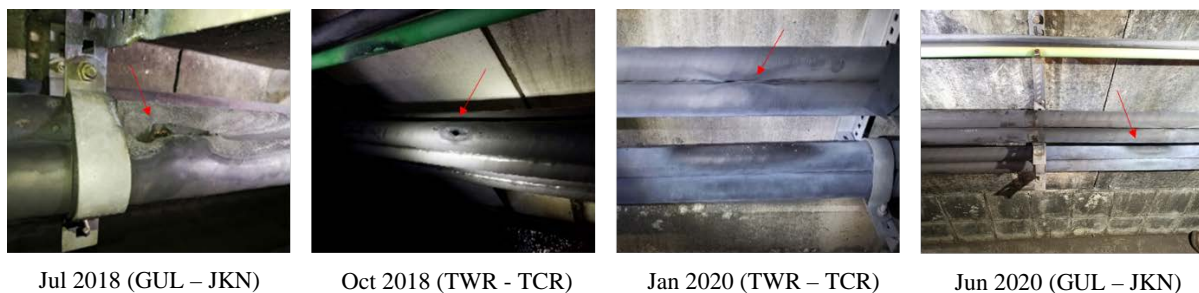
Picture 3: 22kV Cable Faults in 2018 and 2020

24. The Tuas West Extension commenced operations in May 2017. No cable fault was experienced in 2017, two cable faults occurred in 2018, and none in 2019. After the first two instances in 2018, the main power system contractor Alstom had implemented close monitoring for the 22kV cables, including condition monitoring for the affected electrical zones. In January 2020 and June 2020, two further cable faults occurred (Picture 3), Alstom then expanded condition monitoring system for all the 22kV cables along the entire TWE. In all of these four instances of cable faults (located at different stretch of TWE), train services were not affected as the primary protection operated to isolate the faulty cables. After the June 2020 cable fault, Alstom agreed to replace all the upper layer 22kV cables with higher specification cables and provided an extended warranty of 20 years for the lower layer cables, with the commitment that these would also be replaced if the monitoring showed deterioration. This 18-month replacement work was scheduled to start in October 2020.

25. Following the 14 Oct 2020 incident, Alstom has acceded to LTA's further request to extend the cable replacement to include the lower layer, while they carry out fault investigation with their cable supplier into the cause of the 22kV cable failure. Approximately 150km of 22kV cables will be replaced. As replacement for the lower layer of cables will take time to arrive, LTA will schedule Early Closures/Late Openings on weekends or Full Sunday Closures for limited periods in 2021 to facilitate the cable physical replacement works.
