## **Findings of Investigation into the Train Derailment Incident on the East-West Line (EWL) on 25 September 2024**

### **Summary of Findings**

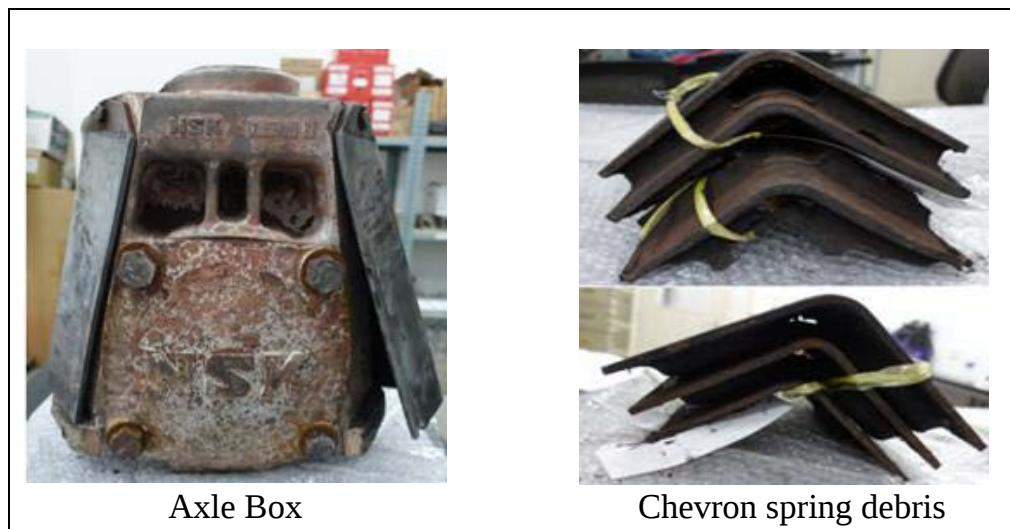
Figure 3: Recovered axle box and chevron spring debris.

5. The recovered axle box and axle bearings were badly damaged, and the grease in the axle box had completely burnt off. The recovered chevron spring debris was also

too badly damaged for any tests to be done to identify any initial damage prior to the incident. It was therefore not possible to establish a definitive root cause.

7. The locations of the damaged components recovered also supported the above findings that this was a likely failure mode. Burnt rubber and pieces of the chevron springs were found along the Incident Train's path of movement, which suggested that an overheated axle box due to the failure of the axle bearings had generated sufficient heat to ignite the rubber layers between the chevron springs, causing them to disintegrate. The chevron springs then progressively dropped off, which eventually resulted in the axle box becoming dislodged near Dover station.
