# SAFETY NEWS

Land Transport Authority  
We Keep Your World *Moving*

32<sup>nd</sup> Edition /  
ISSN 1793-1665  
Sep 2016

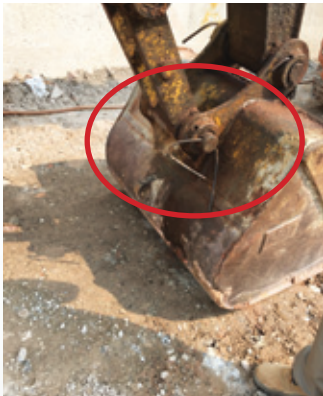
- Use of modified or non-original parts (Figure 4). All bolts / pins or connecting fasteners used must be in accordance to manufacturer's design and be readily identifiable.
- Missing bolts and securing pins on connecting parts of crane / rig, which could lead to structural failure.
- Non-functioning audio and visual alarm. Additional warning alarm must fitted externally and be audible to nearby workers.
- Rusty or damaged wire ropes due to inadequate maintenance (Figure 5). Wire ropes must be properly maintained to prevent the ropes from failing during operation.

Figures 4: Non-original pin used to secure excavator bucket

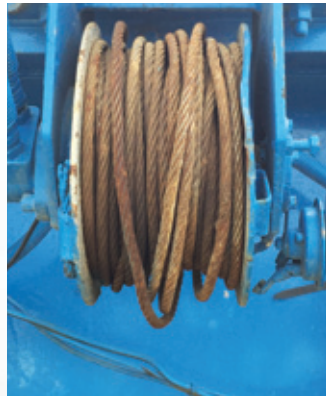
Figure 5: Inadequate greasing leading to corrosion of wire ropes

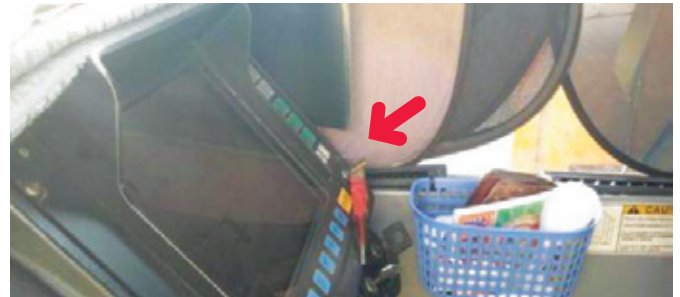
- Bypass switch keys were not kept by the contractor's safety team to prevent unauthorised access to the switches (Figure 6).
- Inadequate or absence of barricade to demarcate crane lifting and slewing zone.

Figure 6: Key to the bypass switch inserted in the control panel

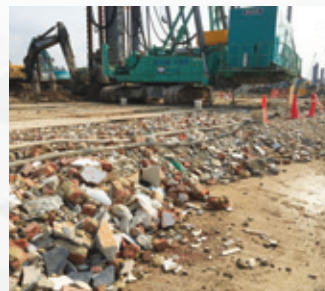
- Absence of hardcore before steel plates were laid.
- Lifting machine failed to keep a safe distance away from a slope.
- Provision of substandard hardcore material (Figure 7) and voids beneath steel plate (Figure 8).
- Weak / soft grounds due to wet weather.

Figure 7: Industrial debris used as hardcore material

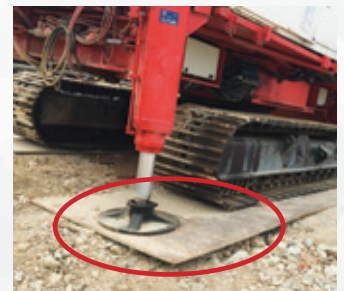
Figure 8: Working platform not properly compacted resulting in voids beneath steel plate

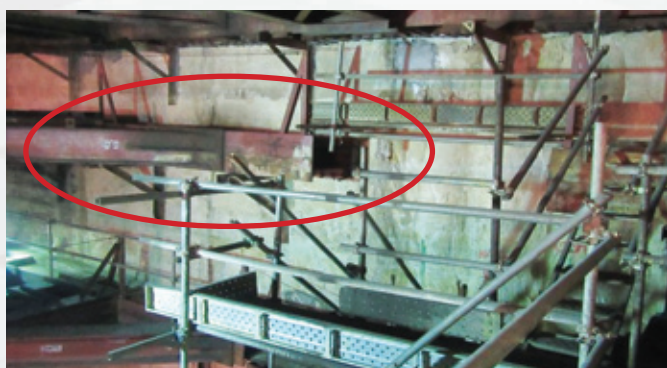
- For hard to reach areas that require checking for larvae and oiling (e.g. intermediate level walers and struts) (Figure 5), proper access with safety provision has to be planned in advance and provided.

Figure 5: An intermediate level waler

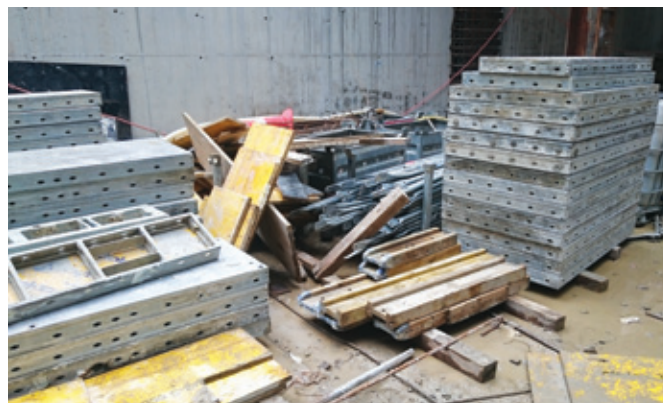
- The storage of excess material within station box can create difficulty for workers to conduct vector inspection (Figure 6). Proper access should be provided to facilitate the removal of excess materials, and this will improve housekeeping standards.

Figure 6: Excess material within the station box

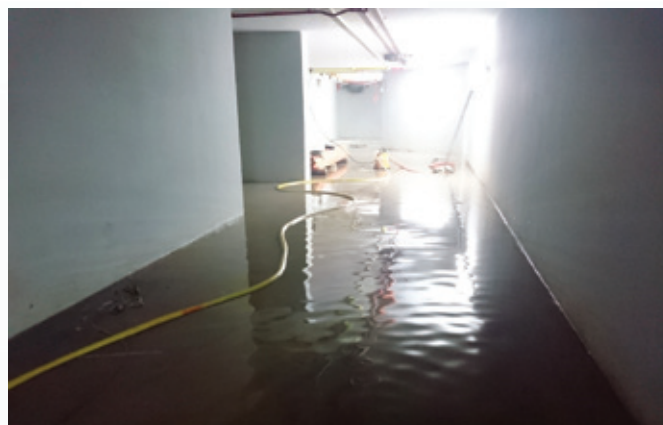
- Heavy rainfall can cause water stagnation on slab (Figure 7). Contractor should develop a plan in advance of these period. Sufficient resources (e.g. workers and equipment) should be allocated during periods of high rainfall.

Figure 7: Water stagnation on slab

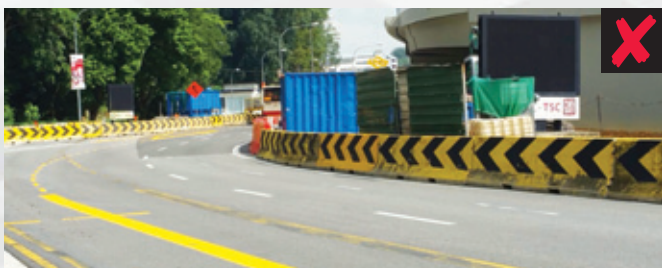
The sight visibility of motorists is often found obstructed by the hoarding installed round the inner bend of the diverted road. Despite the commitment of providing half-height hoarding in the design stage, the view of motorists around the bend is still compromised by the parking of machinery, equipment or storage of materials within the clear zone designated for achieving the required sight distance.

Figure 1: Container placed within the line of sight around inner road bend

A demarcated object-free zone within the hoarded work area should be provided for the motorists to have adequate sight visibility around the road bend and at junction.

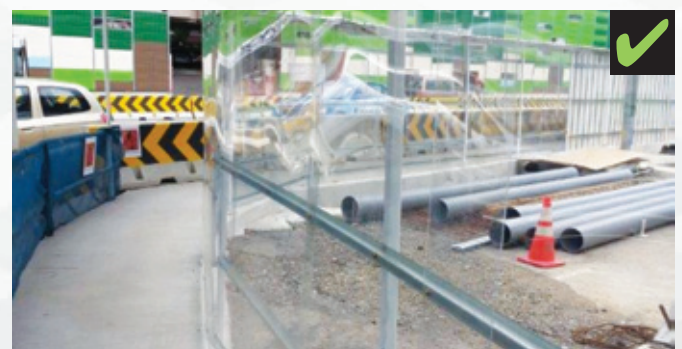
Figure 2: Clear view at the corner of the junction with acrylic panels

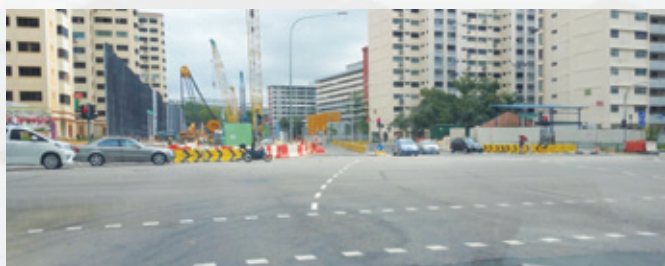
Skewed lane alignment across the traffic junction has been observed in some projects as a result of site constraints. In order to mitigate the hazard, guideline has been provided to guide vehicles across the junction safely so that vehicles will not encroach into the adjacent lanes and cause side-swipe accident.

Figure 6: Guidelines provided across misaligned junction

As much as site condition allows, fundamentally, the hazard of junction misalignment should be designed out. The lanes across the junction are appropriately aligned in the subsequent stage of diversion as shown in Figure 7.

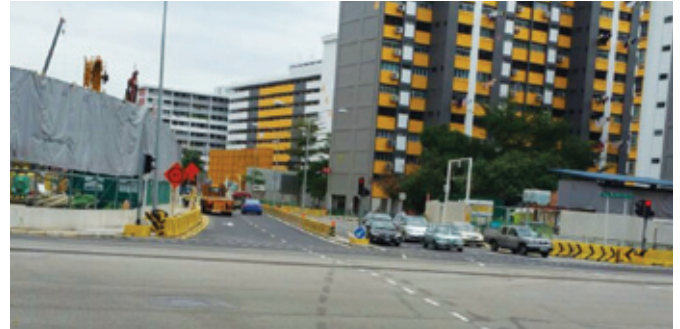
Figure 7: Improved alignment across the junction in subsequent stage of diversion
