"Be Device-Safe" Programme

The "Be Device-Safe" Programme is a joint initiative by the Land Transport Authority (LTA) and the Singapore Civil Defence Force (SCDF). It aims to provide AM device users with valuable tips on purchasing compliant and approved devices, ensuring the safe use of active mobility devices, and the responsible disposal of non-compliant devices.

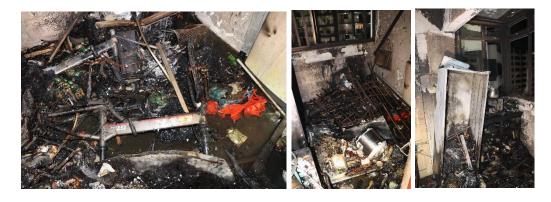
Case Study 3 - Lorong 6 Toa Payoh

The fire originated in a stationary Power-Assisted Bicycle (PAB) left in the kitchen of a residential unit.

The intense heat and fire caused extensive damage to the unit, the corridor ceiling, and even the unit above. The elderly PAB owner also suffered smoke inhalation. Neighbouring residents were prompted to self-evacuate.

Investigations revealed that the circuitry of the PAB was modified with an anti-theft alarm and had not been used for an extended period.
