# DESTROY HOMES AND LIVES

INFO PACK

## Charging devices with non-original parts can destroy homes and lives

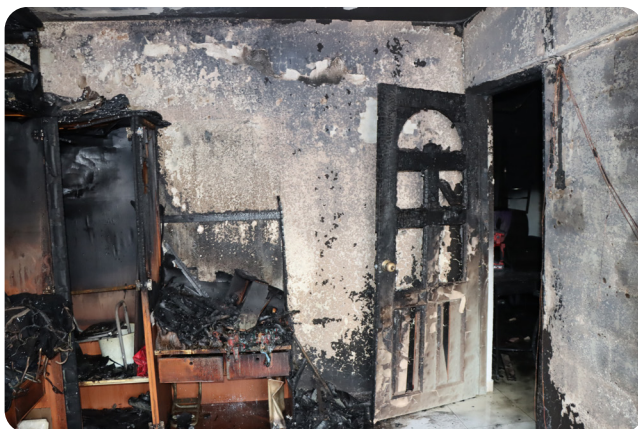
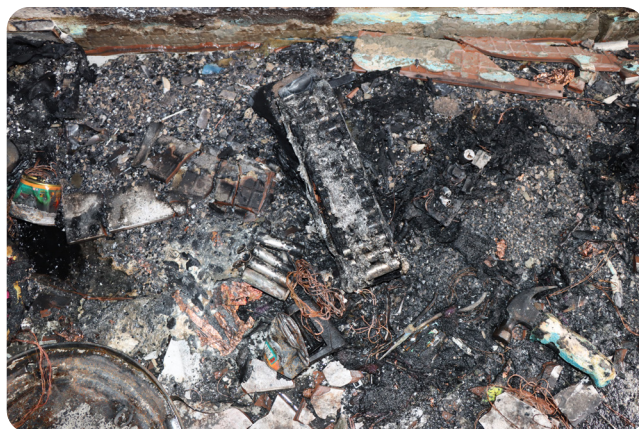
### Case Study 1: Bedok North Road

The owner was awoken by the sound of explosion and saw smoke emitting from his Power-Assisted Bicycle (PAB) battery which was left charging unattended. A fire broke out from the device and attempts to put out the fire were unsuccessful.

Investigations revealed that that fire originated from the battery of the PAB and a non-original charger (without Safety Mark) bought from an online marketplace seller was used at the time of the fire.

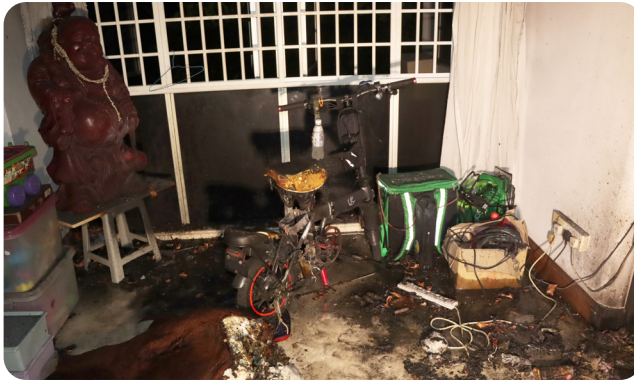
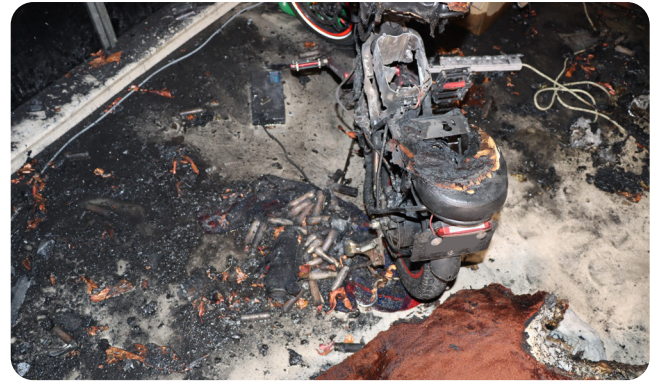
### Case Study 2: Tampines St 45

The owner was charging the Power-Assisted Bicycle (PAB) when smoke started emitting from the lithium-ion battery pack on the PAB and it exploded. The resulting fire spread rapidly in the unit and the owner suffered 2nd degree burns to his right forearm.

**Investigations revealed that the device was bought first-hand from a retail shop and the lithium-ion battery used at the time of fire was a non-original part bought from an online marketplace seller.**

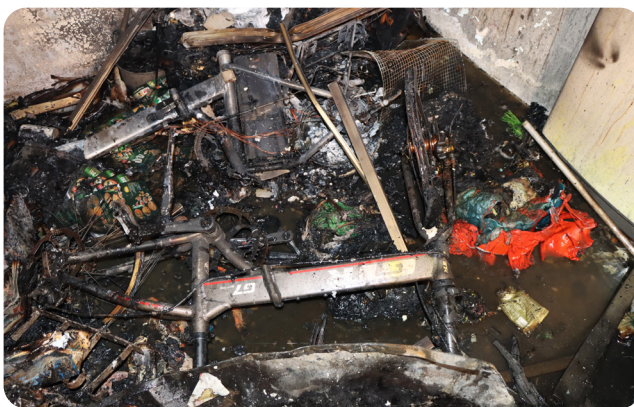
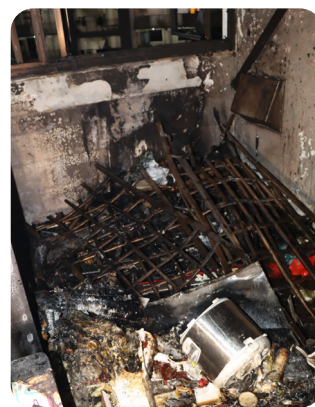
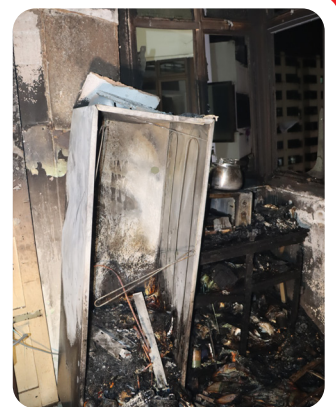
### Case Study 3: Lorong 6 Toa Payoh

The fire originated in a stationary Power-Assisted Bicycle (PAB) left in the kitchen of a residential unit. The intense heat and fire caused extensive damage, including to the unit above. The elderly PAB owner also suffered smoke inhalation.

**Investigations revealed that the circuitry of the PAB was modified with an anti-theft alarm (non-original) and had not been used for an extended period.**

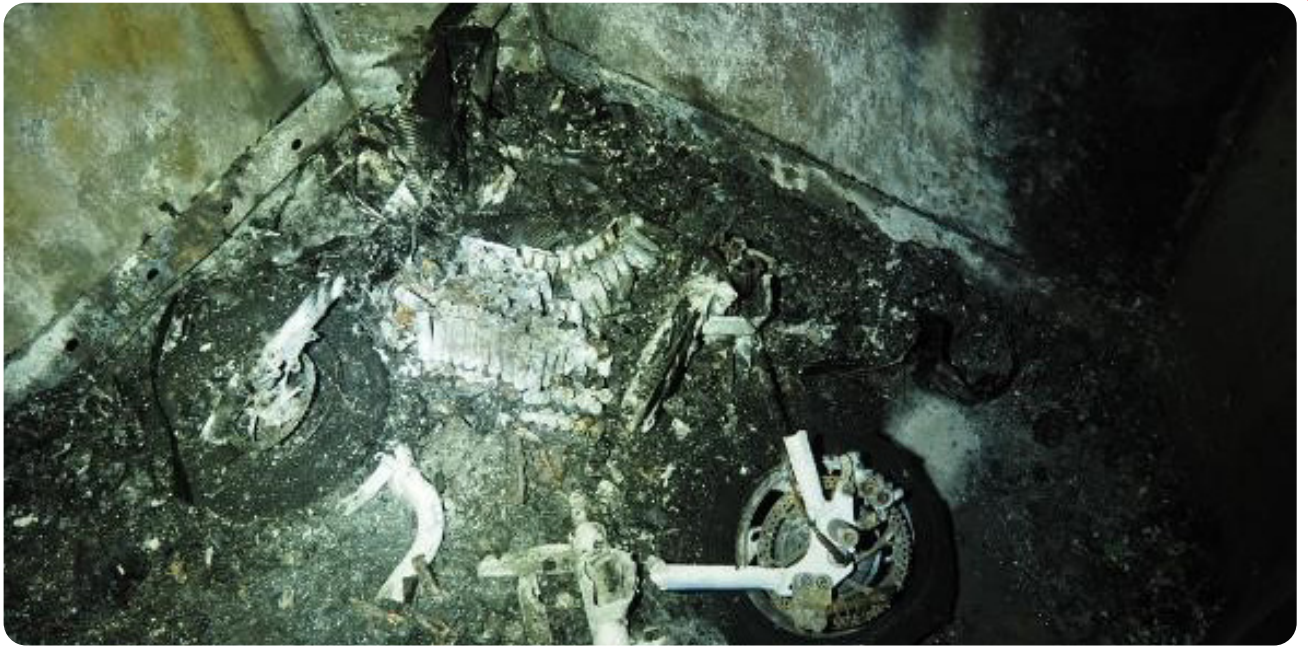
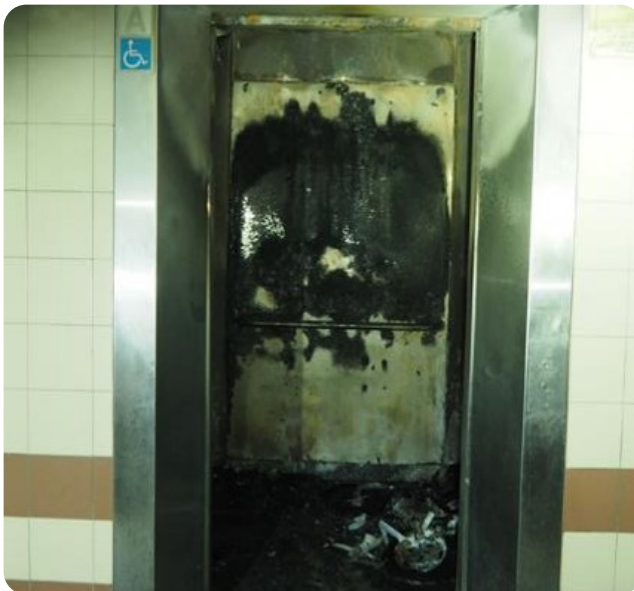
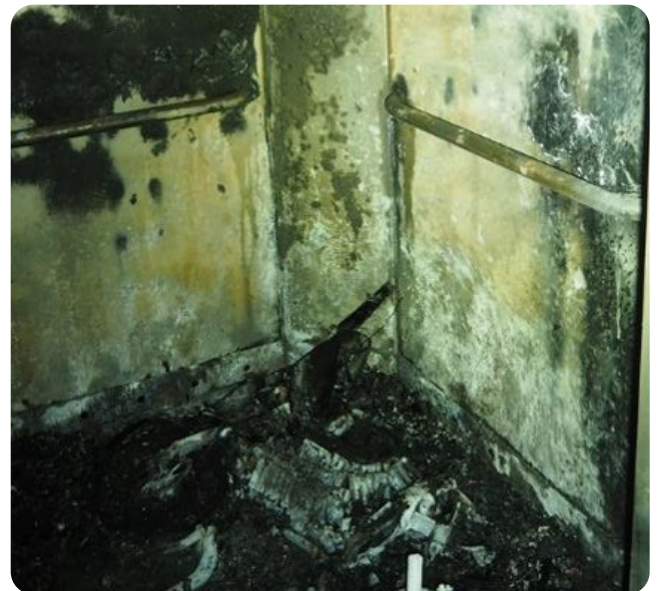
## Case Study 4: Woodlands Drive 16

The owner of the Personal Mobility Device (PMD) was taking the lift down from the ninth floor with his device when a burst of flames suddenly occurred and engulfed the entire lift car within seconds. The PMD owner sustained serious burns to his body and unfortunately, succumbed to his injuries thereafter.

**Investigations revealed that the PMD was a non-compliant device and had been modified with a non-original, higher-powered battery pack. The motor of the PMD was also found to be modified. The most probable cause of fire was due to a damaged battery pack and overheating of components.**

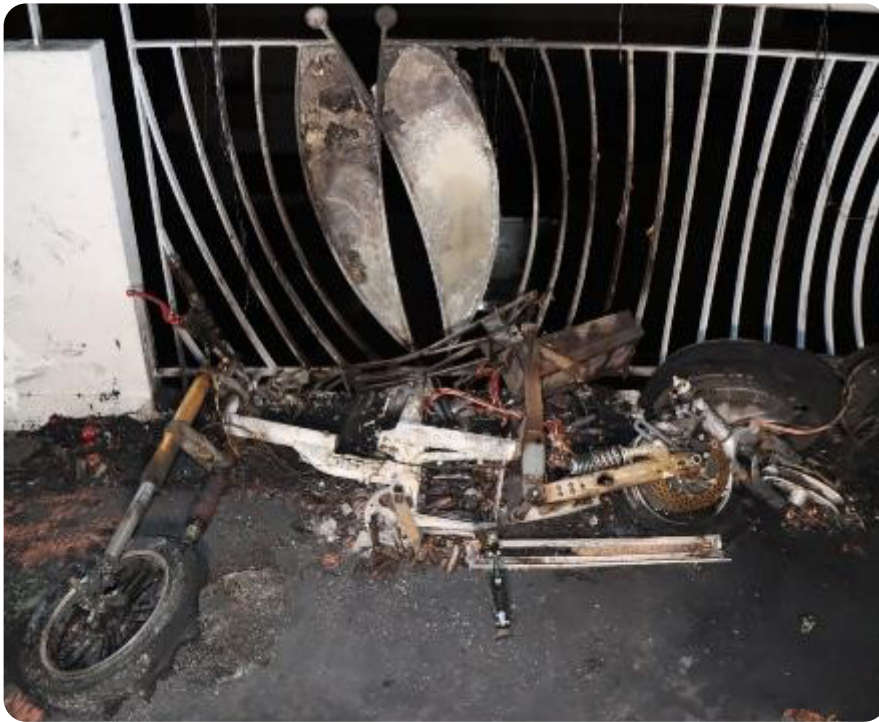
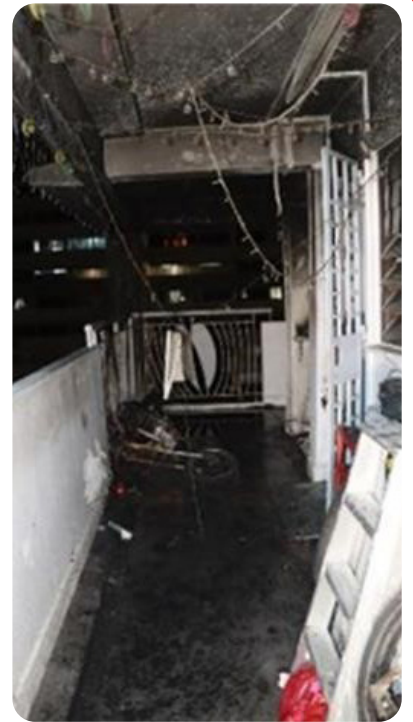
### Case Study 5: Bedok South Road

The owner of the Power-Assisted Bicycle (PAB) was charging his device along the corridor from a power socket within his house via an extension cable when he noticed the PAB emitting sparks. He removed the extension cable and returned to his house. Despite his efforts, the PAB caught fire thereafter and triggered an evacuation of some 50 residents.

**Investigations revealed the PAB was non-registered and was purchased from a secondhand seller back in 2021. The owner had also modified the PAB by equipping it with a non-original battery bought from an online marketplace.**

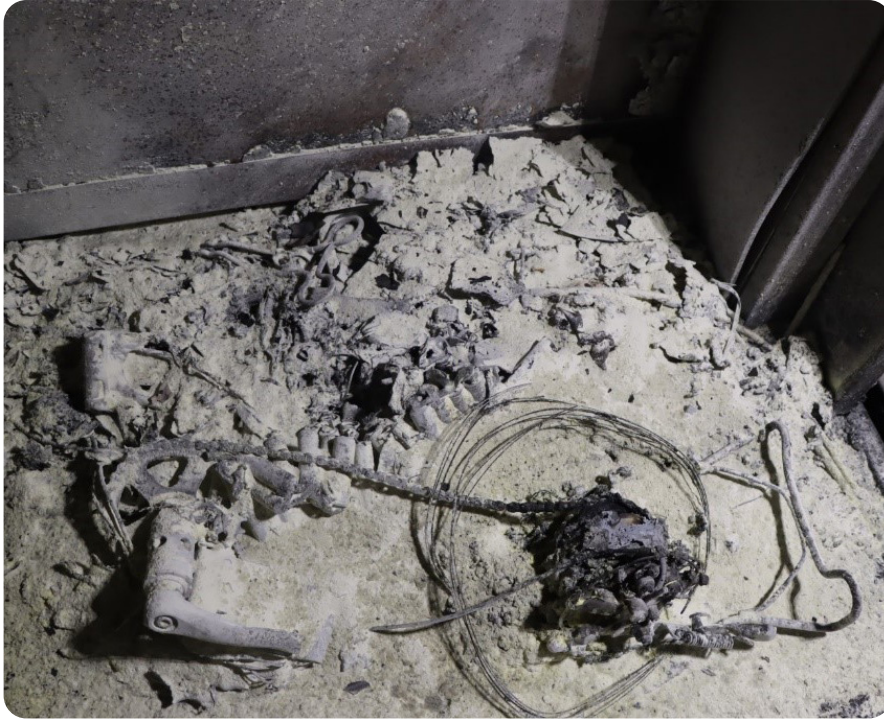
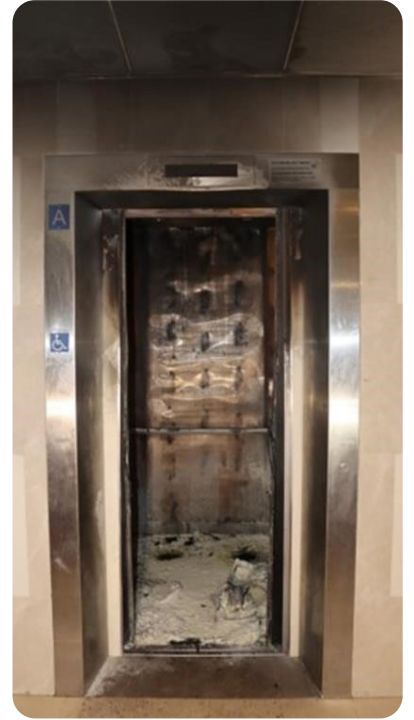
## Case Study 6: Bukit Batok West Ave 9

The owner of the Power-Assisted Bicycle (PAB) was taking the lift from the 10th floor when sparks occurred from the bottom of the battery. Shortly after, smoke was seen, and a fire ignited in the lift.

**Investigations revealed that modifications were carried out to the device controller. The controller has also been shifted from the bottom bracket area to the rear rack. Additionally, the device LCD display panel and other controls were also removed from its default locations.**

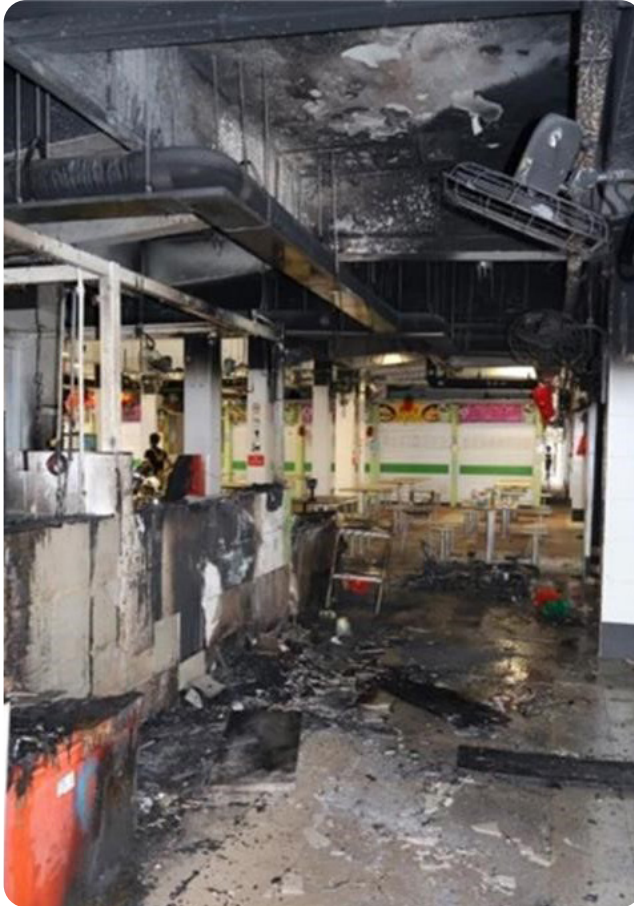
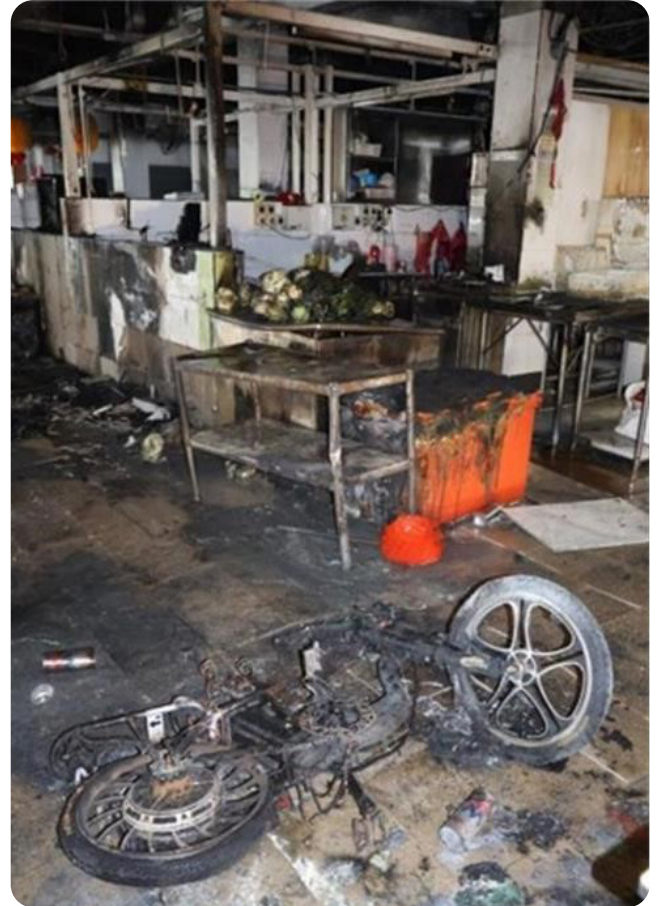
## Case Study 7: Jalan Bukit Merah

A Power-Assisted Bicycle (PAB) parked at a hawker centre saw smoke emitting out from its battery. Shortly after, an explosion occurred, and the device was ablaze. Several stalls near the device suffered extensive heat damage.

**Investigations revealed that the owner had a non-original battery pack in the delivery bag attached to his PAB. The battery has been modified to increase voltage.**

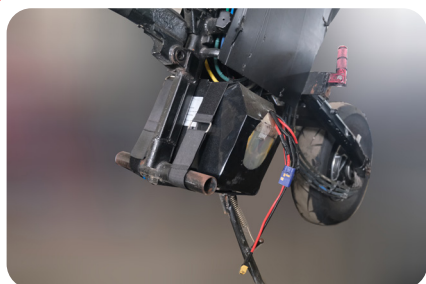
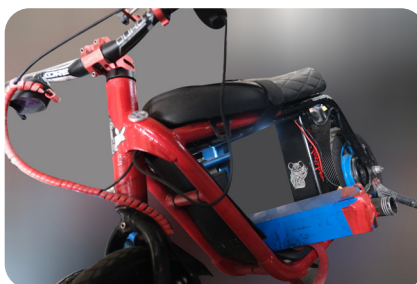
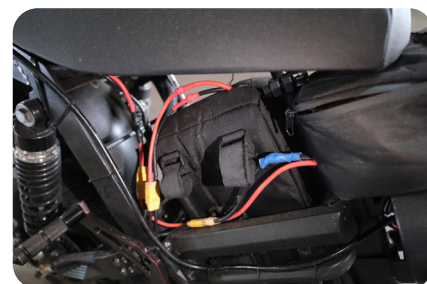
▲ Additional battery pack or extra cabling that leads to a bag concealing additional battery pack.

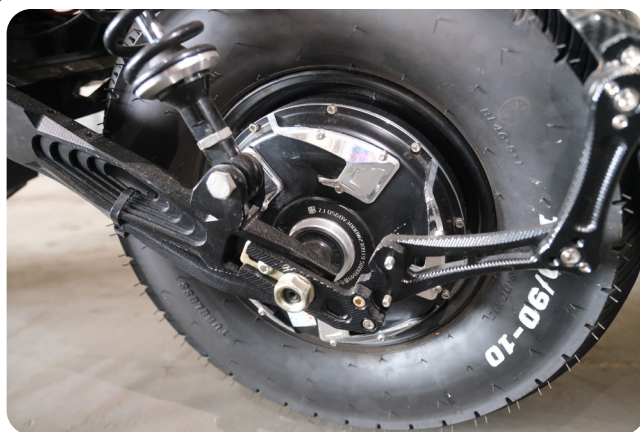
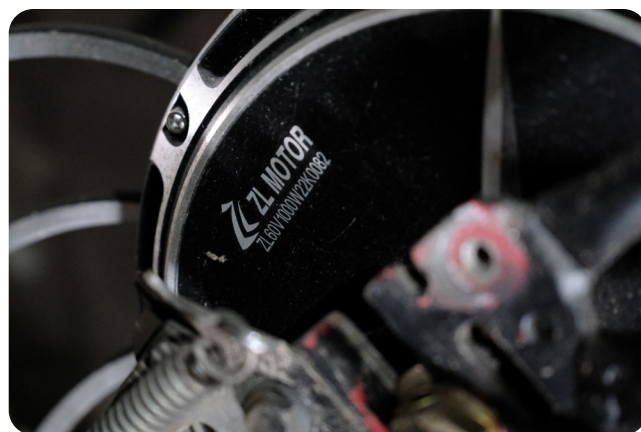
▲ Non-original motorhub with printed wattage value showing more than 250W for Orange seal and 200W for Blue seal.

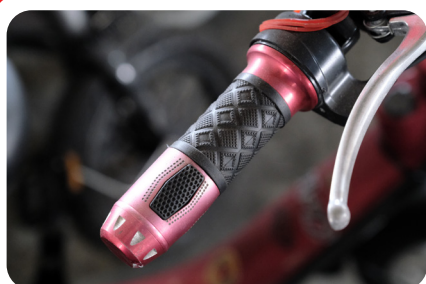
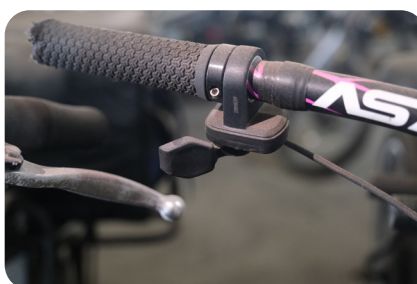
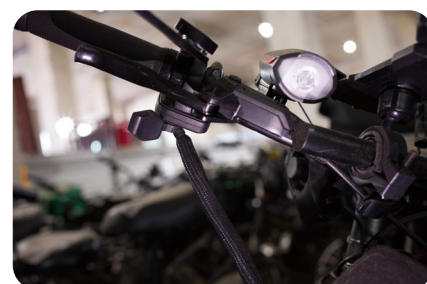
▲ Non-original handlebar grip that rotates or added levers that may suggest device is modified with throttle to bypass the pedal-assisted function.

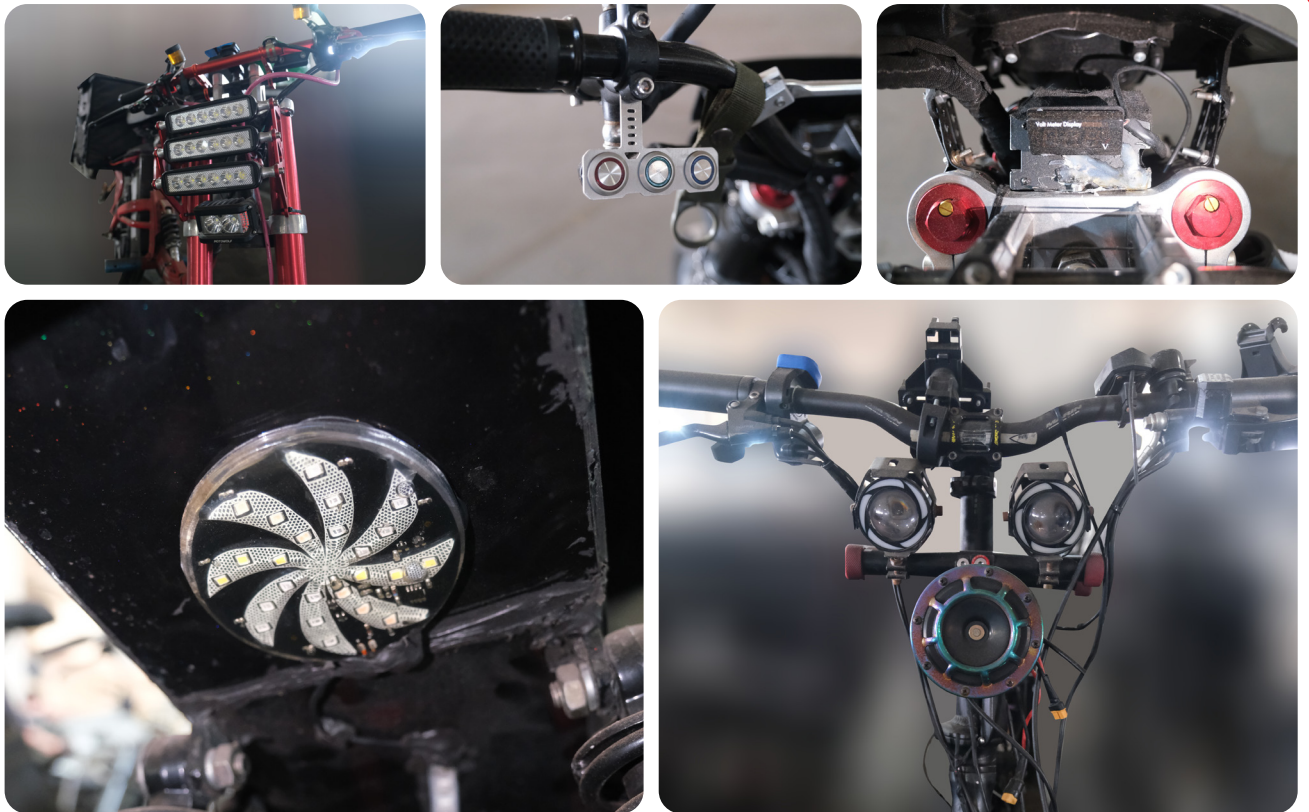
▲ Tampering of the electrical components through installation of additional lighting, electronic accessories, etc. that draw power from the active mobility device's electrical system.
