Arrival of 12 New Trains in LTA Livery

Design Features of the New C151C Trains

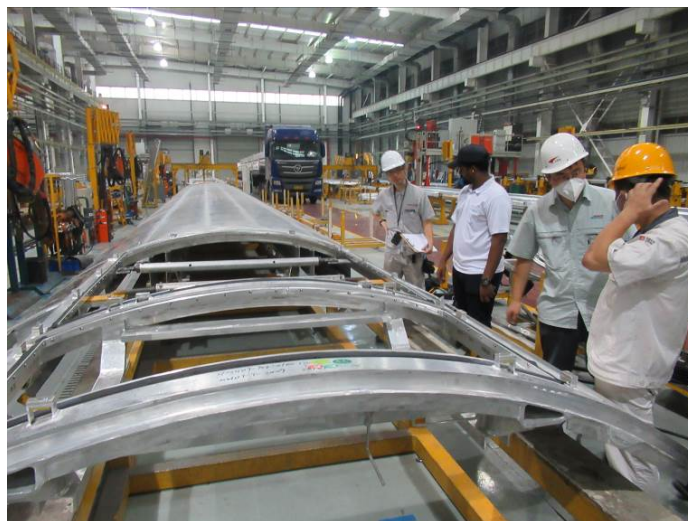
Figure 2: Inspection of train carbody parts

The safety, functionality, passenger comfort and performance of the trains and associated sub-systems are thoroughly tested and validated before the new trains are shipped to Singapore. LTA engineers are also stationed at the KSF factory in Qingdao to ensure consistently high standards throughout the process of train assembly and testing.

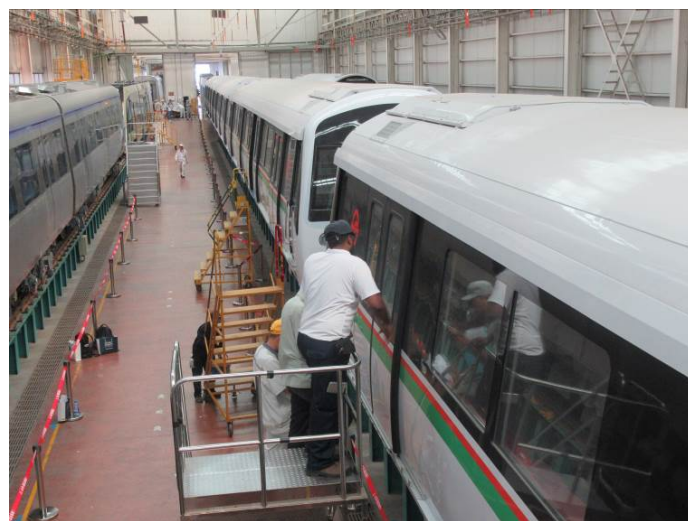
Figure 3: Inspection of the train exterior after testing

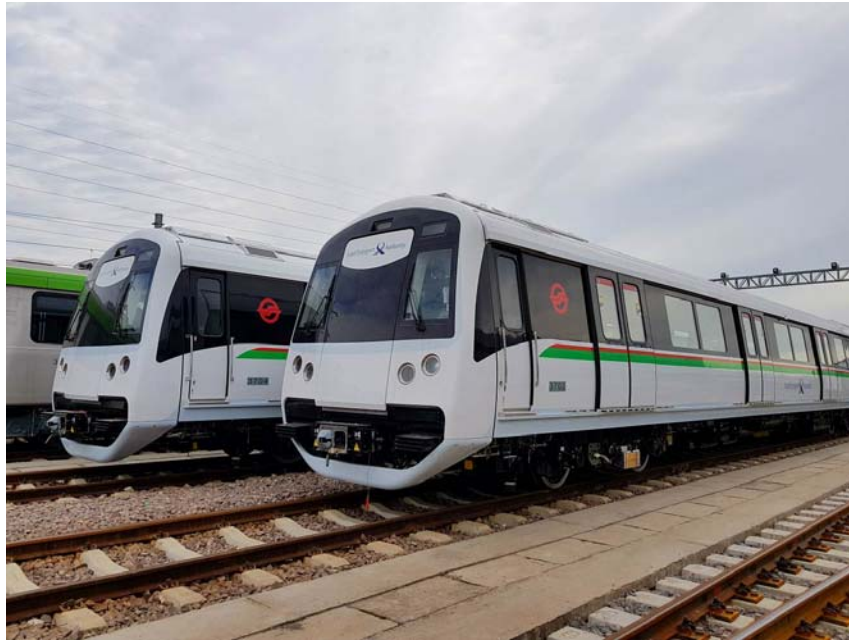
Figure 4: Trains #01 and #02 in CRRC Sifang factory in Qingdao, China

The new train livery incorporates red and green stripes against a white background. The colours symbolise the two lines that the trains will be operating on i.e. the North-South Line (red line) and the East-West Line (green line). This is also the first time that LTA's logo will be featured on the body of an NSEWL train.

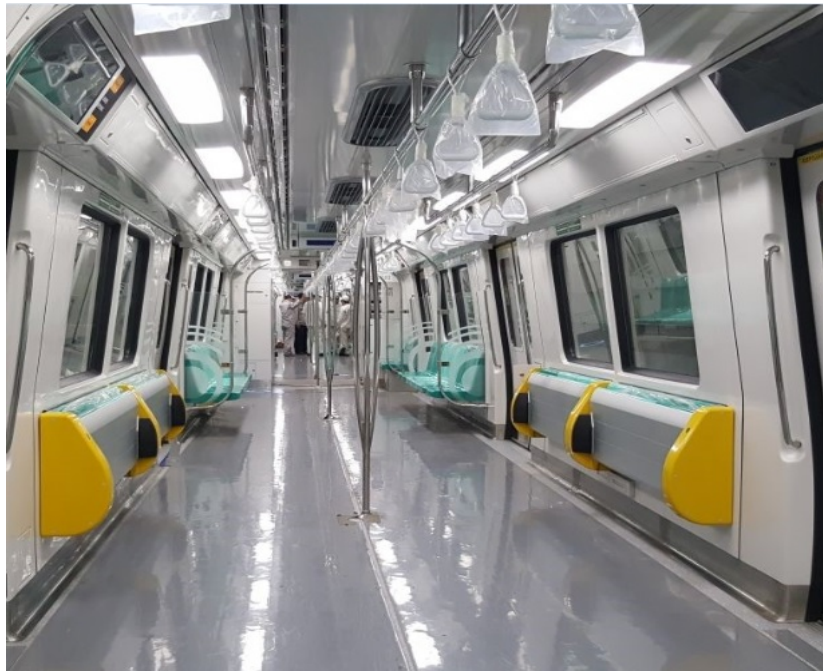
Figure 6: The tip-up seats when folded

These new trains will be the first in Singapore to incorporate tip-up seats. Four sets of tip-up seats with three seats each are located in the centre of each car. This feature is expected to provide more standing space for passengers during morning and evening peak periods.

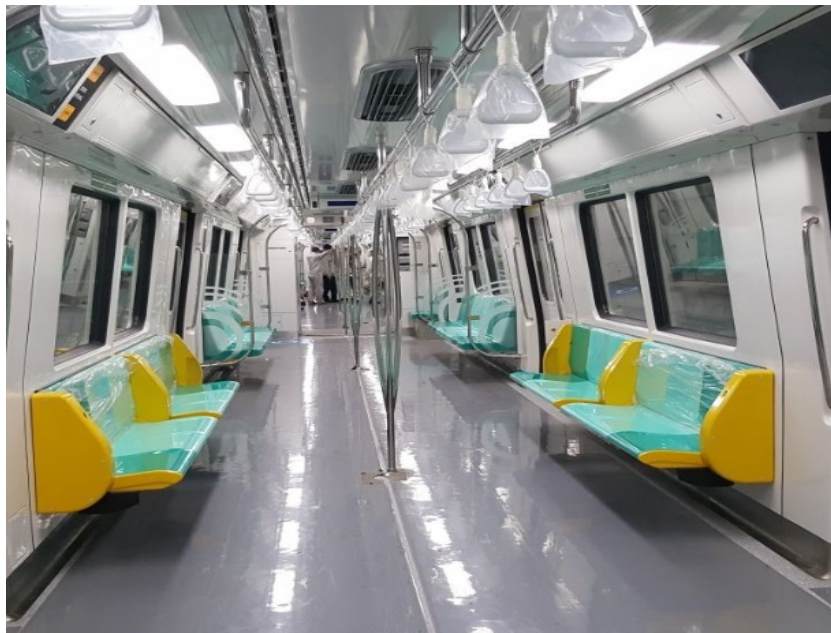
Figure 7: The tip-up seats when unfolded
