SAFETY NEWS

28th EDITION / ISSN 1793-1665 OCT 2014

Reducing Hazards Through Innovation and Technology

Safety Considerations in System Enhancement for BPLRT

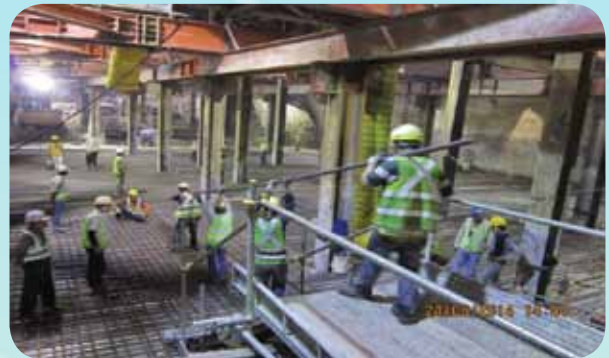
Figure 1: Conventional way of fixing rebars for ground slab

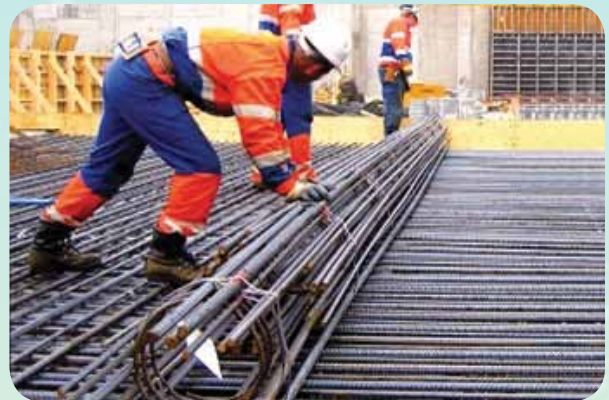
Figure 2: Workers rolling out a bundle of the 'rebar carpet'

One approach to reducing the hazards associated with rebar works is for designers to consider the innovative idea of using rebar carpets. As its name implies, this involve using machines to pre-weld rebars to flexible straps and rolling them up, very much akin to rolls of carpet grass that can be found at nurseries, for easy handling and delivery to worksites. These rebar carpets are then positioned and unrolled on site at the designated areas.

This method substitutes the laborious conventional rebars tying process where workers are required to manually carry the rebar pieces and tying them manually. This significantly reduces the need for manual handling and consequently lowers the risk of hand and lower back injuries typically associated with rebar works.

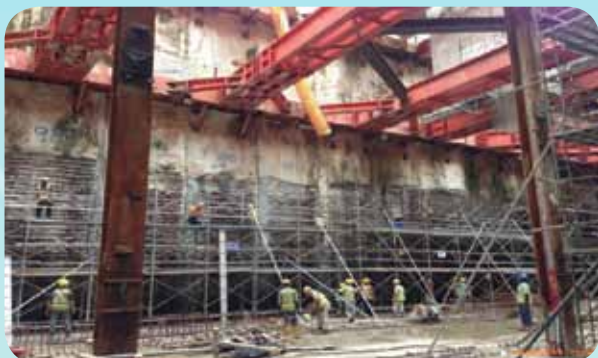
Figure 3: Conventional method of using scaffold and pneumatic breakers

The conventional way to expose the D-wall rebars require the use of scaffolding to allow workers to access and

manually hack off the covering concrete using pneumatic / electrical handheld breakers. The hazards associated with this work activity include falling from height, struck by concrete debris, exposure to excessive noise and dust, and vibration white finger (also known as hand-arm vibration syndrome (HAVS) or dead finger; an industrial injury caused by continuous use of vibrating hand-held machinery).

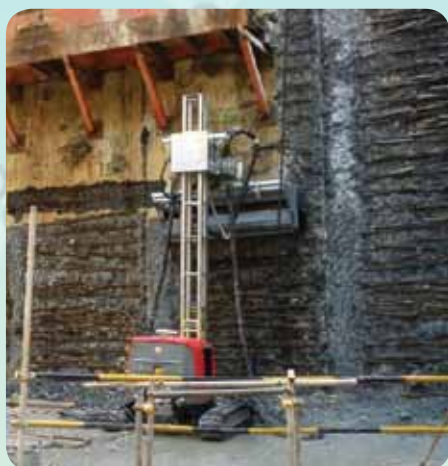
Figure 4: Use of high pressured water jet to remove concrete layer to expose rebars for integration with skin wall, slab and beam

These hazards can be eliminated with the use of a remote controlled robotic hydro cutter machine. The hydro cutter machine uses high pressured water to cut the concrete; it is equipped with a rubber lined splashguard and can swivel and position the water-jet nozzles over any area of the concrete surfaces to be demolished. The depth of the concrete surface to be cut can be adjusted by varying the pressure of the water. Besides significantly reducing the number of workers required for the work, it also keeps the workers from being exposed to the typical hazards associated with this work. In addition, it can work continuously over an extended period of time with minimal supervision, resulting in increased productivity at minimal risks to the workers.

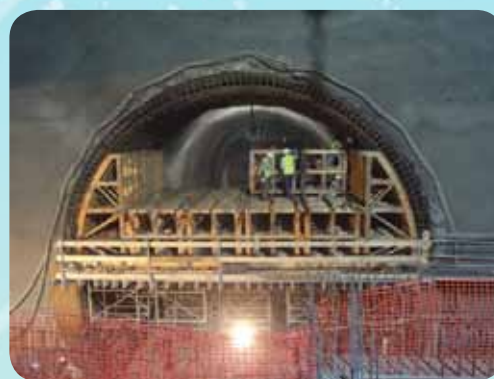
Figure 5: Conventional timber formwork system used for the construction of the permanent lining of a mined tunnel

Conventional timber formwork and proprietary system formwork are commonly used for the construction of permanent lining for mined tunnels. These systems usually require the formwork to be constructed in a few stages; typically some for side walls and another for the tunnel crown, and they are required to be dismantled and re-erected for each advance along the tunnel length. The hazards associated with the use of such systems include falling from height and formwork structure failure.

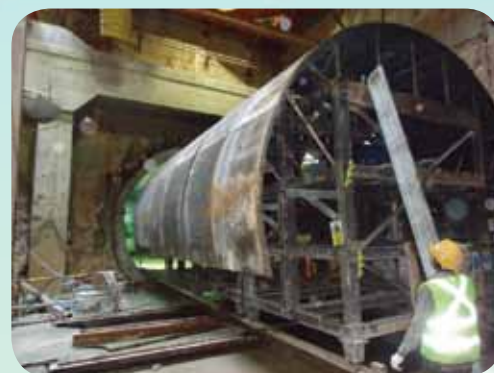
Figure 6: A Self Propelled Hydraulic Formwork System

The self-propelled hydraulic formwork system consists essentially of prefabricated steel-form panels fitted with hydraulic jacks. When extended, the hydraulic jacks hold the formwork in place and can be adjusted to fit the variable geometry of the final permanent lining of the tunnel. Fresh concrete is injected via a stationary pump to a network of discharge points to fill the mould. When the desired concrete strength is achieved, stripping of formwork becomes a breeze simply by retracting the hydraulic jacks to debond the formwork from the concrete surfaces. This formwork system is mounted on steel wheels and rested on rail tracks, and depending on the length of steel-form, it can be manually pushed or propelled by a pair of geared hydraulic motors to aid its advancement.

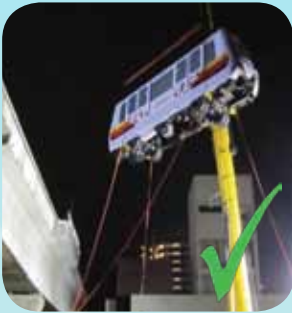
Figure 3: Tagline used to control of swing of load

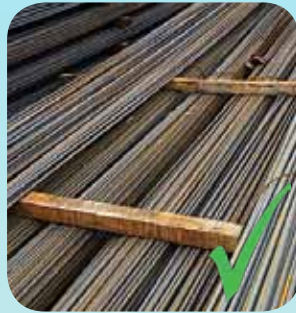
Figure 4: Timber spacers between stacked rebar for easy rigging

- Ensure that rebar bundles are stacked with (timber) spacers to allow room for rigging them up to the lifting gears.
- Ensure that the rigging is rigidly secured and firmed before the load is to be lifted. Where needed, use a crow bar or timber to make the adjustment.
- Use tag lines to control the load to prevent abrasion injury.
- Wear suitable leather gloves when handling the loads and lifting gears.
- Always keep a safe distance away from lifted loads.

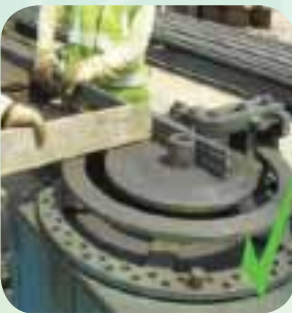
Figure 5: Use timber planks to wedge rebars

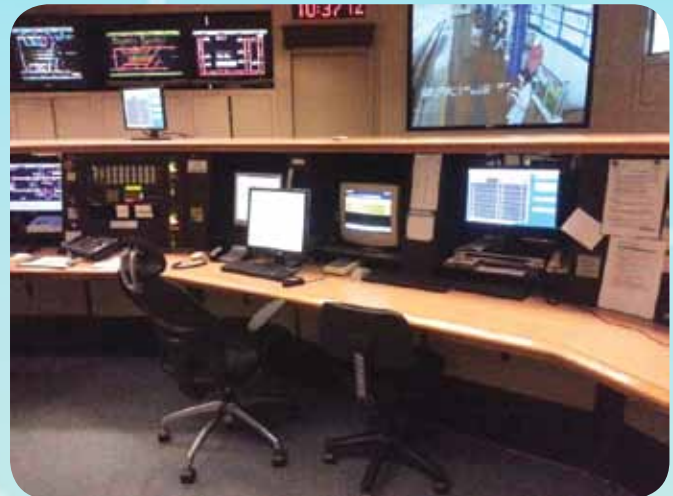
Figure 1: New ORS (Operational Radio System) PC installed during Stage 1 Radio Migration

At stage 1, new radio equipments were commissioned progressively. A thorough coverage test before installation and commissioning of the new radio equipments was conducted to serve as a baseline. After the commissioning of the new radio equipments, another coverage test was conducted to ensure that introduction of new radio equipments did not interfere with the performance of the existing radio system.

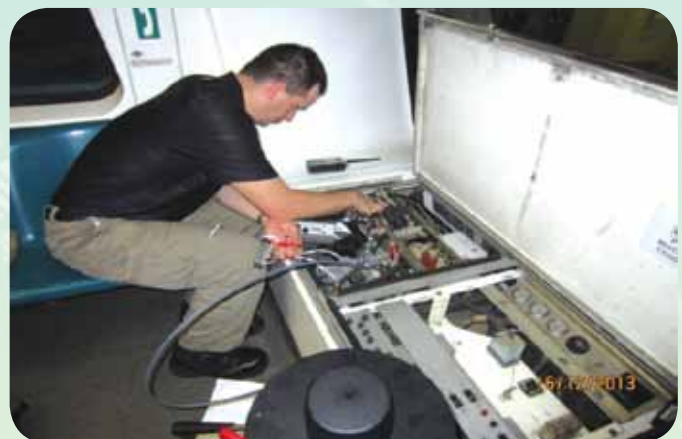
Figure 2: Testing the newly retrofitted kit and antenna during Stage 2 Radio Migration

At stage 2, extensive functional testing was carried out on the vehicle with retrofitted radio kit. Subsequently, the

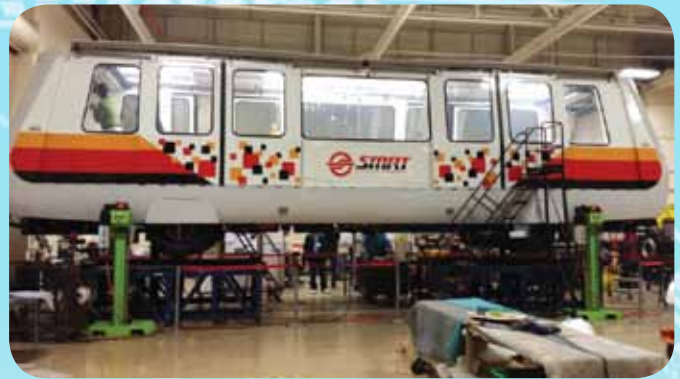
Figure 4: Offshore static and dynamic testing in Pittsburgh

Intensive offshore static and dynamic tests were performed on the performance of the new vehicles in Pittsburgh, USA, prior to them being shipped to Singapore. In addition, vehicle endurance test of 5000km had to be done prior to revenue service running.

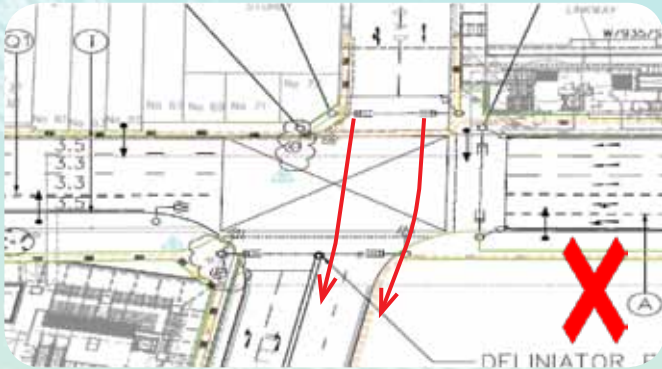
Figure 1a: The approaching lanes do not align with the receiving lanes at the junction

Traffic will generally follow the approaching lane alignment to travel across a junction. In the event that the junction layout is skewed, motorists would require guidance to manoeuvre across the junction and continue into the receiving lanes properly. Unfamiliar motorists travelling through a junction with inadequate lane alignment often result in lane encroachment which leads to potential sideswipe collisions.

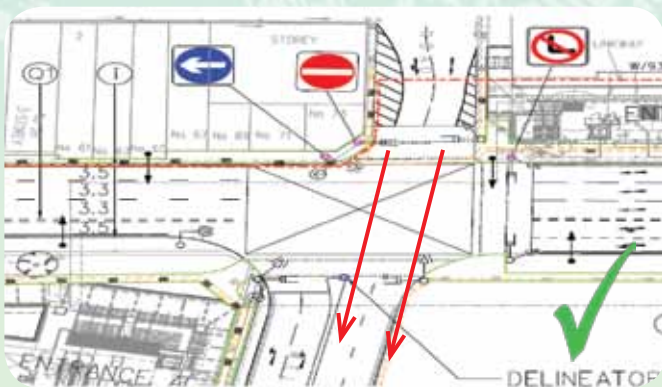
Figure 1b: In order to improve the alignment, chevron marking has been added to guide motorists across the junction

Proper alignment between the approaching and receiving lanes across a junction is necessary to ensure safety of the motorists. If there are any site constraints to do so, mitigation measures such as provision of guidelines or chevron marking to align the lanes across the junction could be adopted.

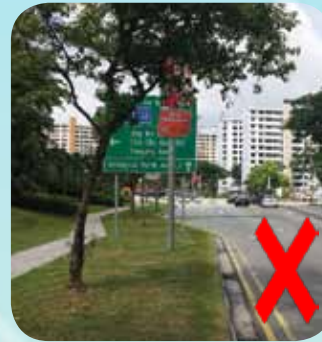
Figure 2a: Directional sign is obstructed by tree and street lighting pole

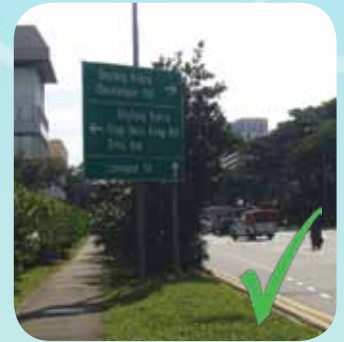
Figure 2b: Directional sign is unobstructed by trees or street furniture

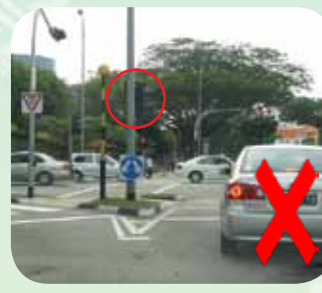
Figure 3a: Traffic signal pole is obstructed by street lighting pole that is located on the same traffic island

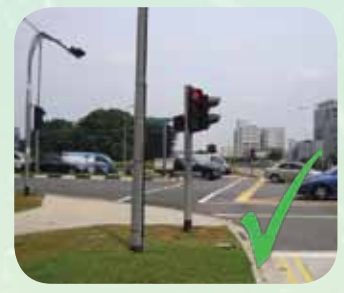
Figure 3b: Street lighting pole is located away from traffic signal pole to ensure unobstructed visibility of the traffic signal pole

For this purpose, the provision and placement of the primary, secondary and tertiary traffic signal aspects at a junction should take into consideration the presence of any street furniture nearby such as street lighting poles, trees or traffic signs as well as maintain a proper offset from the road edge.

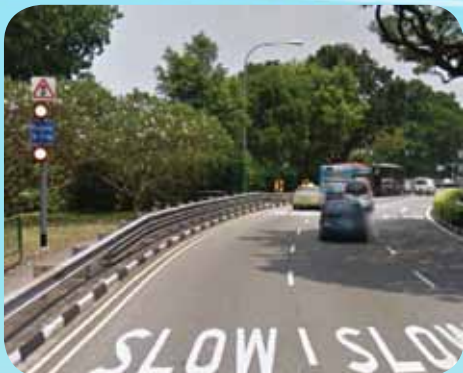
Figure 4: Providing Advance Warning Light along a bend helps to forewarn motorists of the changes in traffic signals in the junction ahead

Advance Warning Light is normally provided upstream where there is a vertical crest curve or a sharp horizontal bend in advance of the junction to alert oncoming motorists of the traffic signal downstream turning red lest their view of the traffic signal aspects ahead is limited. This measure could help to reduce the risk of running the red light.

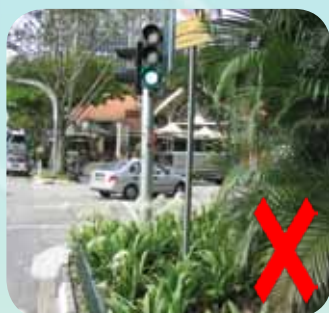
Figure 5a: The overgrown shrubs at the roadside verge of the junction is obstructing the motorists' visibility of the pedestrians crossing this junction

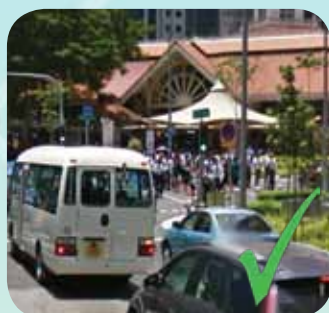
Figure 5b: The overgrown shrubs have been replaced by a low planting strip to provide clear visibility of the pedestrians utilising the crossing

At signalised road junctions, adequate visibility should continue to be provided at all corners of a junction. The arrangement gives motorists a good view of the pedestrian crossing and minimises the potential of motorists driving straight into pedestrians who might be starting to cross from the corner of a junction. It is essential that motorists are given adequate time to react appropriately.

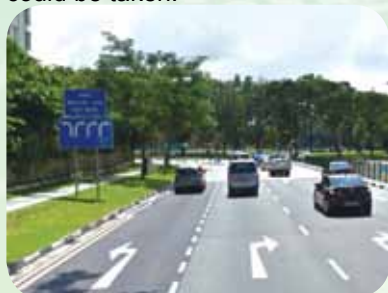
Figure 6: Motorists are informed of the exclusive turning lanes and adequately guided at a junction by providing a lane indication sign

Adequate information on the lane arrangement and layout at a junction will guide motorists to travel in the correct lane and across the junction safely. The use of lane indication sign for multi-lane junction and providing proper lane markings to define various lane use are some of the measures that could be taken.

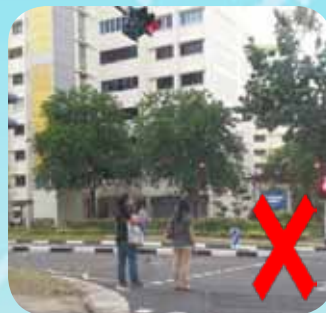
Figure 7a: Pedestrians are seen waiting on the carriageway as the pedestrian crossing lines are painted outside the physical traffic island

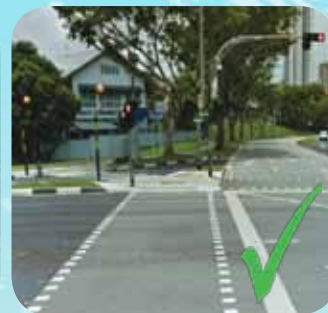
Figure 7b: The pedestrian crossing lines are painted within the traffic island, thus preventing pedestrians from waiting outside the island

Such an arrangement is likely to mitigate the risk of pedestrians being hit by passing vehicles by preventing pedestrians from standing on the live carriageway while waiting to cross the road.

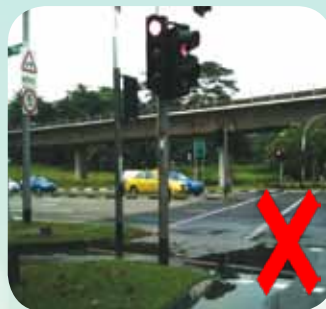
Figure 8a: Waterponding occurs due to inadequate drainage at the traffic island

Waterponding at the junction will occur if drainage provision is poor, especially at the traffic islands. Accidents arising from aquaplaning and skidding could happen if a vehicle were to travel through the pond of water at a high speed. To address the concern, there is a need to provide sufficient drainage outlets along the edge of the traffic islands to ensure that surface runoff from heavy downpour is drained off adequately.

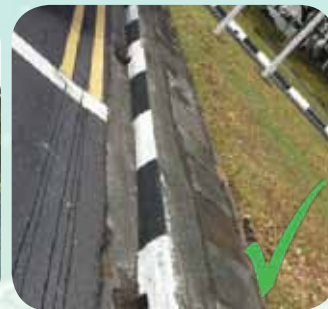
Figure 8b: Drainage inlets have been provided along the edge of the traffic island to channel away surface runoff adequately

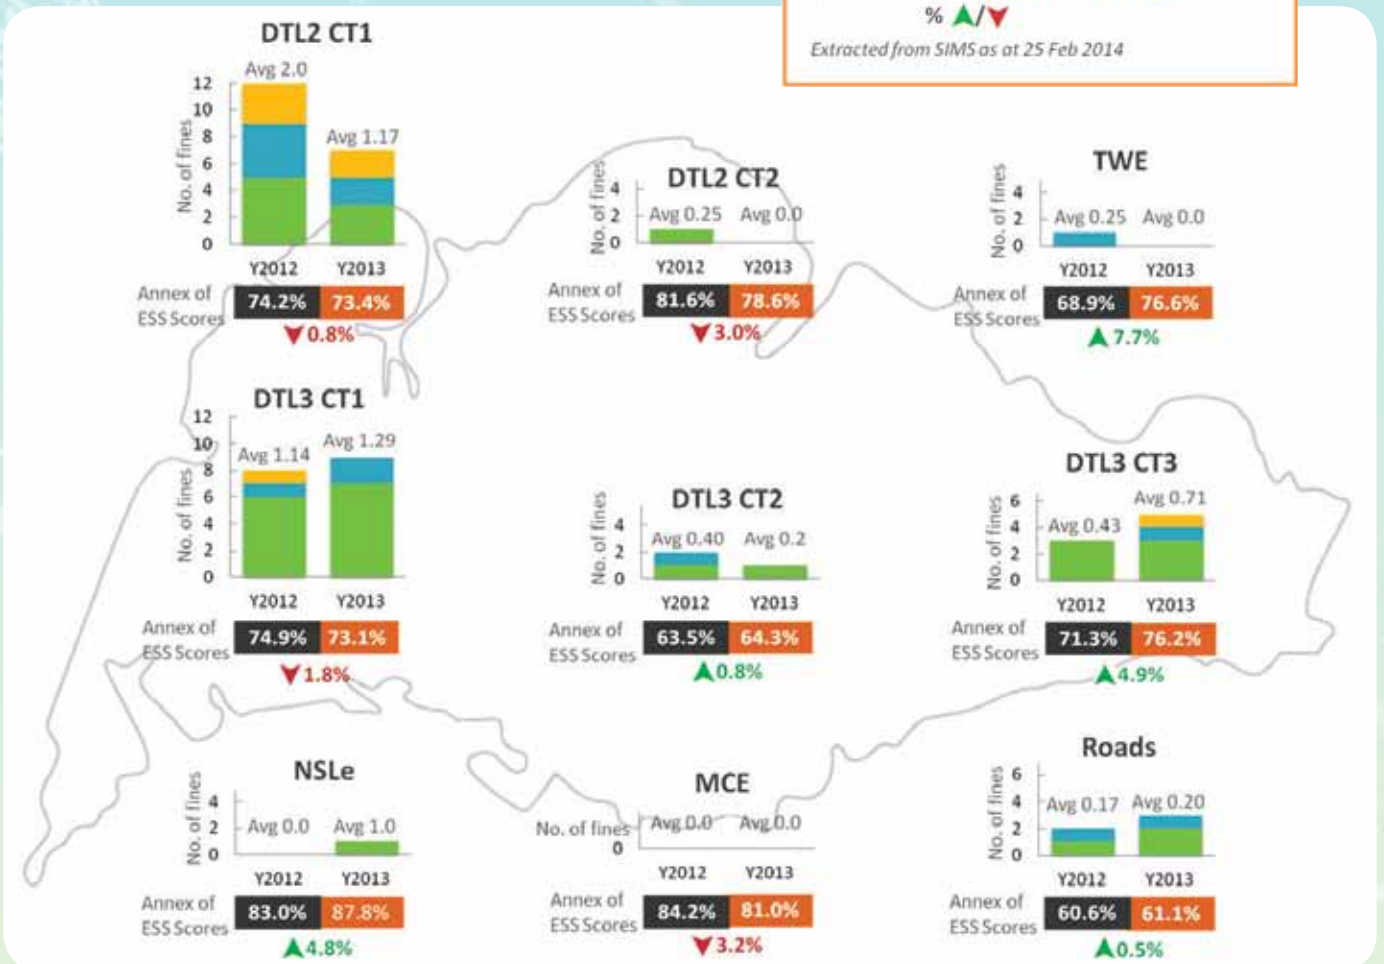
Figure 2: Comparison of environmental performance of LTA projects in 2012 and 2013

As shown below, a comparison was made between Year 2012 and Year 2013 for the number of environmental fines received and the average environmental ESS scores obtained by various projects.

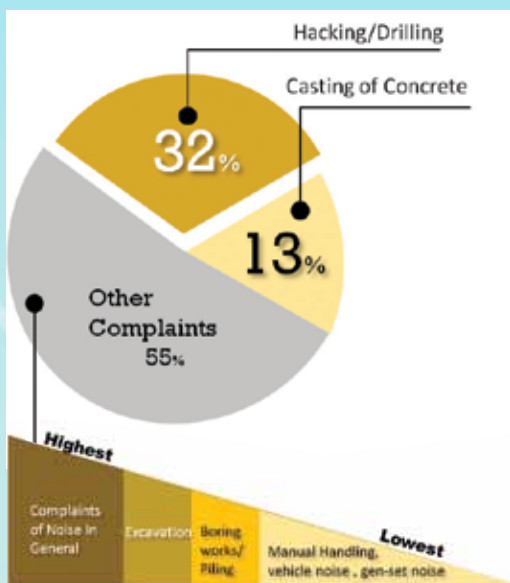
Figure 3: Breakdown of activities that lead to noise complaints

Through the complaints, trends were analysed. However, not all complaints received from residents were specific. Certain complainants did not provide details of the noise they experienced but gave feedback that the site was “noisy”. Such complaints were summed under the general heading of “Complaints of Noise in General” in Figure 3.

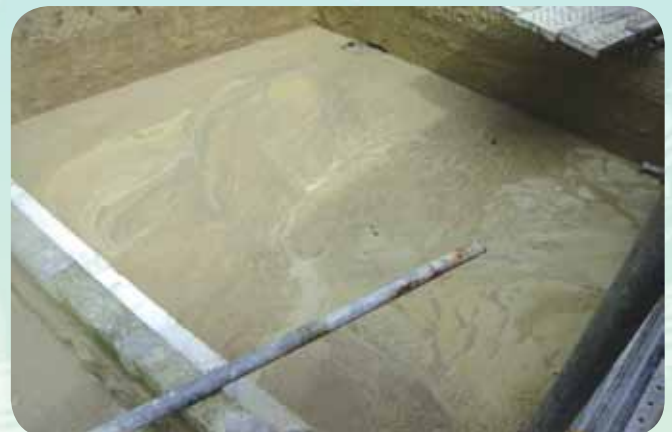
Figure 4: Tunnelling wastewater was channelled to holding pond leading to ECM treatment plant
