SAFETY News

34th Edition • ISSN 1793-1665 • Sep 2017

Important Facts on Fall Control Measures

Thematic Exercise on Electrical and Hot Works

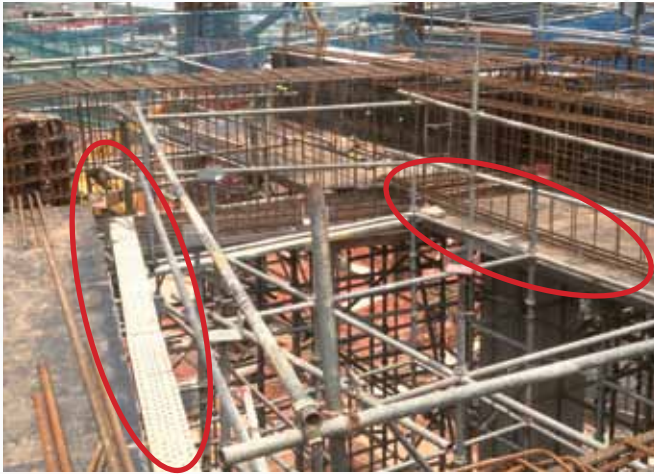
Figure 4: Example of poor edge protection where there is risk of person falling from open sides

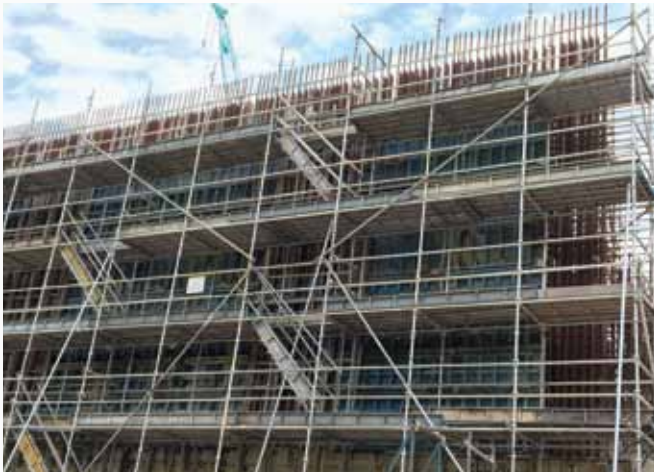
Figure 5: Example of good edge protection where guardrails and toe boards are securely installed

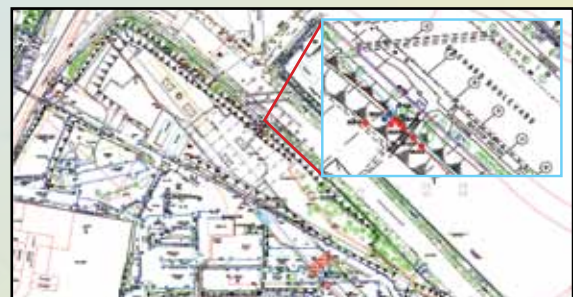
Figure 2: Systematic electrical DB tracking of actual site location

- A systematic way to identify and monitor all the electrical distribution boxes (DBs) on site with their actual locations clearly defined on regularly updated site plans (Figure 2). This assists both the Contractor's safety team and Licensed Electrical Worker (LEW) in ensuring that these DBs are checked and maintained regularly. The site plans also identifies potential areas that may require the shifting of the DBs for efficiency.

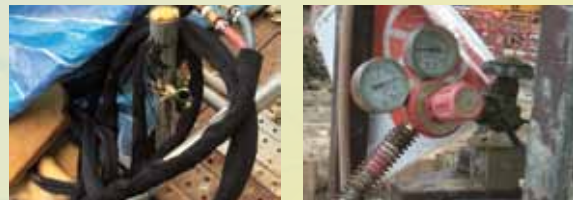
Figure 3: Engineering control to protect gas hoses

- The use of protective sleeves to prevent damage to the gas hoses as well as the use of coil springs to minimise the bending radius of the gas hose connection to the gas cylinder gauge outlet (tight bending radius causes over stretching of the gas hose which may result in cracks or in more severe cases, the disconnection of the gas hose) (Figure 3).

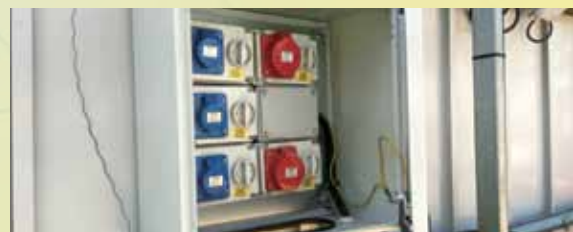
Figure 4: SOA with weatherproof box cover

- Installation of the weatherproof protection box cover for Socket-Outlet Assembly (SOA) located in open areas exposed to the environment, to eliminate water ingress to electrical sockets during inclement weather (Figure 4).

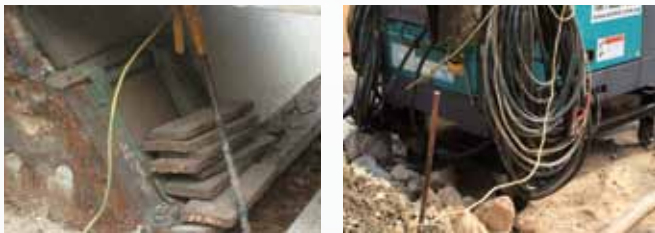
Figure 5: Welding machines not adequately earthed

- Improper / inadequate earthing of equipment (Figure 5)
- Substandard SOA extensions (Figure 6)
- Improper personal protective equipment used
- Gases not purged from hoses when not in use.

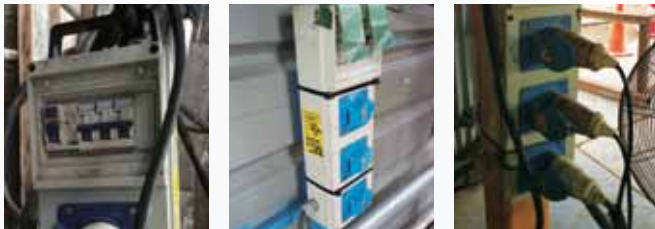
Figure 6: Substandard SOA extensions

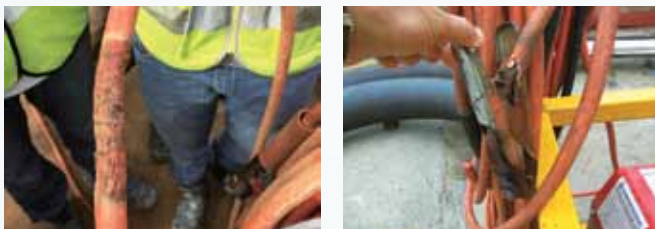
Figure 7: Damaged / exposed welding cables

- Exposed and damaged welding cables / terminals (Figure 7)
- Damaged gas hoses (Figure 8)
- Damaged pressure gauge on gas cylinders
- Defective fire fighting equipment (empty / expired fire extinguishers).

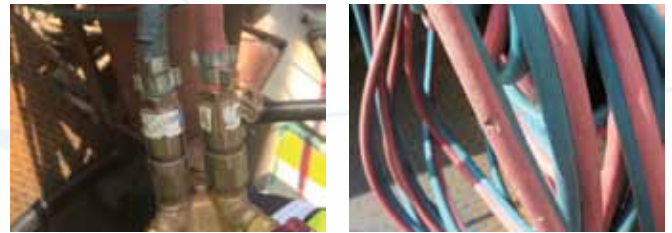
Figure 8: Damaged / cracked gas hoses

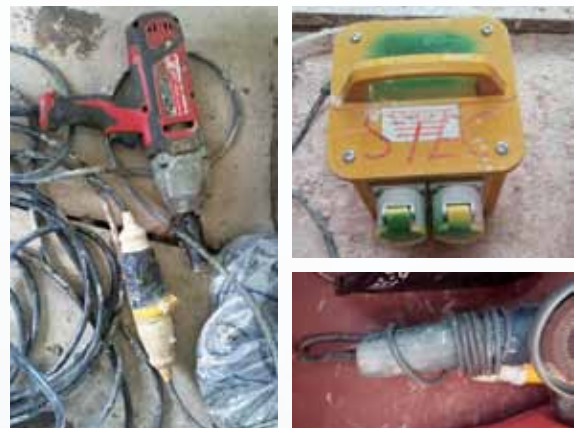
Figure 9: Electrical equipment / tool without LEW's monthly inspection sticker

While not widespread, inadequate inspection regime at some sites had resulted in workers using faulty electrical equipment, exposing them to electrical hazards. To prevent accidents from happening, it is important that electrical equipment are regularly inspected by a LEW to ensure that they remain in good working condition. Factors contributing to inadequate inspection include:

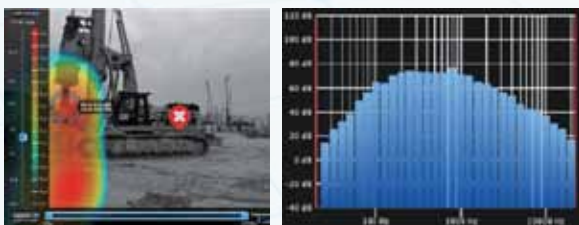
Bore Piling	Vibratory Piling	Excavating	Hacking	Concrete
Sound Pressure Level	91 dB _(A)	104 dB _(A)	84.5 dB _(A)	94.7 dB _(A)	92.5 dB _(A)
Peak Frequency	800 Hz	250 Hz	250 Hz	800 Hz	630 Hz

Figure 1: Analytical results for noise mapping

To achieve this, the first step was to conduct noise mapping to analyse noise arising from the construction activity, as well as understanding the frequencies and the sound level emitted from noisy machineries (Figure 1).

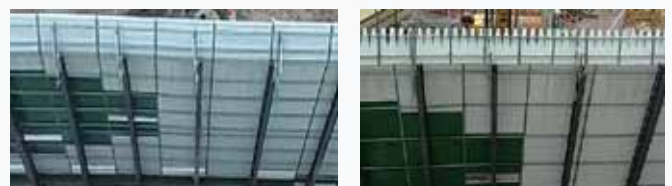
Figure 2: Normal cantilever barrier (left), and new jagged edge design (right), at TEL T221 during pilot testing

With the establishment of these parameters, the research team then developed a new noise barrier design inspired by the engine nacelle of the Boeing 787 plane. The principle behind the jagged-edge design was that it results in destructive interference of the sound waves, which reduces more noise as compared to a straight-edge design.

To determine the effectiveness of this design, noise measurements were taken for both noise barrier designs, under similar site conditions (Figure 2) at TEL Contract T221 Havelock Station. The results proved that the jagged edge noise barrier design consistently achieved a better

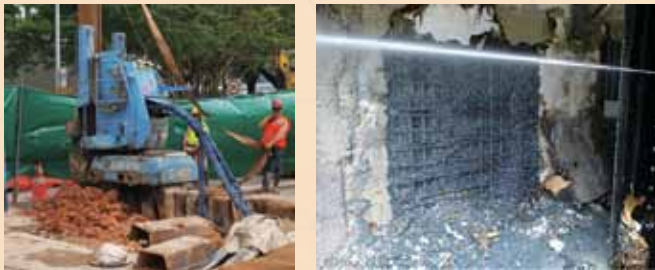
Figure 4: Use of a silent piler (left) and aqua cutter (right)

Quieter machines and methods are adopted to reduce noise generated at source. For example, employing quieter alternatives such as silent piler instead of traditional vibro hammer to install sheet piles, and use of aqua cutter instead of hacking machine.

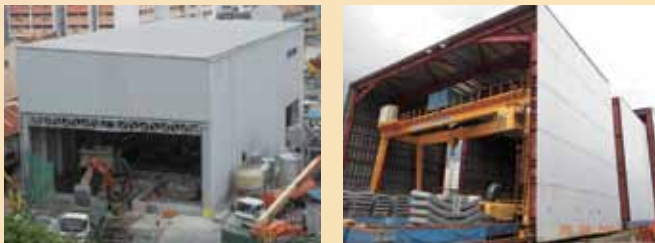
Figure 5: Full noise enclosure at DTL C935 (left), and retractable noise enclosure at TEL T216 (right) installed at launch shafts for noisy tunnelling works

Noise enclosure at launch shafts is provided to reduce the noise emitted from noisy tunnelling works. As illustrated in Figure 5 (right), the retractable noise enclosure provided at TEL Contract T216 allows for the flexibility in movement of machineries, including multiple TBM launches.

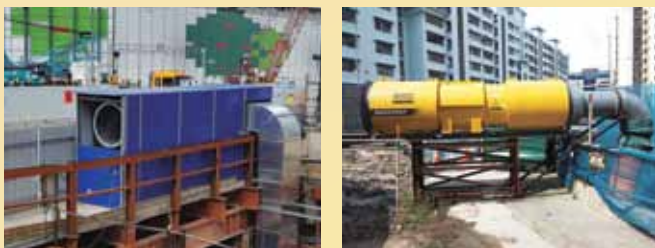
Figure 6: Noise enclosure over the ventilation fan unit at TEL T221 (left), and ventilation fan silencer installed at DTL C929A (right)

Noise enclosures are also provided at stationary noise sources such as ventilation fans to minimise the noise emission. One example is the introduction of noise enclosure over ventilation fan units at TEL Contract T221 to minimise noise emission. Alternatively, silencers are also installed onto ventilation fans at DTL Contract 929A to ensure good noise control.

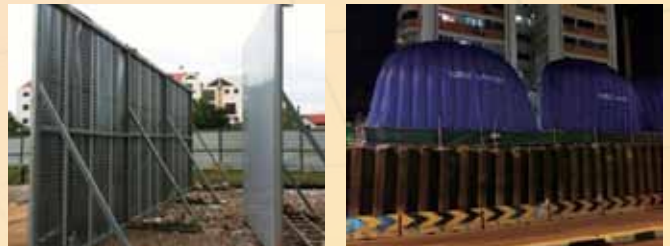
Figure 7: Mobile noise barrier at DTL C923 (left) and air inflated temporary noise barrier at TEL T211 (right)

Portable noise barriers are used to reduce noise emission at source with greater mobility. These barriers can be installed to form partial enclosures and partitions, which are useful for unavoidable night works. Some examples of portable noise barriers include the mobile barrier and the inflatable barrier (Figure 7).

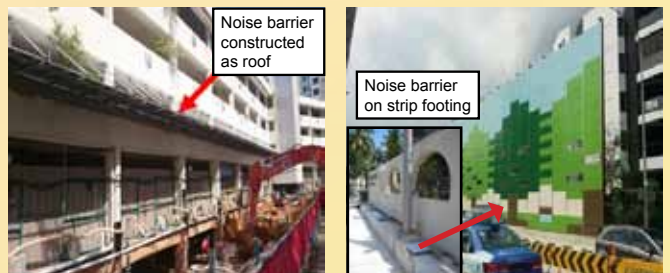
Figure 8: Noise panels was used to construct roof canopy at TEL T211 along the corridor (left), and noise barrier was constructed on a narrow strip footing at TEL T216 to overcome space constraint (right)

Space constraint has been recognised as a major obstacle on site when erecting noise barrier. In view of that, contractors has initiated to propose inventive ideas to rectify this obstacle. At TEL Contract T211 (Figure 8, left), the work site is right below a HDB block where there is no space for the erection of a 10m noise barrier. Hence, the contractor used noise panels to construct a roof canopy along the corridor of the second storey to reduce noise impact on nearby residents. Likewise, in order to overcome space constraint at Stevens Road, TEL Contract T216 has constructed a narrow strip footing for installation of the perimeter noise barrier (Figure 8).

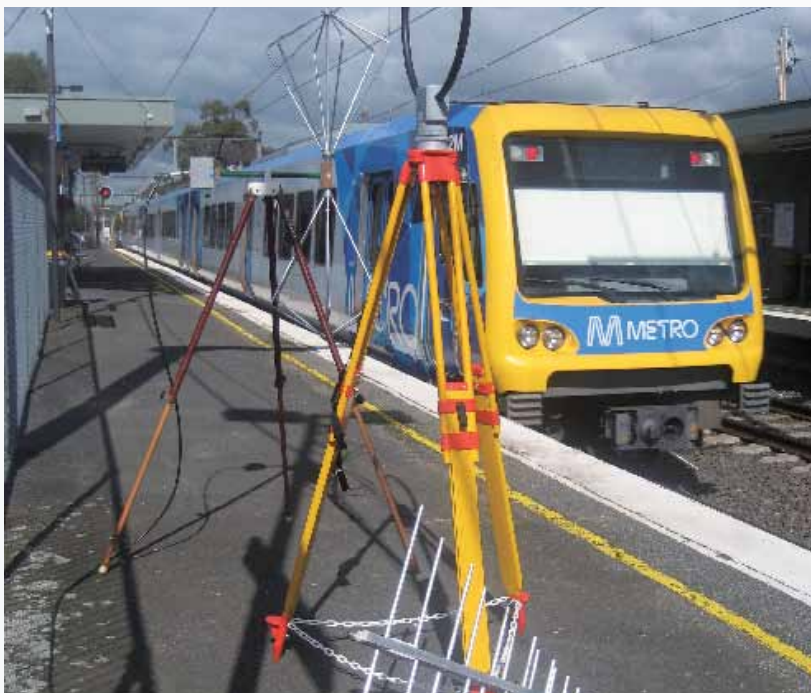
Figure 3: On-Site Train Emission Measurement

LTA's EMC team supported the investigation of the suspected interference case which happened at Singapore's inaugural Formula One night race in year 2008. Mark Webber, racer of Red Bull Racing team, experienced gearbox malfunction when he was on course for a possible podium. The racing team suspected that an interference from the nearby Mass Rapid Transit (MRT) system was responsible for the gearbox malfunction. However, the nearest MRT track is 200 metres away with a depth of 10 metres. After thorough investigation and on-site measurement, the LTA EMC team determined that interference from MRT was not the cause for the gearbox malfunction.

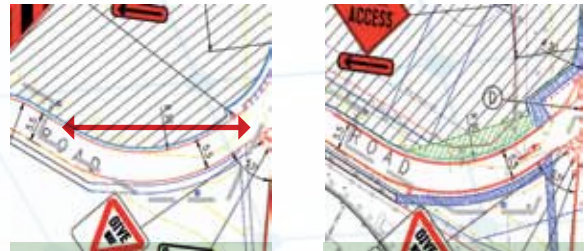
Figure 2c: Safety issue identified during construction stage

Safety Issue Identified:
Inadequate sight distance around road bend due to placement of site hoarding.

Recommendation:
Provision of half-height hoarding and 'No Obstruction by Machinery' zone.

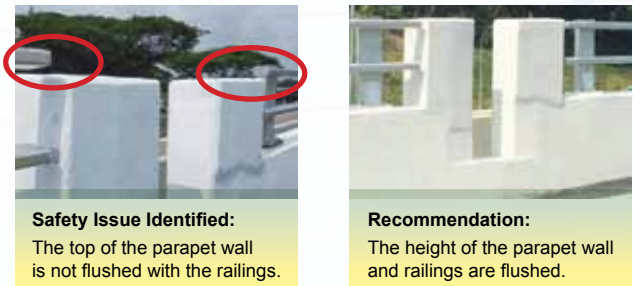
Figure 2d: Safety issue identified before public opening of a new road after completion

Safety Issue Identified:
The top of the parapet wall is not flushed with the railings.

Recommendation:
The height of the parapet wall and railings are flushed.
