Safety NEWS

DRIVING SAFETY EXCELLENCE THROUGH BEHAVIOUR BASED SAFETY

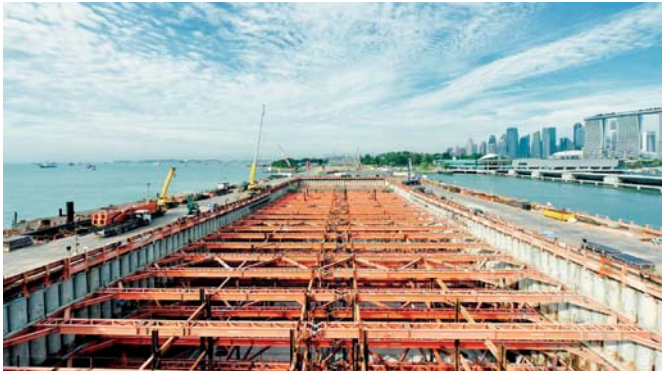
Figure 1: Double wall cofferdam construction at MCE Contract 485

The Marina Coastal Expressway (MCE) Contract 485 involves the construction of double wall cofferdam with four to five layers of steel strutting as temporary earth retaining structure.

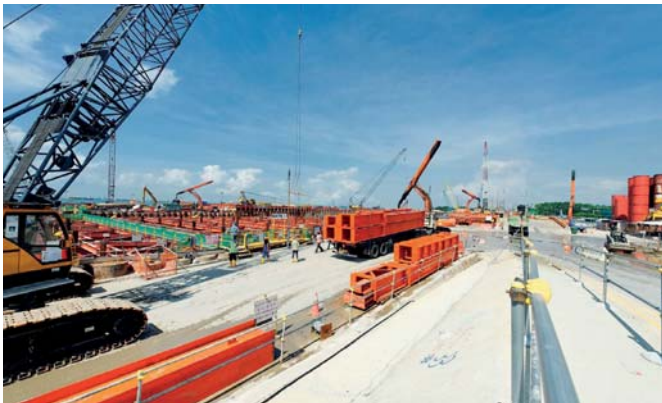
Figure 2: Adequate access route to ensure safe delivery and movement of machinery and materials

- Site layout has to be planned carefully to ensure that there will be adequate access routes into the site for safe delivery of equipment, machinery, materials, as well as safe access for workers.

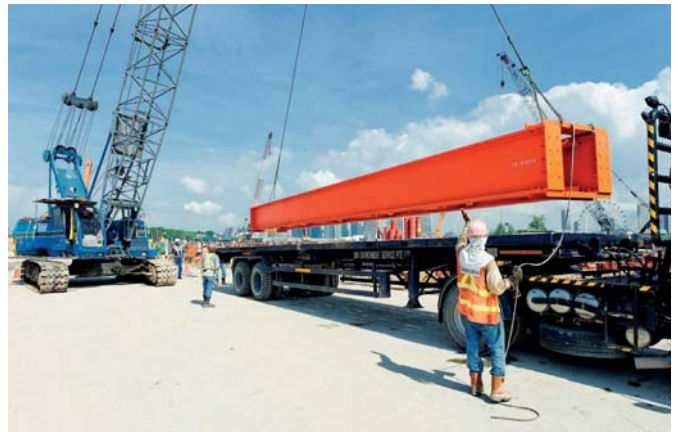
Before commencement of any lifting operation, consider prevailing ground conditions and whether soil compaction is necessary in areas which cranes are moving and operating. Cranes must be setup on firm ground and level surfaces suitable for the intended activities. The crane operator must be qualified and competent to perform the lifting operation. Visual inspection by crane operator for all the crane components is required before performing the job.

Figure 3: Crane setup on firm ground and level surface

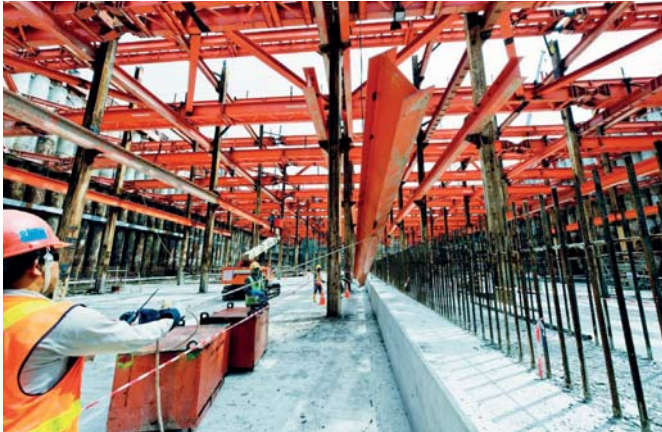
Qualified rigger shall rig and inspect the load prior to each lift and tag line shall be used to control the load. Steel erection must be done under the supervision of a competent person who is present at the work site.

Figure 5: Use of tag line to control the load

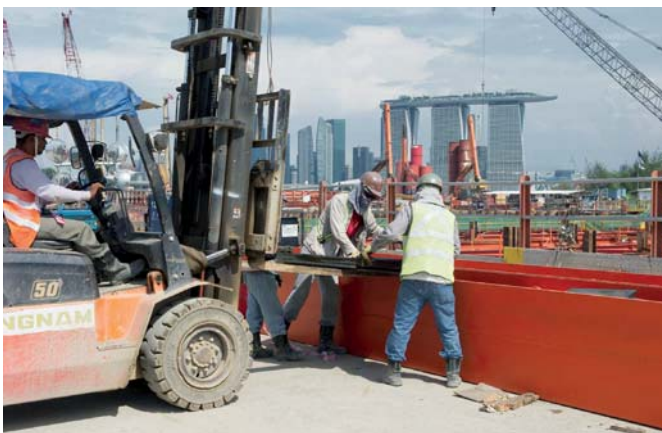
Figure 6: Appropriate machinery to help worker handle heavy or irregularly-shaped loads

Minimize manual handling of loads or materials by workers. Provide appropriate equipment to help workers handle heavy or irregularly-shaped loads.

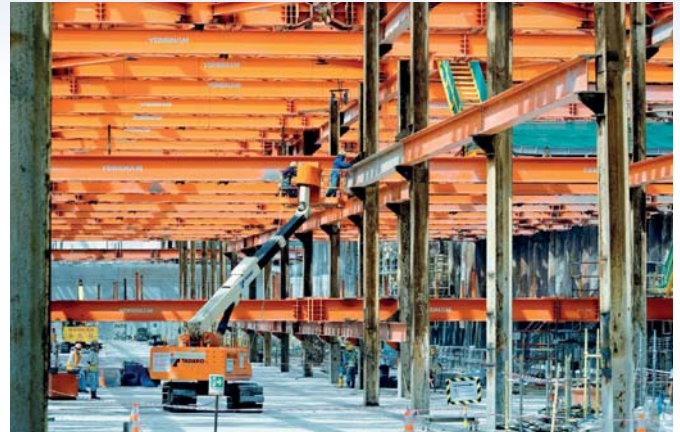
Boom lift or tower scaffold can be used as an alternative during the erection process as a working platform for the workers.

Figure 7: Use of boom lift as an alternative for working at height

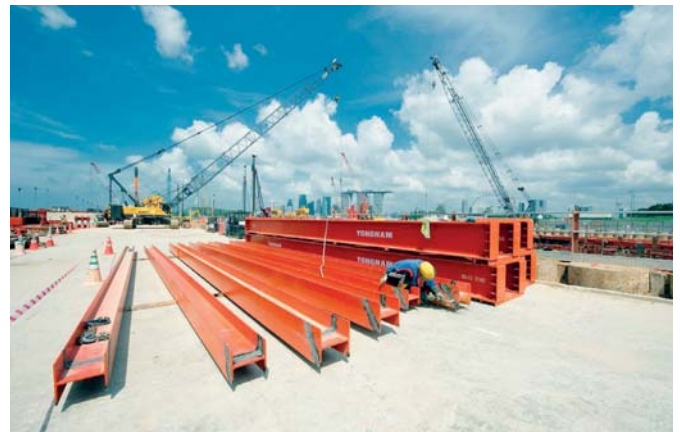
Figure 8: Proper storage of materials and maintain good housekeeping at work site

It is also important to maintain proper housekeeping at the worksite. Perform ongoing cleanup as required.

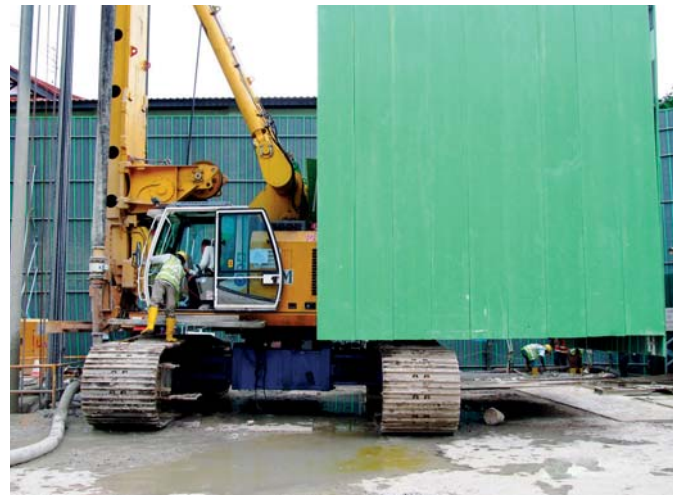
To minimize noise nuisances to the nearby residents, noise barriers were erected along the shared perimeter, lifting machines and generators were enclosed with noise absorbing panels as well as the selection of less noisy machinery. In addition, the contractor carried out a strict machinery maintenance regime to ensure that all machinery were in good working condition without being unduly noisy.

Figure 3: Noise barriers installed to contain noise

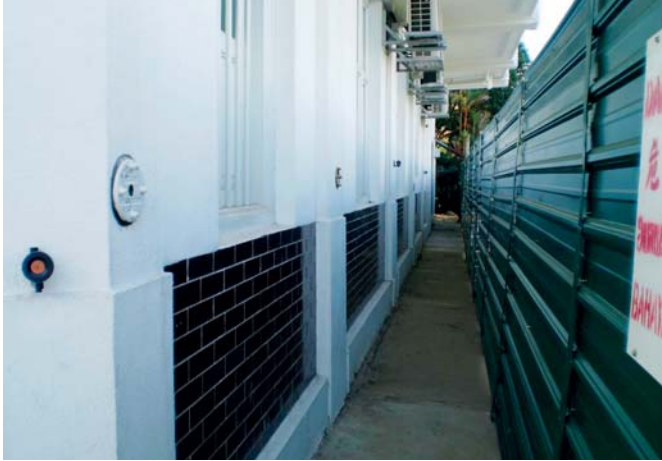
Figure 5: Ensuring adequate walkway/access spaces

In order to facilitate the construction of Stevens Station, Robin Walk was closed to vehicular traffic from Bukit Timah Road and only accessible by foot. To minimise the inconvenience caused to the residents, the project team worked closely with the contractor to ensure that proper and safe walkways were provided and maintained so that the residents could still gain access to Bukit Timah Road by foot.

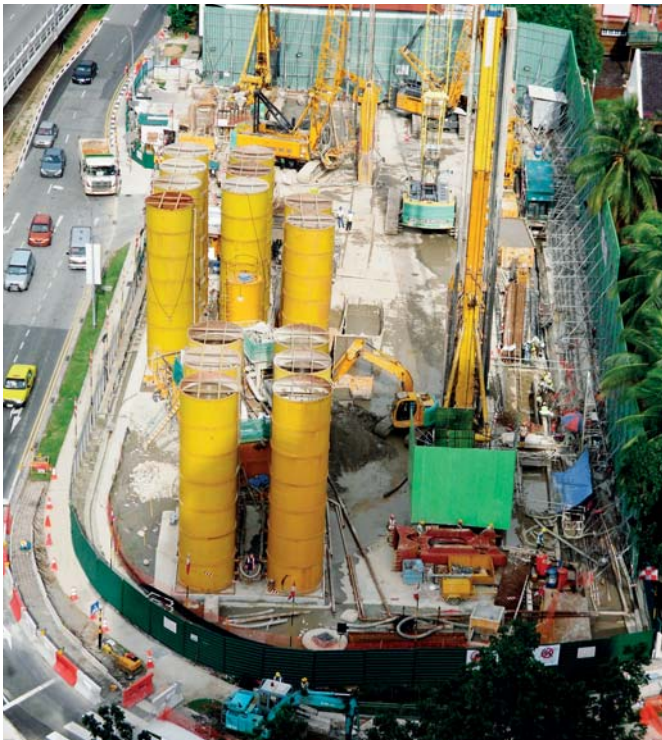
Figure 6: Space constraint on site

Given its relatively small footprint, congestion on the worksite is aggravated by the large number of heavy machineries for the diaphragm wall construction, silos for the batching plant as well as several 8-foot containers which served as site offices and storage.

Safety is a primary concern on the congested site as there is little room available for the safe access of heavy machinery on site. In addition, the working radius of the individual lifting machine must be strictly monitored and enforced to minimise the potential of collision during lifting operations.

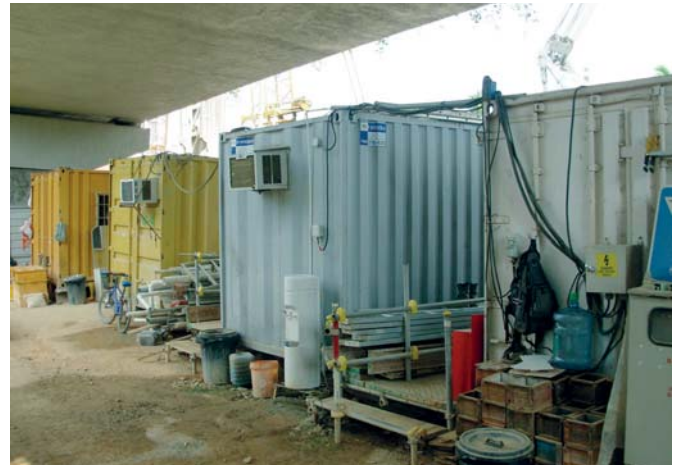
Figure 7: Using spaces beneath the flyover for container offices and storage

To lessen the site congestion, the project team worked closely with the contractors to find alternative areas for the storage of the less critical entities such as the 8-foot containers. The project team managed to secure the use of the vacant land beneath the Wayang Satu Flyover (located opposite the worksite) to house the 8-foot container site offices as well as to serve as a storage yard.

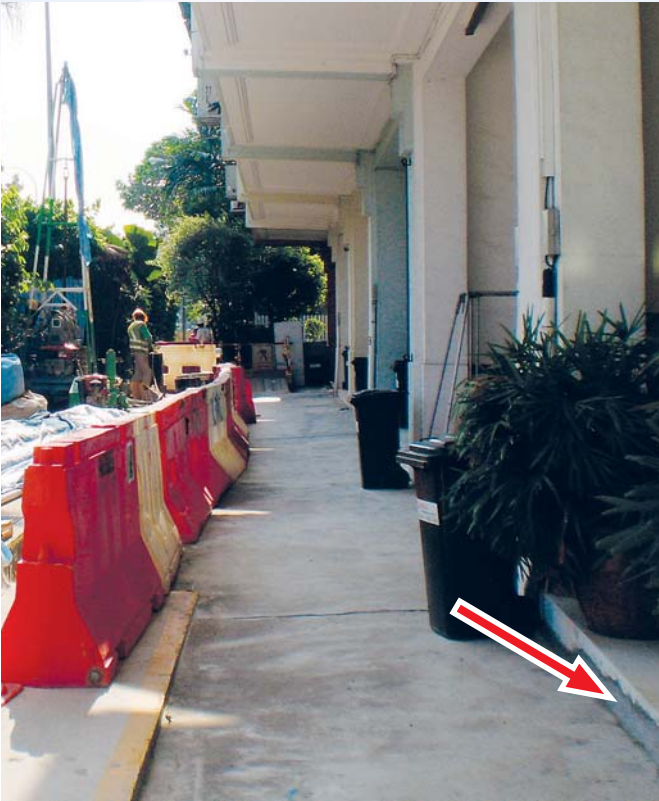
As the deep excavation for the construction of the Stevens Station is carried out very close to the Wayang Satu Flyover, residential units and shophouses, the potential for ground settlement and damage to the nearby structures are very real, especially for the row of shophouses which are supported only on footings and not piled foundations.

Figure 8: Settlement of the nearby shophouses (patched up with cement)

To mitigate the risk of settlement to nearby structures, the top down construction approach was adopted using adequate strutting at every level of the excavation to reduce the likelihood of deflection and settlement. In addition, extensive instrumentation is deployed to carry out round the clock monitoring of ground movement.

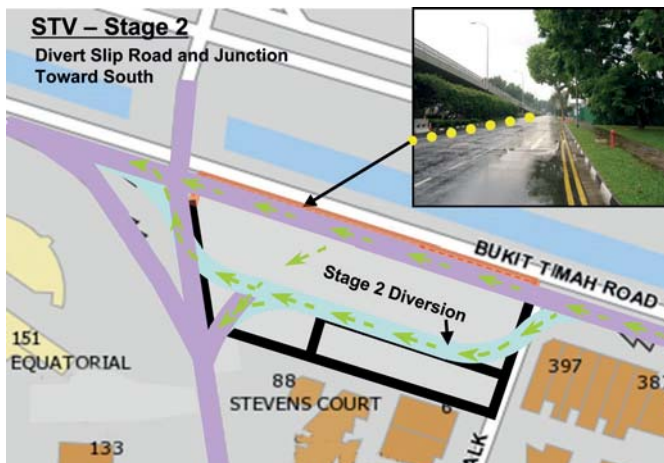
To facilitate the temporary works as well as construction of the station-box, the traffic on the heavily used Bukit Timah Road had to be diverted in several stages. For every stage of diversion, the project team carried out meticulous planning to ensure that ease of traffic flow and the safety of both the motorists and pedestrians were not compromised.

Figure 9: Road diversion schematics

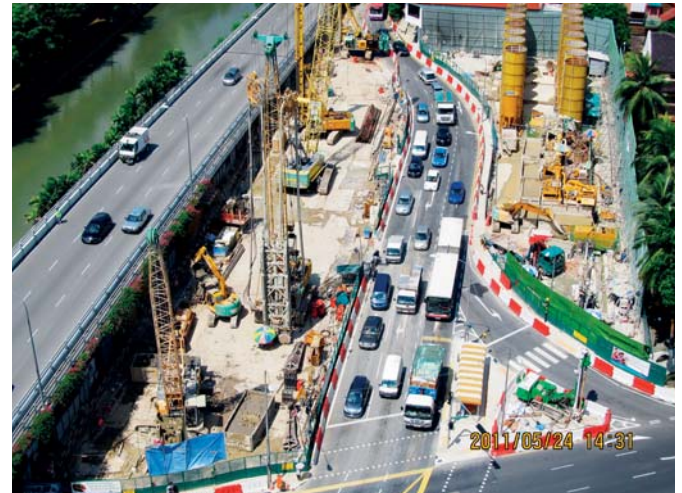
Figure 10: Completion of road diversion

One such example of this meticulous planning was the re-alignment of the slip road to Stevens Road carried out on Sunday, 20 March 2011 (as part of stage 2 road diversion). Road markings and removals started at 1900 hours. With the assistance of AETOS to conduct traffic control, the contractor disabled the existing traffic lights at junction of Bukit Timah and Stevens Road and concurrently activated and synchronized the new traffic lights installed. The bus number pole and bus guide at the bus stop were shifted. The new slip road was opened to the public at 0230 hours, 21 March 2011, 7 ½ hours after the road diversion started.

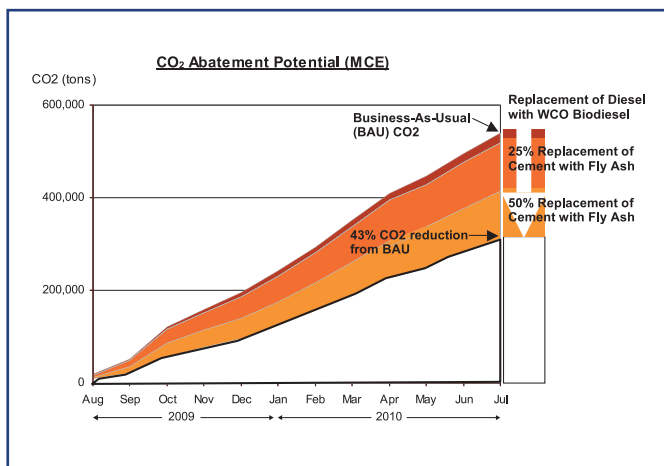
Figure 3: CO₂ Abatement Potential

Presented in Figure 3 above, each colored wedge indicates the amount of CO₂ that can be abated by the respective mitigation measure. For example, the first wedge indicates that the substitution of diesel to WCO Biodiesel can reduce Business-As-Usual CO₂ emissions by 20kton (4% reduction). Replacing cement in concrete by 25% fly ash can reduce CO₂ emissions by 19% and a further 20% reduction can be achieved with 50% replacement. In this proposed package of mitigation measures, a maximum potential of 43% reduction in CO₂ emission can be attained. Apart from the measures considered in the test, there are other mitigation possibilities such as replacement of cement with blast furnace slag, designing out carbon, improving resource management, better waste management and increasing process efficiency which can be considered by various stakeholders along the value chain.

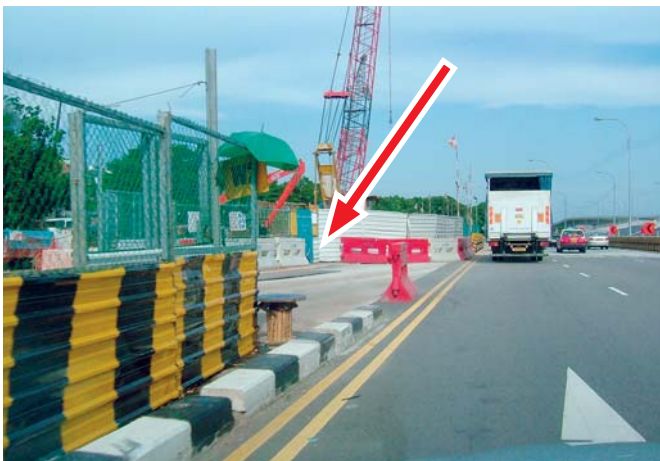
The example below shows the provision of a lay-by with acceleration lane on a major arterial road (70km/hr). The lay-by arrangement provides construction vehicle with some space and distance to pick-up speed in order to merge safely with the main road traffic. The contractor has also adopted the use of low height hoarding to provide drivers of construction vehicles leaving the work site with a good view of approaching vehicles and vice versa.

Figure 1: Lay-by with acceleration lane

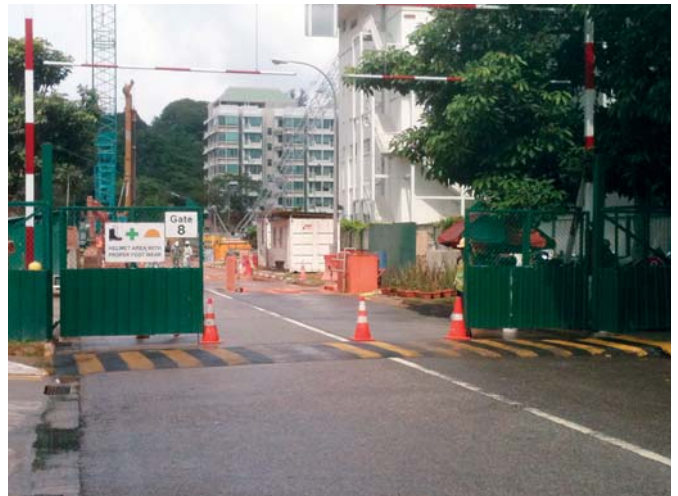
Figure 2: Site access arrangement at high pedestrian movements area

- The full height hoardings located close to the work site access have been replaced with low height type to enhance visibility so that pedestrians and construction vehicles are able to see each other near the entrance and egress.
- A speed regulating hump has been installed just at egress to encourage construction vehicles to reduce speed at this area.
- Trained traffic controllers are positioned at the work site access/egress to regulate the movement of pedestrians and construction vehicles during operation hours.

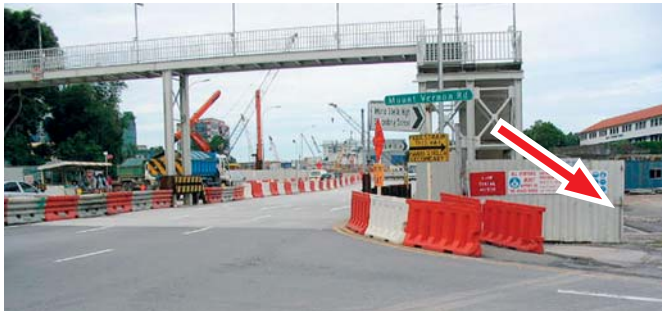
- Downstream on the inside of the horizontal bend
- Downstream after the crest of a vertical curve
- Near a junction

Figure 3: Poor site access arrangement near junction

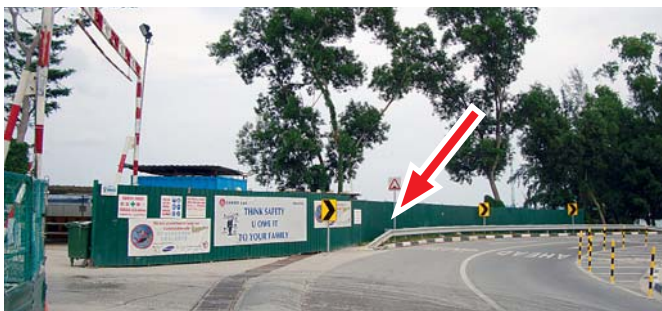
The next example below shows the contractor implementing proper treatments to the approaching ends of the safety barrier near a work site access. The ramp down end treatment would protect any run-off vehicles from hitting the exposed ends of the safety barriers. Being a low speed road, the ends of the VIG has been ramped down in accordance with the design standard.

Figure 4: Proper end treatment of VIG

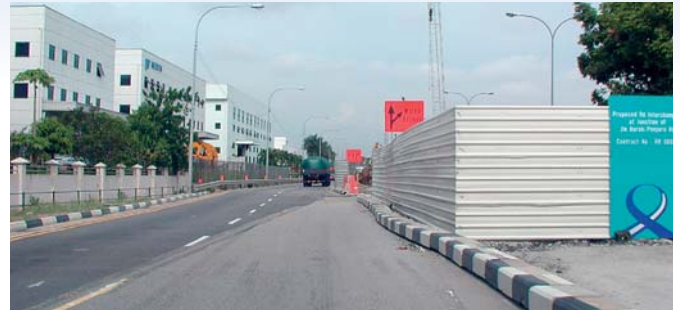
"Work Access Ahead" signs needs to be positioned with at least 0.6m lateral clearance from the edge of traffic lane so that they do not protrude out onto the carriageway.

Figure 5: Adequate lateral clearance from carriageway

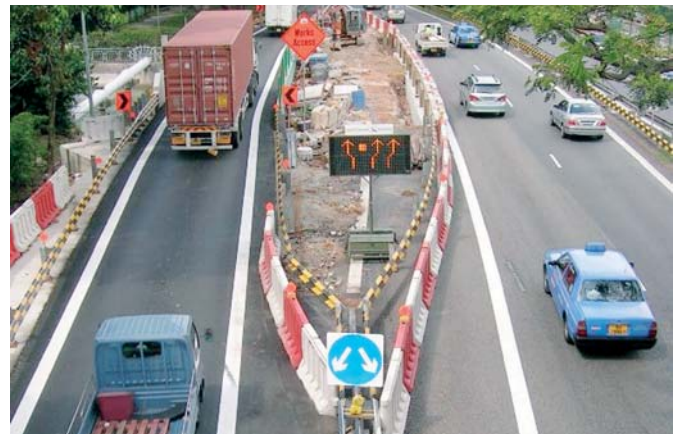
Figure 6: Bifurcation challenges in the arrangement of site access

"Bifurcations" are sometimes introduced as part of a road diversion scheme in tight corridors with space constraints. For the example shown, safe usage required the designer and construction team working together to not only developing a safe design but also to implement additional operation controls for vehicle movements. With the work being carried out on the expressway, strict controls were introduced and construction vehicles were only permitted to enter/leave the work site during specific hours during the off-peak periods. The slow lane was also closed during these periods to allow the safe movements of construction vehicles.

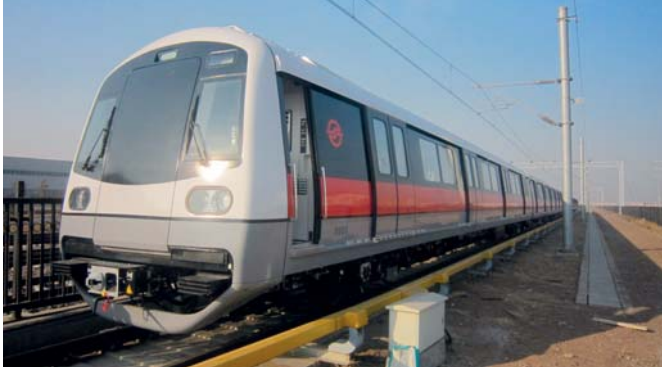
Figure 1: C151A Train

The scope of Contract 151A (C151A) comprises of the supply of 22 new trains for the existing North-South Line (NSL) and East-West Line (EWL). The contract was awarded to Kawasaki/CSR Sifang Consortium in May 2009 and the first 5 trains entered revenue service in May 2011.

The trains are designed by Kawasaki Heavy Industries (KHI) of Japan. Carbody manufacturing, train assembly and testing are conducted by China Southern Railway (CSR) Sifang in Qingdao, China.

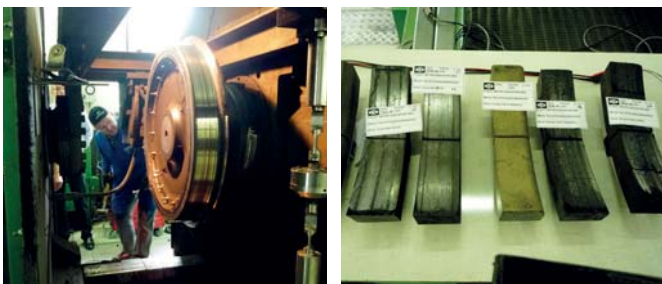
Figure 2: Dynamometer and brake blocks used in dynamometer test

The test simulated the interaction between the train wheel and brake block under operating conditions of train run profiles, such as the real route profile of NSL and EWL. By repeating the same series of run profiles using different brake blocks, an assessment of the most optimal choice of brake block material was completed.

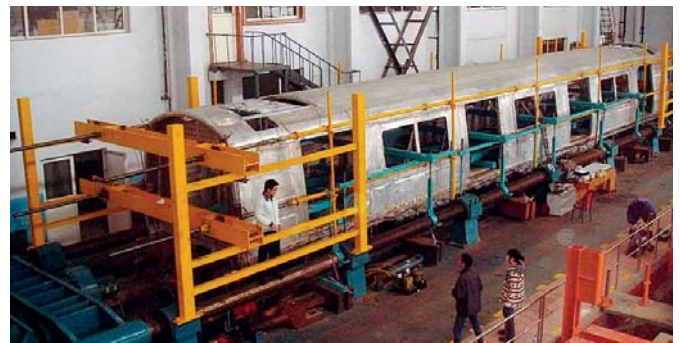
As the main load carrying structure of the train, the carbody shell is designed to withstand exceptional loading conditions without sustaining permanent deformation and fracture, and at the same time, achieving the required service life under normal operating conditions.

The first completed carbody shell was subjected to a series of compression and tension tests under various loading conditions before mass production. During the test, all measured stresses were within the material yield stress limits. It proved that the design of carbody shell manufactured could meet the design requirements.

Figure 3: Crashworthiness Test

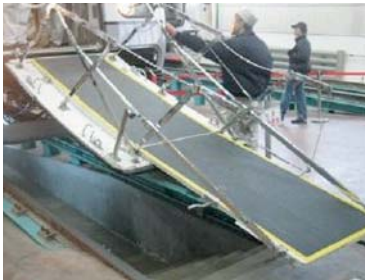
Figure 6: Emergency Detrainment Door Deployment Test

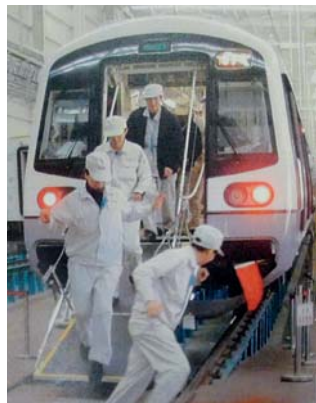
The Emergency Door Detraining Time test demonstrated that the time taken to deploy the detrainment door ramp and to evacuate a full load train of approximately 1600 passengers is not more than 30 minutes.

Figure 7: Emergency Detrainment Test

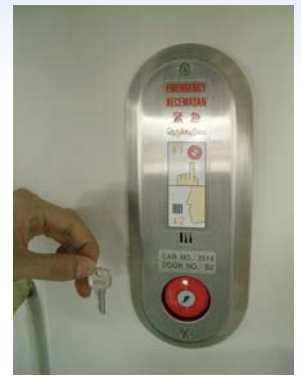
There are four (4) PEC units in each car and these are located on the door pillars. The push button of the PEC units was tested to ensure its functionality. When any of the PEC push buttons is pressed, an audible buzzer alarm and the 'Passenger Alarm' indicator light would be triggered in the cab.

Figure 8: PEC and Alarm Reset Key
