**CONTRACT J112 – DESIGN AND CONSTRUCTION OF JURONG HILL STATION, JURONG
PIER STATION AND VIADUCT FOR JURONG REGION LINE**

ENVIRONMENTAL IMPACT ASSESSMENT (EIA) FOR JURONG HILL (AREA 1 & 2)

Job No: SO00752-2 (Rev 14)

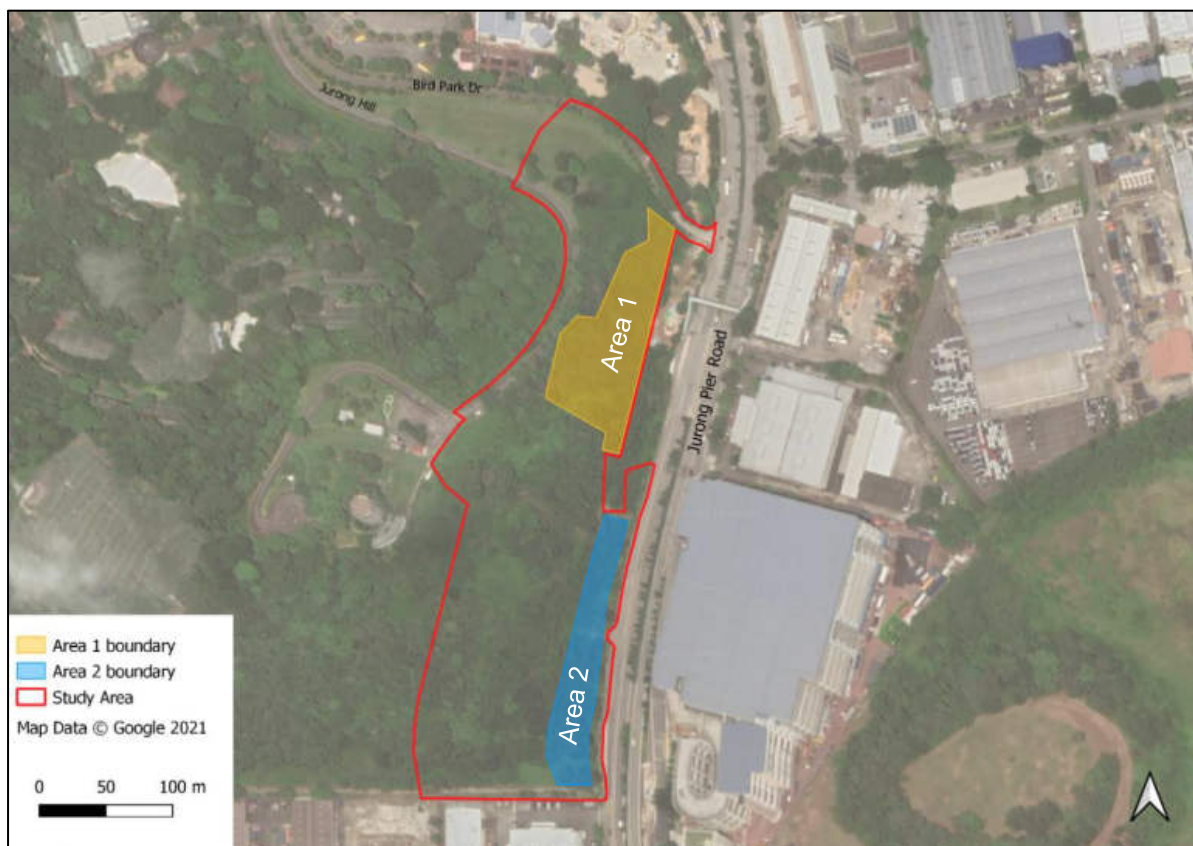
Figure 1: Study Area (100m from the boundary of Area 1 and 2)

The proposed development will include the construction of the new Jurong Hill MRT Station (JS11) and vehicular underpass at Jurong Pier Road. Two areas, namely Area 1 (7,520 m², in yellow) and Area 2 (4,875 m², in blue), which are located within the Jurong Hill forested area will be cleared to facilitate the construction of the Project. The Environmental Impact Assessment (EIA) Study Area will thus cover up to 100 m from the proposed work boundary and has a size of approximately 60,000 m², as shown in Figure 1 below. The EIA has assessed the impacts of the development on the surrounding environment and biodiversity, the residual impacts will be reduced to mainly slight impacts with the proposed mitigation measures. These proposed mitigation measures should be implemented during the construction phase of the Project.

As shown in Figure 1-2, Area 1 (7,520 m², in yellow) and Area 2 (4,875 m², in blue) are located adjacent to Jurong Pier Road, and within Jurong Hill forested area. The EIA study area will thus cover up to 100m from the proposed work boundary. Therefore, an EIA has been carried out to study environmental and biodiversity impacts of construction works for slope cutting and Contiguous Bored Piled (CBP) at Area 1 and Excavation & Cable Laying at Area 2 during construction stage only. The study is also to recommend appropriate mitigation measures to further aid the Environmental Monitoring and Management Plan (EMMP), which aims to minimise environmental impact during the construction phase.

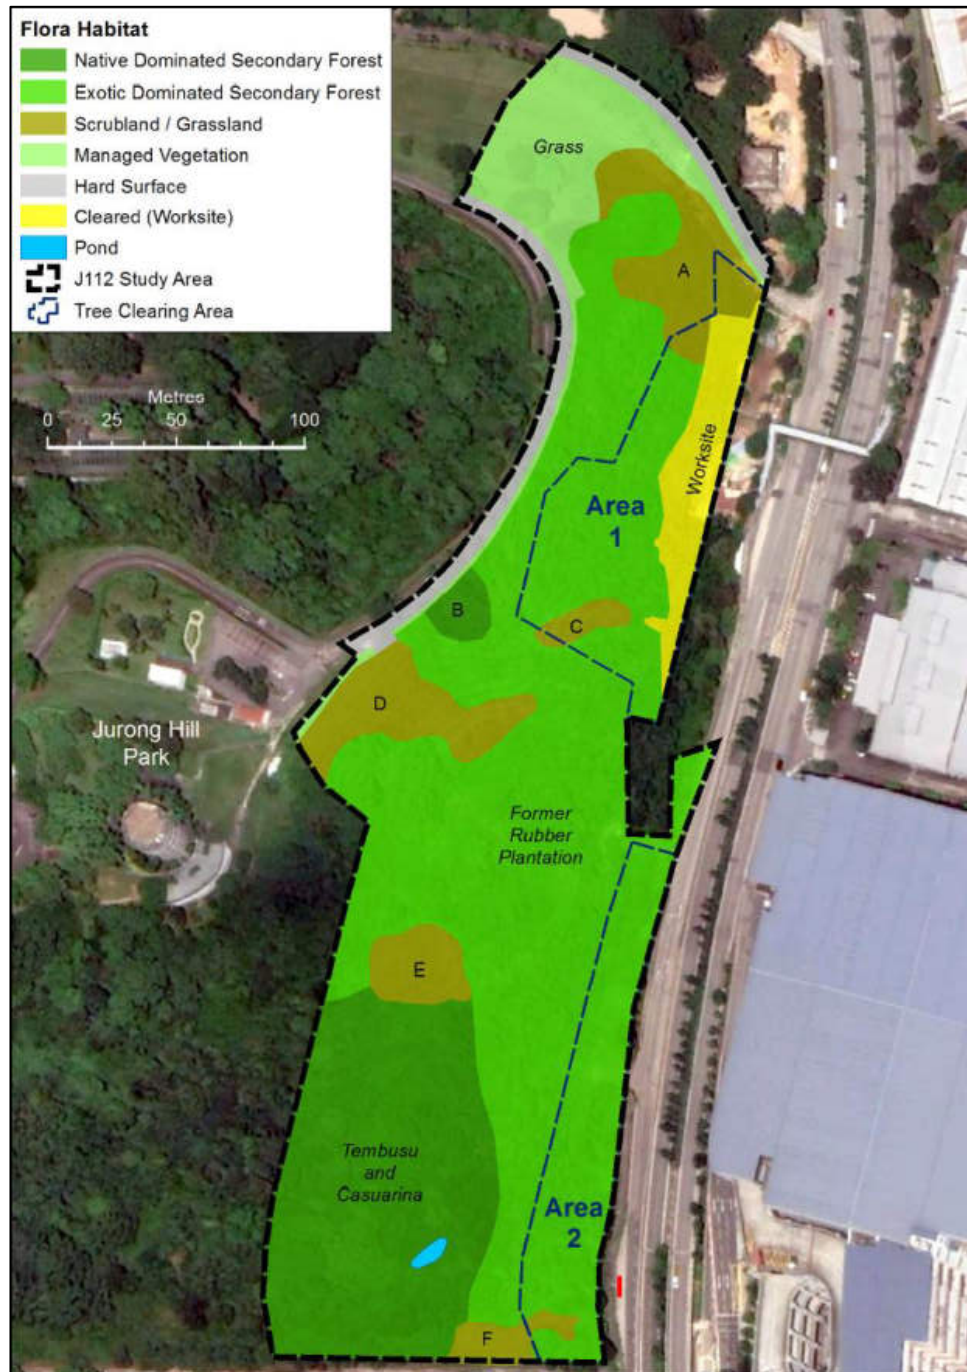
Figure 2: Habitat Map

The habitat map is compiled with reference to formal flora sampling plots and walking transects utilised as ground truth basis for satellite image interpretation. The Study Area comprises of four (4) distinct vegetative habitats (refer to Figure 2 below). It also includes a small ephemeral pond which is located at the southern extent of the Study Area. The pond could be fed by surface runoff and could dry up during longer dry spells.

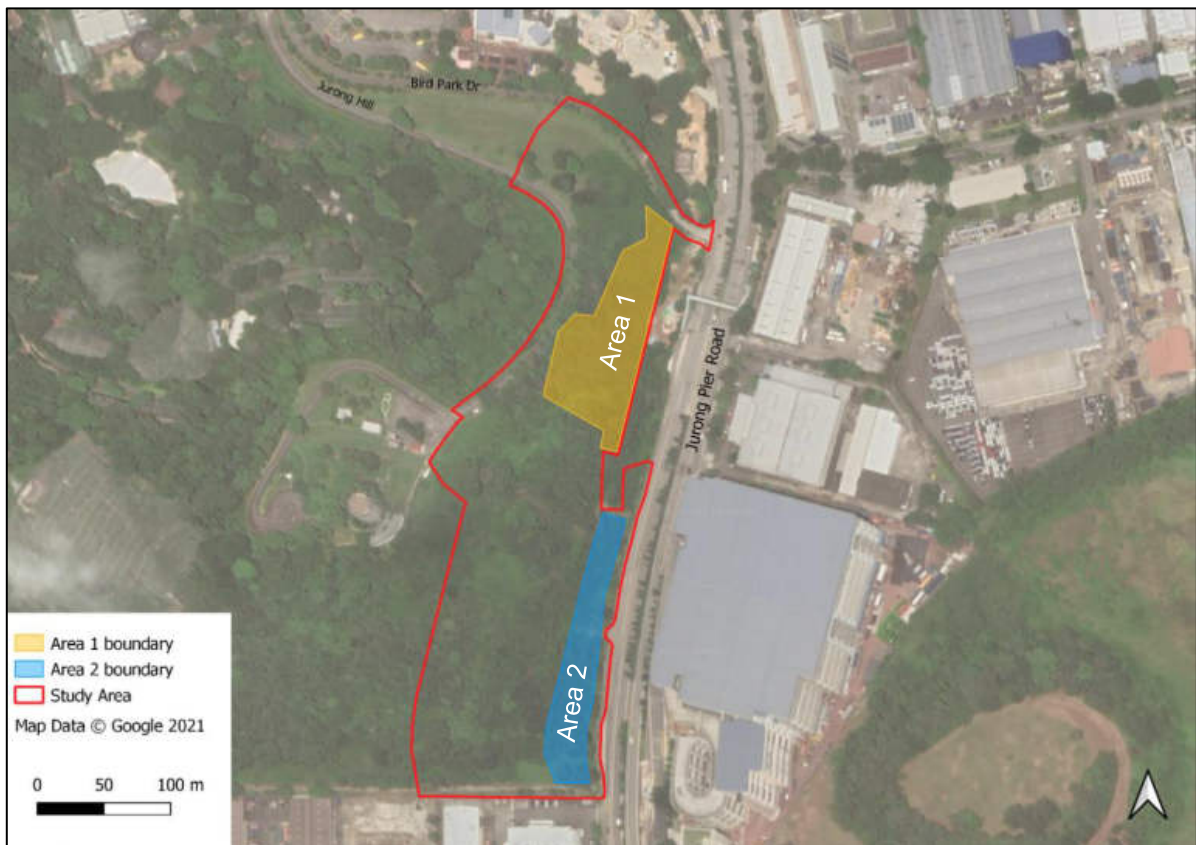
Figure 1-2: Study Area (100m from the boundary of Area 1 and 2)

The EIA study area, refer to Figure 1-2, has a size of approximately 60,000 m².

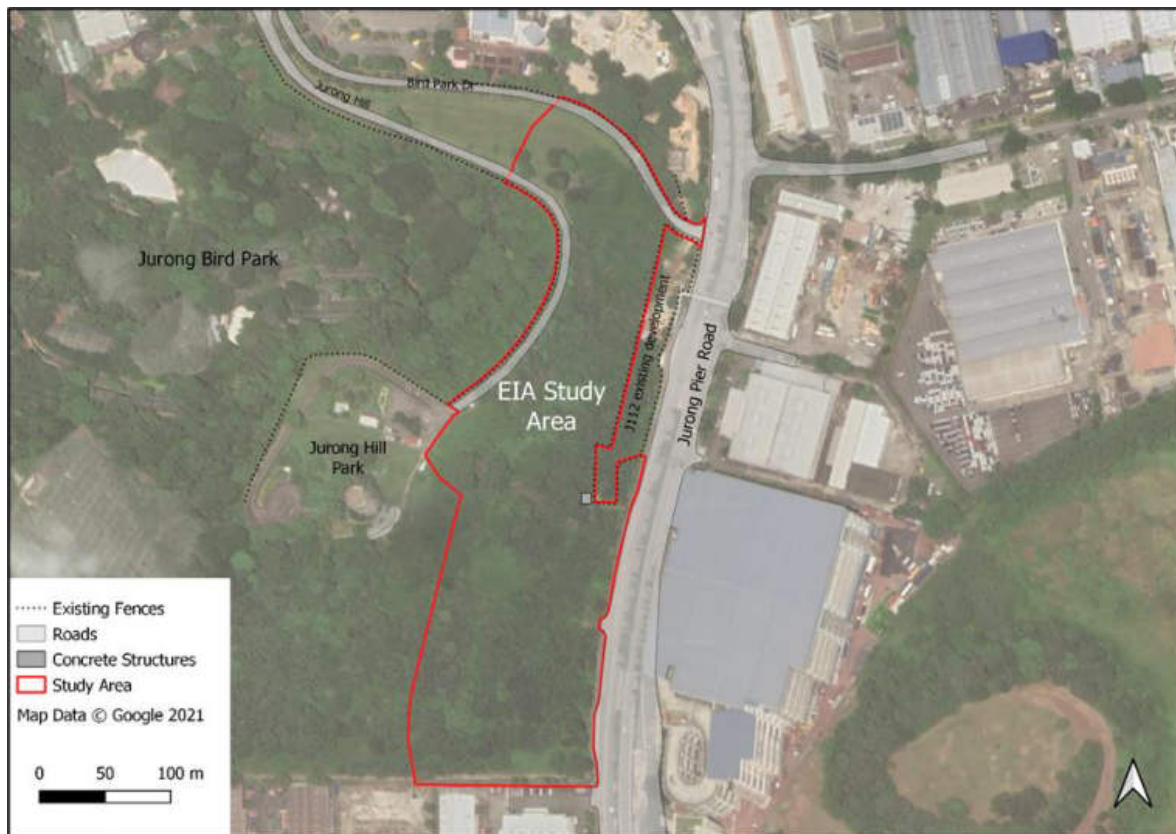
Figure 1-4: EIA Study Area and nearby facilities

The scope of work for the Project within the Study Area comprises of installation and construction of the Contiguous Bored Piles (CBP) Wall, removal of the existing retaining wall system and have the new JS11 MRT Station built in this location. The development would thus involve land clearance, construction of access path and cutting of slopes to carry out the scope of works. The Project area is presented in Figure 1-2, where Area 1 and 2 are located adjacent to Jurong Pier Road, within Jurong Hill forested area. The EIA study area (Figure 1-4) covered up to 100m from the proposed work boundary. Certain parts of the study area did not extend to a whole 100m as the areas fall under Jurong Bird Park (to the West of study boundary) or are existing urban infrastructure (to the East of study boundary). The total study area is approximately 60,000 m².

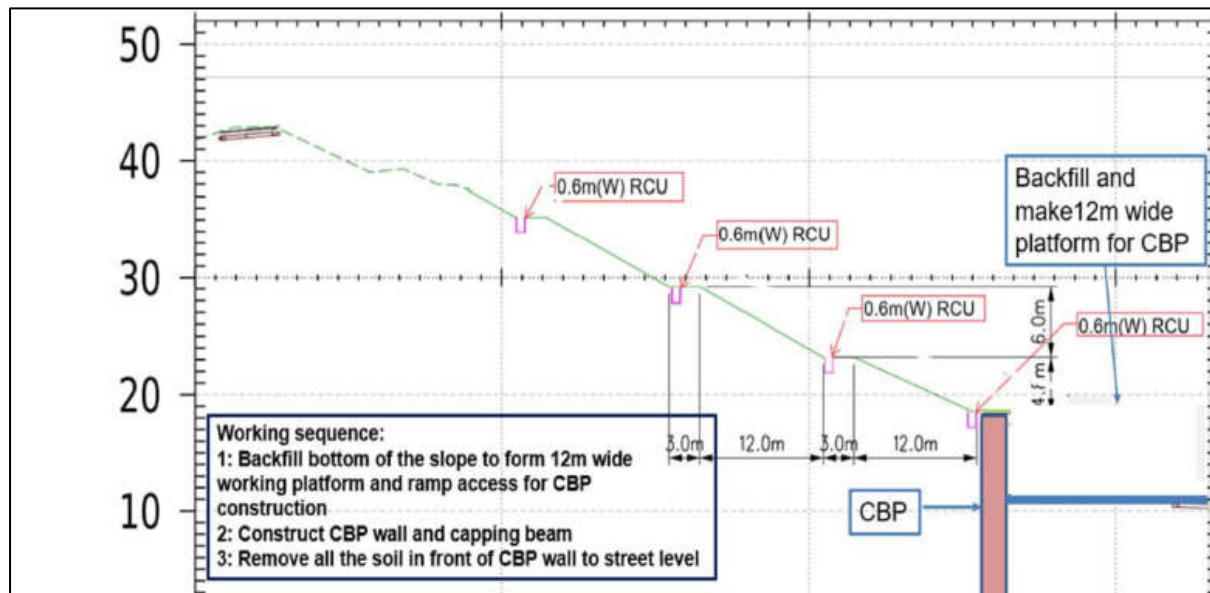
Figure 1-7: Elevation view of backfilling to existing Retaining wall to construct CBP wall

- ii. Building up a compacted temporary working platform
 1. Backfill works at bottom of slope
 2. Road diversion works

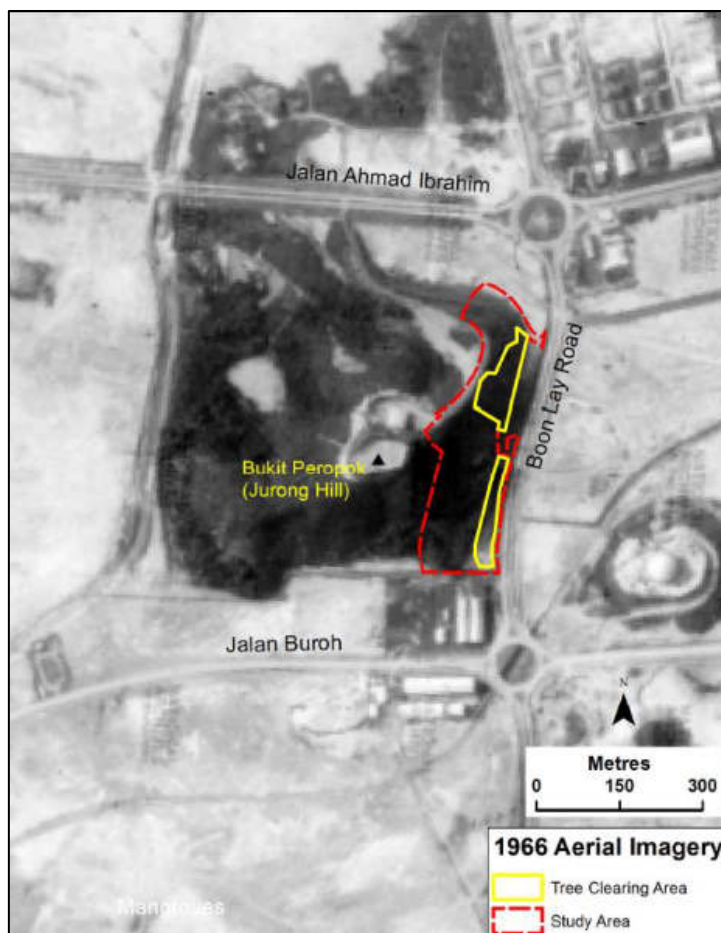
Figure 3-4: Aerial Imagery of Jurong Hill, dated 1966 (NAS, 1966)

The 1966 aerial imagery shows the reclamation and development of the Jurong Industrial precinct. Jurong Hill was retained as an island of regenerated forest. In 1968, the Jurong Town Council established Jurong Hill Park at this location.

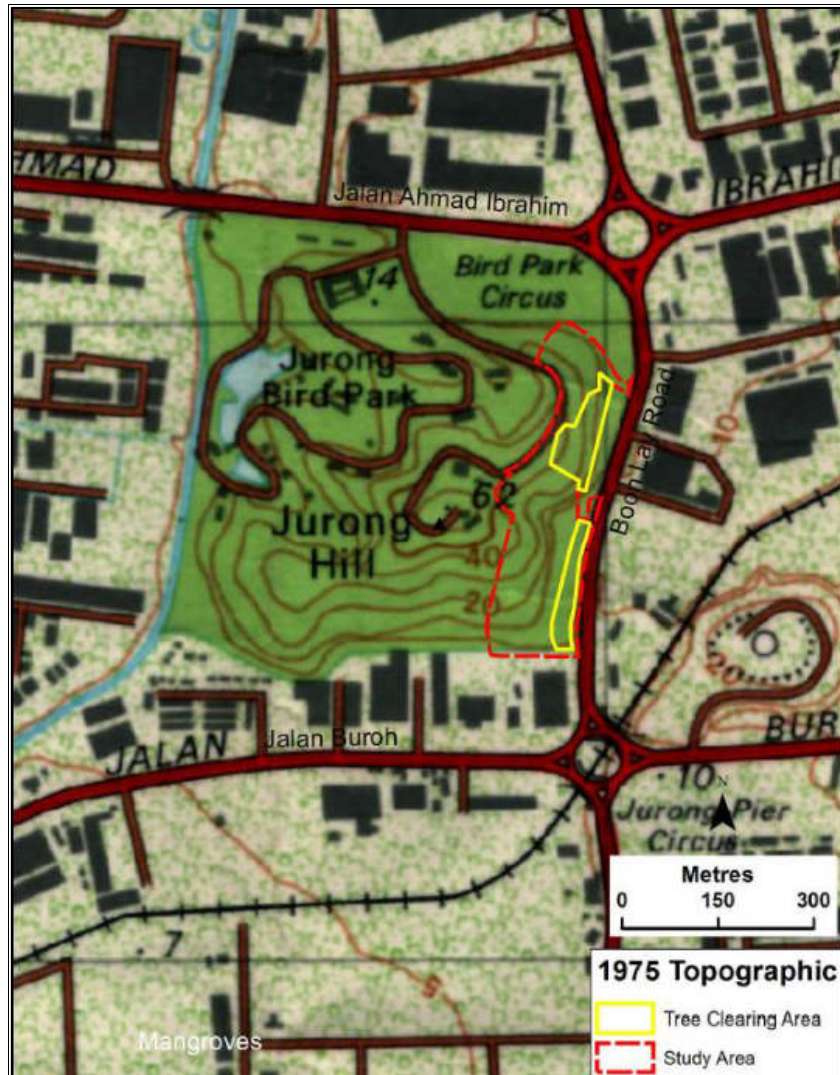
Figure 3-5: NUS Map Library Topographic map, dated 1975

The 1975 Topographic map shows the Jurong Hill Park along with the adjacent Jurong Bird Park established and surrounded by industrial development. The 2022 Google imagery shows the Jurong Hill Park and adjacent Jurong Bird Park (now relocated to Mandai) surrounded by industrial development. The historical analysis shows that while the Jurong Hillside was originally planted with rubber trees, these were removed during or just after the war. Since then, the site has undergone spontaneous regeneration for the past 70+ years.

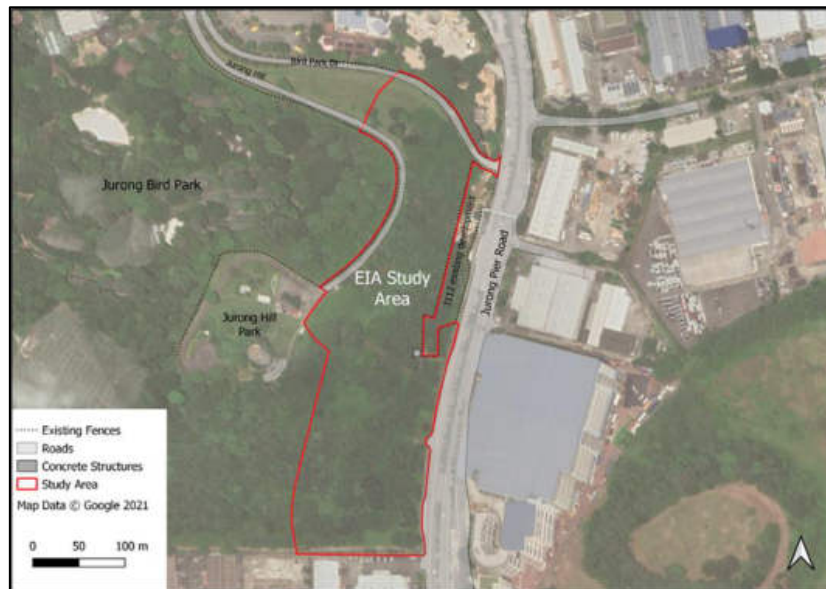
Figure 3-7: Jurong Hill EIA Study Area

Presently, the site is vegetated with secondary forest and grassland. The Study Area is enclosed by public amenities, such as roads, former Jurong Bird Park and existing J112 development work site.

The Study Area is an open forested area that is accessible to the public. However, due to the topography of the area and the intensity of flora growth within the understory, it is unlikely that much human activity is observed within the forest. The area has a steep incline ranging approximately 20m – 50m.

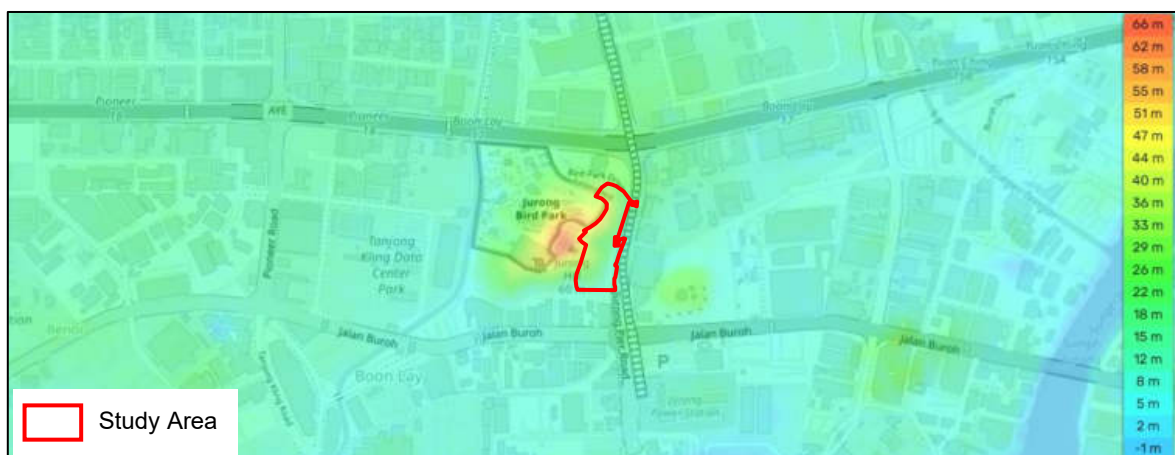
Figure 3-18: Topography of surrounding region around the Study Area

The surrounding vicinity showed no drastic changes in topography unlike within the study area. The highest peak would be Jurong Hill Park, to the west of study area.

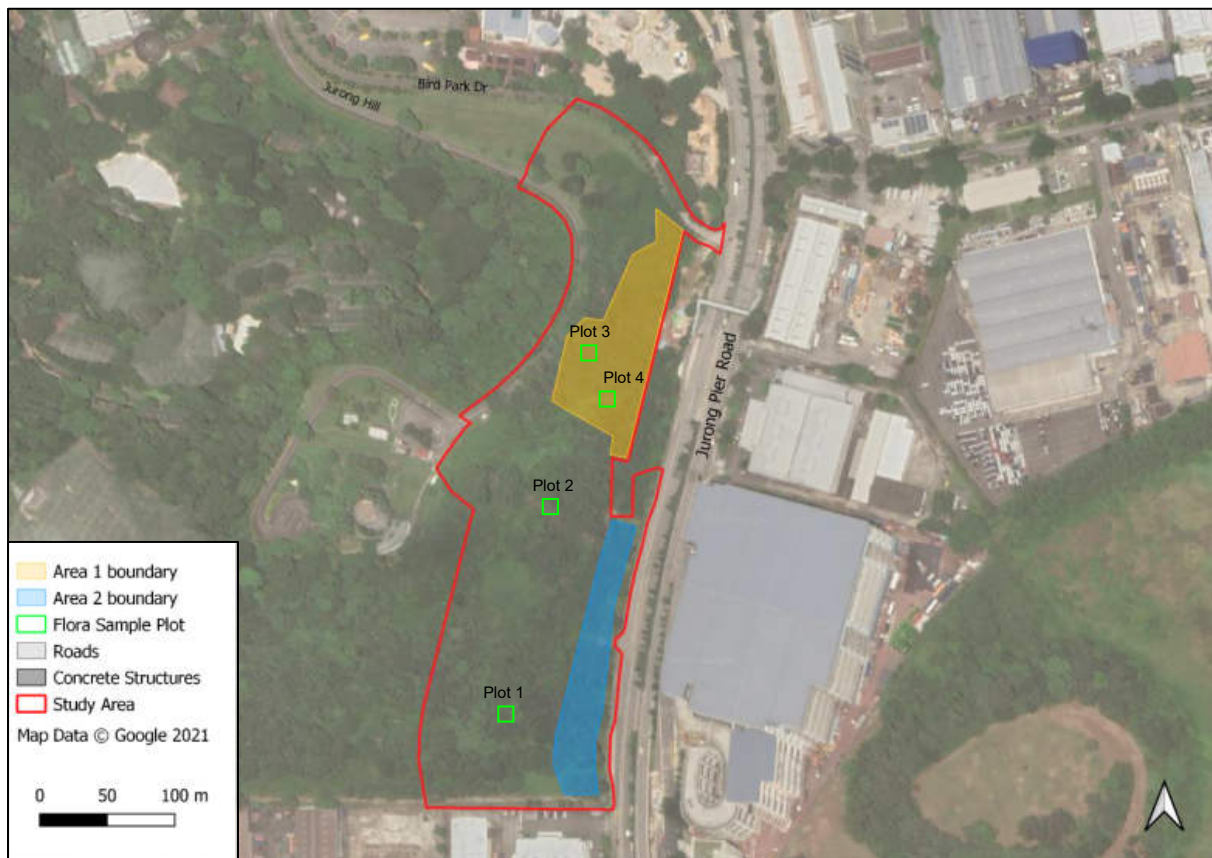
Figure 3-19: Flora Survey Sampling Plots

The location of all observed Conservation-significant (CS) flora and tree species found along the transects and plots were mapped using a handheld GPS. The species of CS species (i.e., trees, shrubs, herbs, climbers and epiphytes) were recorded. The conservation status of all trees more than 1m girth were also recorded using a handheld GPS. Their location, girth size, height, species, and conservation status are provided.

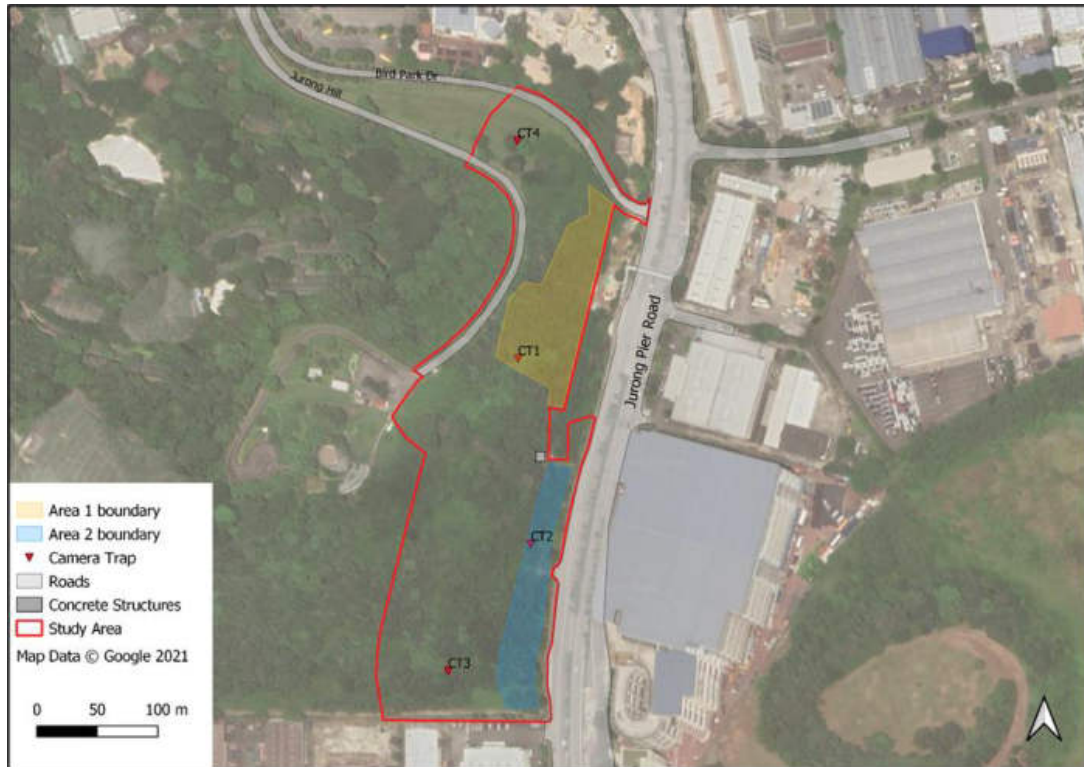
Figure 3-20: Camera Trap Locations

The locations of the camera traps are included below, Figure 3-20. The camera traps were deployed based on field considerations, such as terrains, habitats and possible sighting of fauna during the recce. This was done considering to best option to document fauna within the study area.

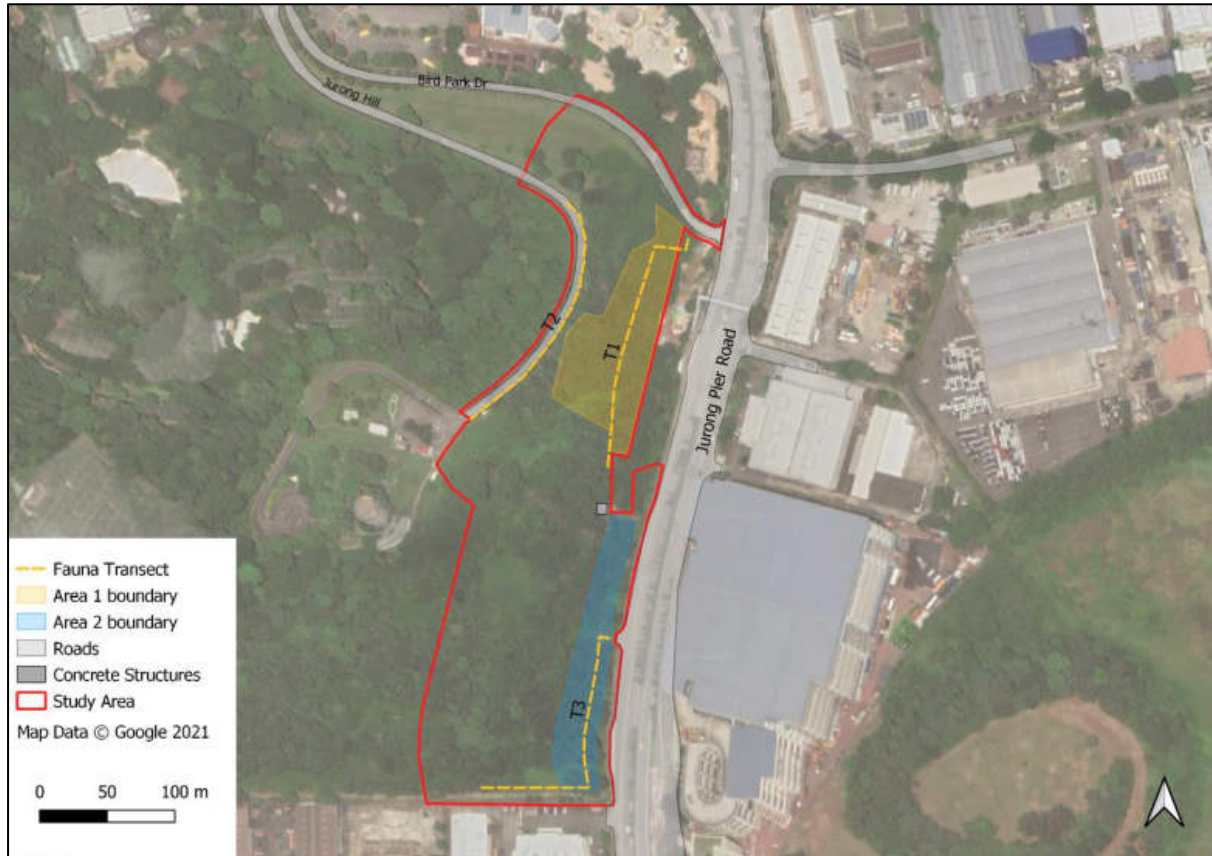
Figure 3-21: Fauna Survey Transects

The transects were allocated along the boundary of Study Area as indicated in Figure 3-21, which are flanked by Jurong Pier Road and Jurong Hill Road. The transects were placed along the boundary as the terrain of the study area within the boundary is observed to be steep which raises safety concerns during the survey, especially during nocturnal survey.

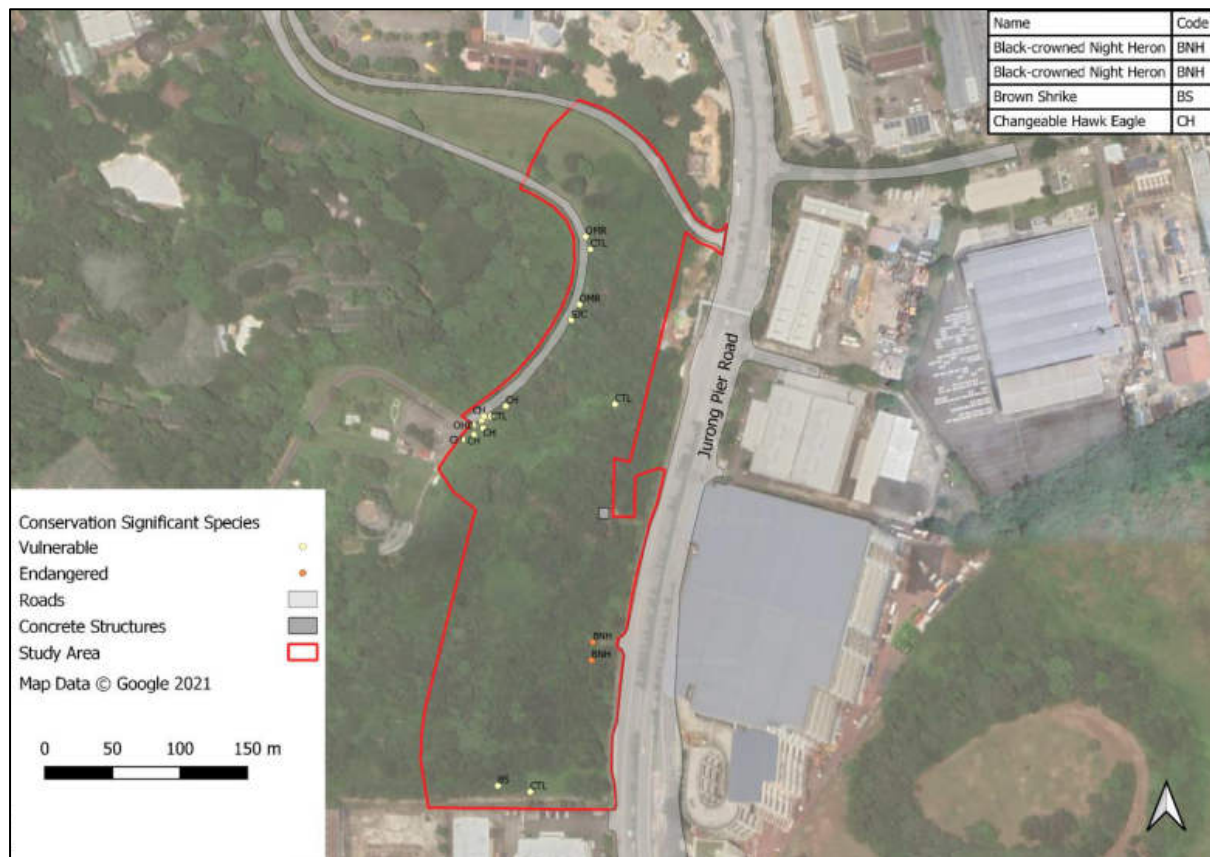
Figure 3-26: Locations of Fauna Conservation Significant Species from Fauna Transect Surveys

One observation made was the encounter of Changeable Hawk-Eagle (*Nisaetus limnaeetus*) was more frequent at T2, as indicated in Figure 3-26. The concentrated encounter along T2 is due to a potential nest outside the study area. Most of the Changeable Hawk-Eagles were observed to be perching on bare branches in the area.

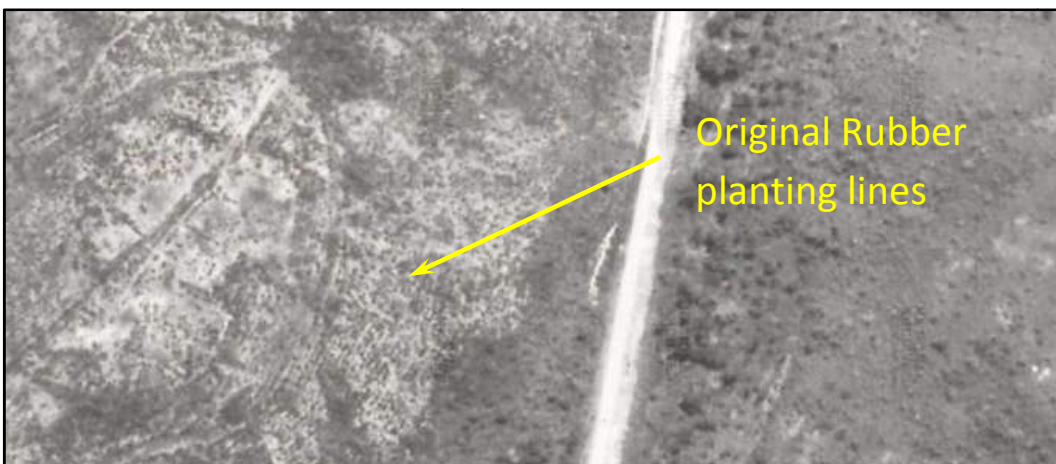
Figure 4: Enlarged section showing original rubber planting lines (NAS Accession 260946).

The 1951 aerial imagery (Figure 3 and Figure 4 above) shows cleared rubber plantation. During the war years rubber plantations were harvested for building material and some were cleared for purpose of agriculture. During the post war period some older rubber plantations were cleared and replanted as a result of research indicating productivity gains by doing so. It is apparent that rubber plantation on this site was cleared post war however there is no evidence of replanting and natural regeneration of vegetation occurred from this point onwards.

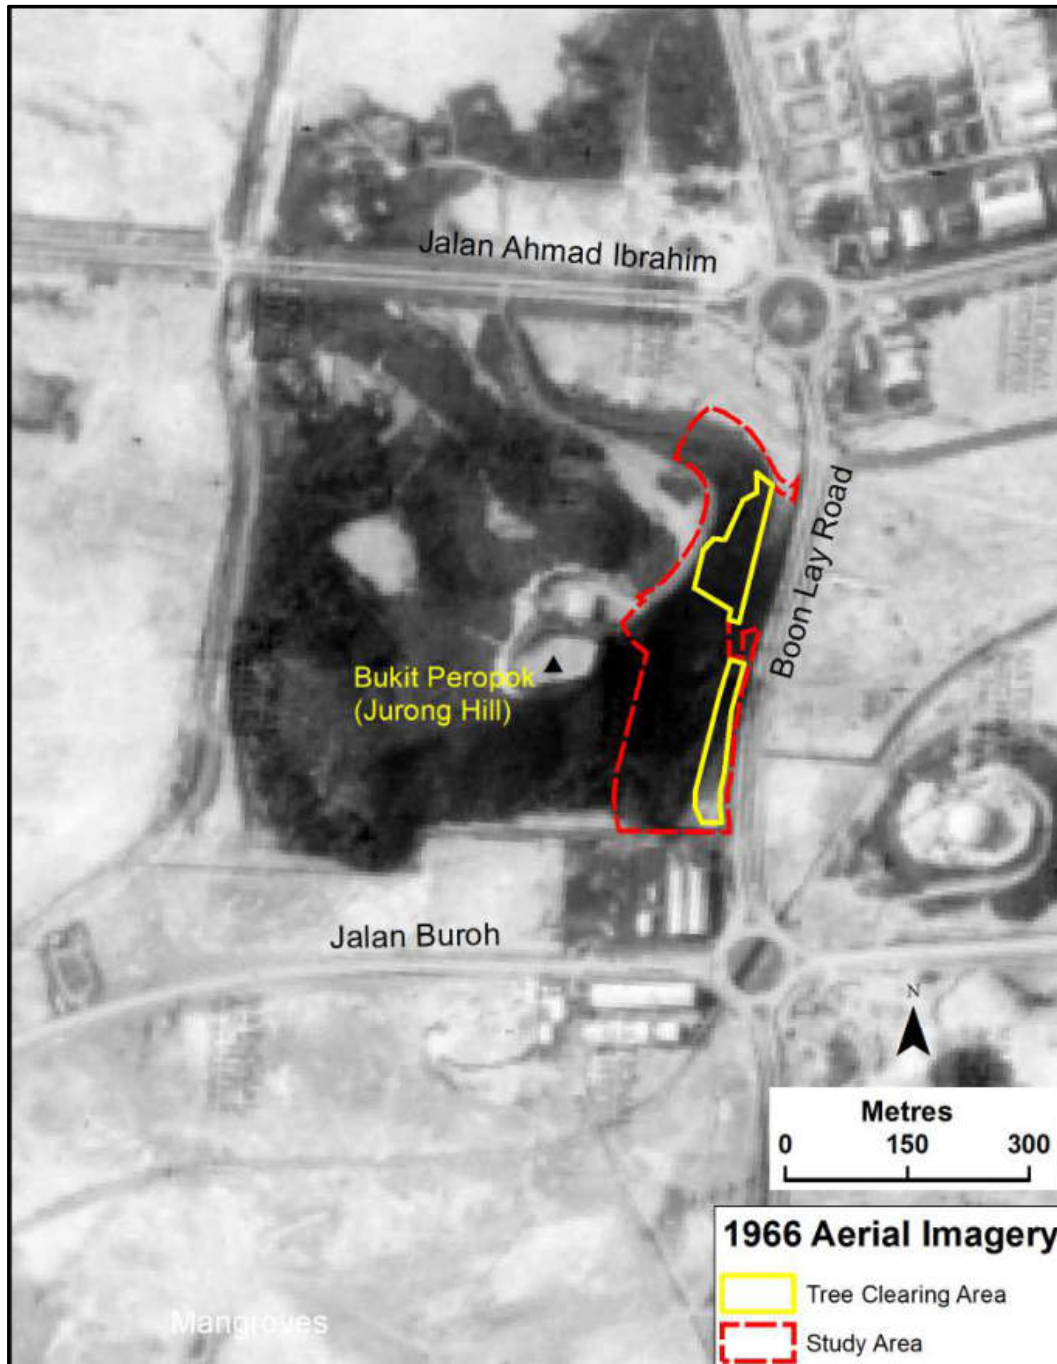
Figure 5: NAS 1966 Aerial Imagery (NAS Accession: 246200).

The 1966 aerial imagery shows the reclamation and development of the Jurong Industrial precinct. Jurong Hill was retained as an island of regeneration forest. In 1968 the Jurong Town Council established the Jurong Hill Park at this location.

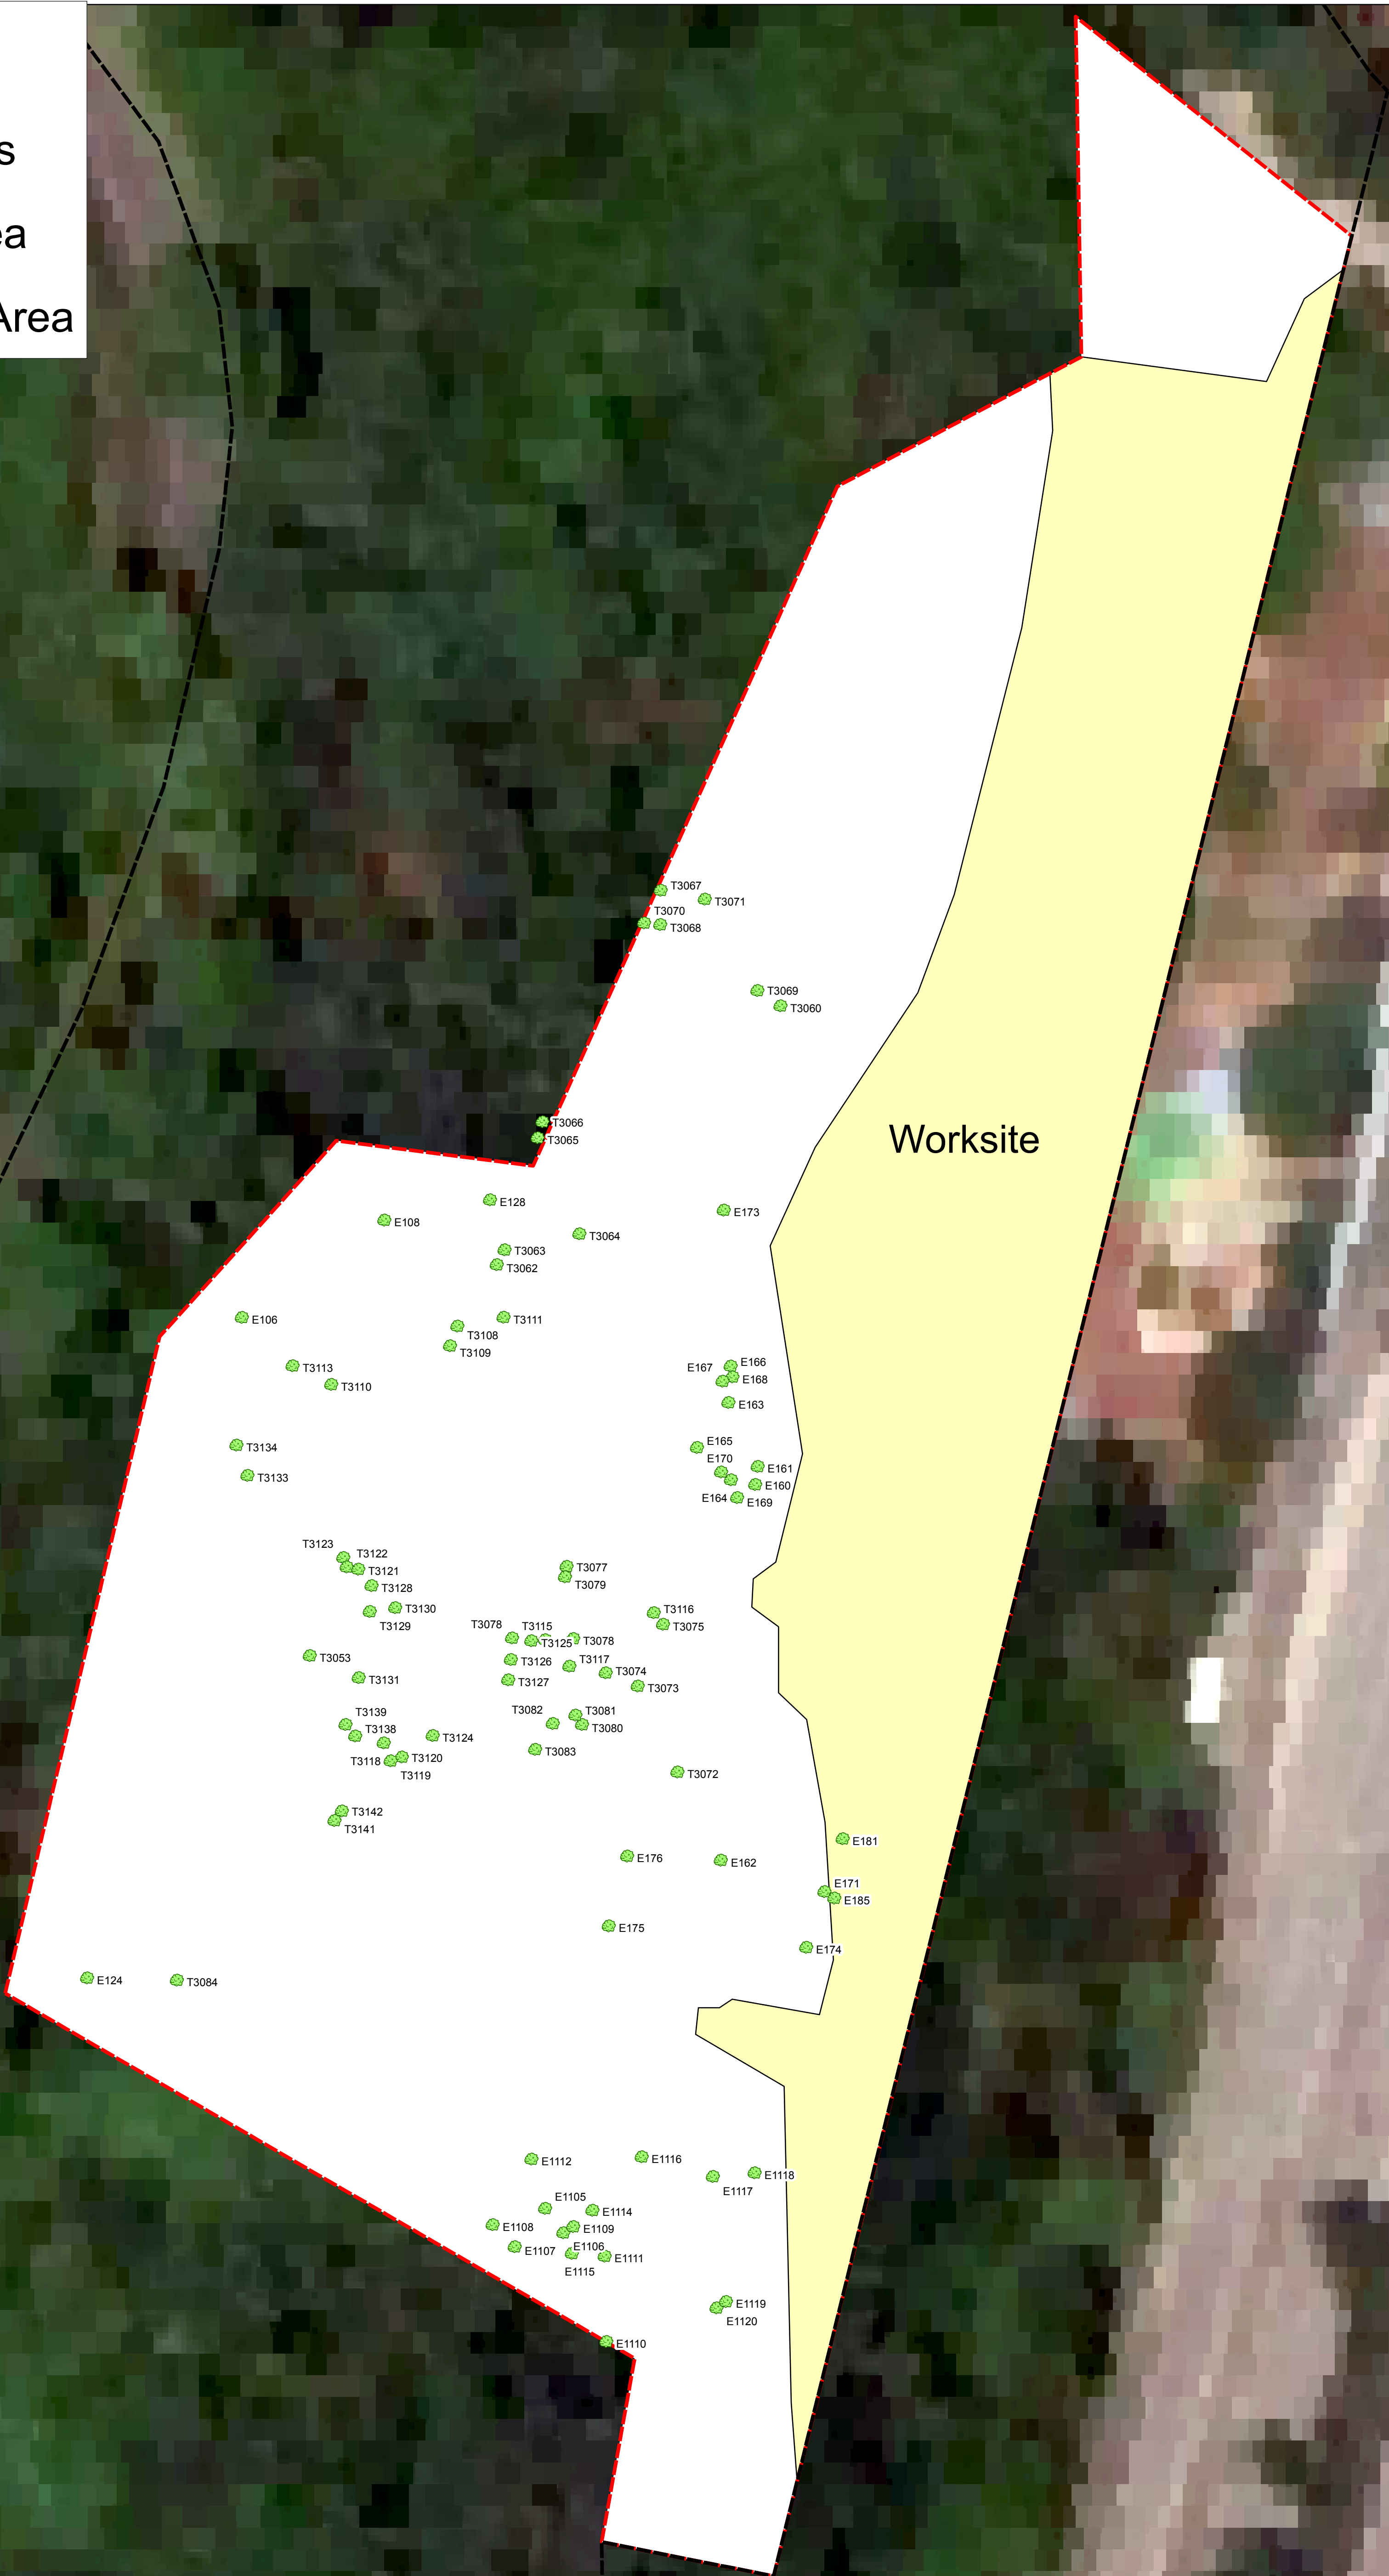
Tree Schedule (North)

J112 Study Area

Tree Clearing Area

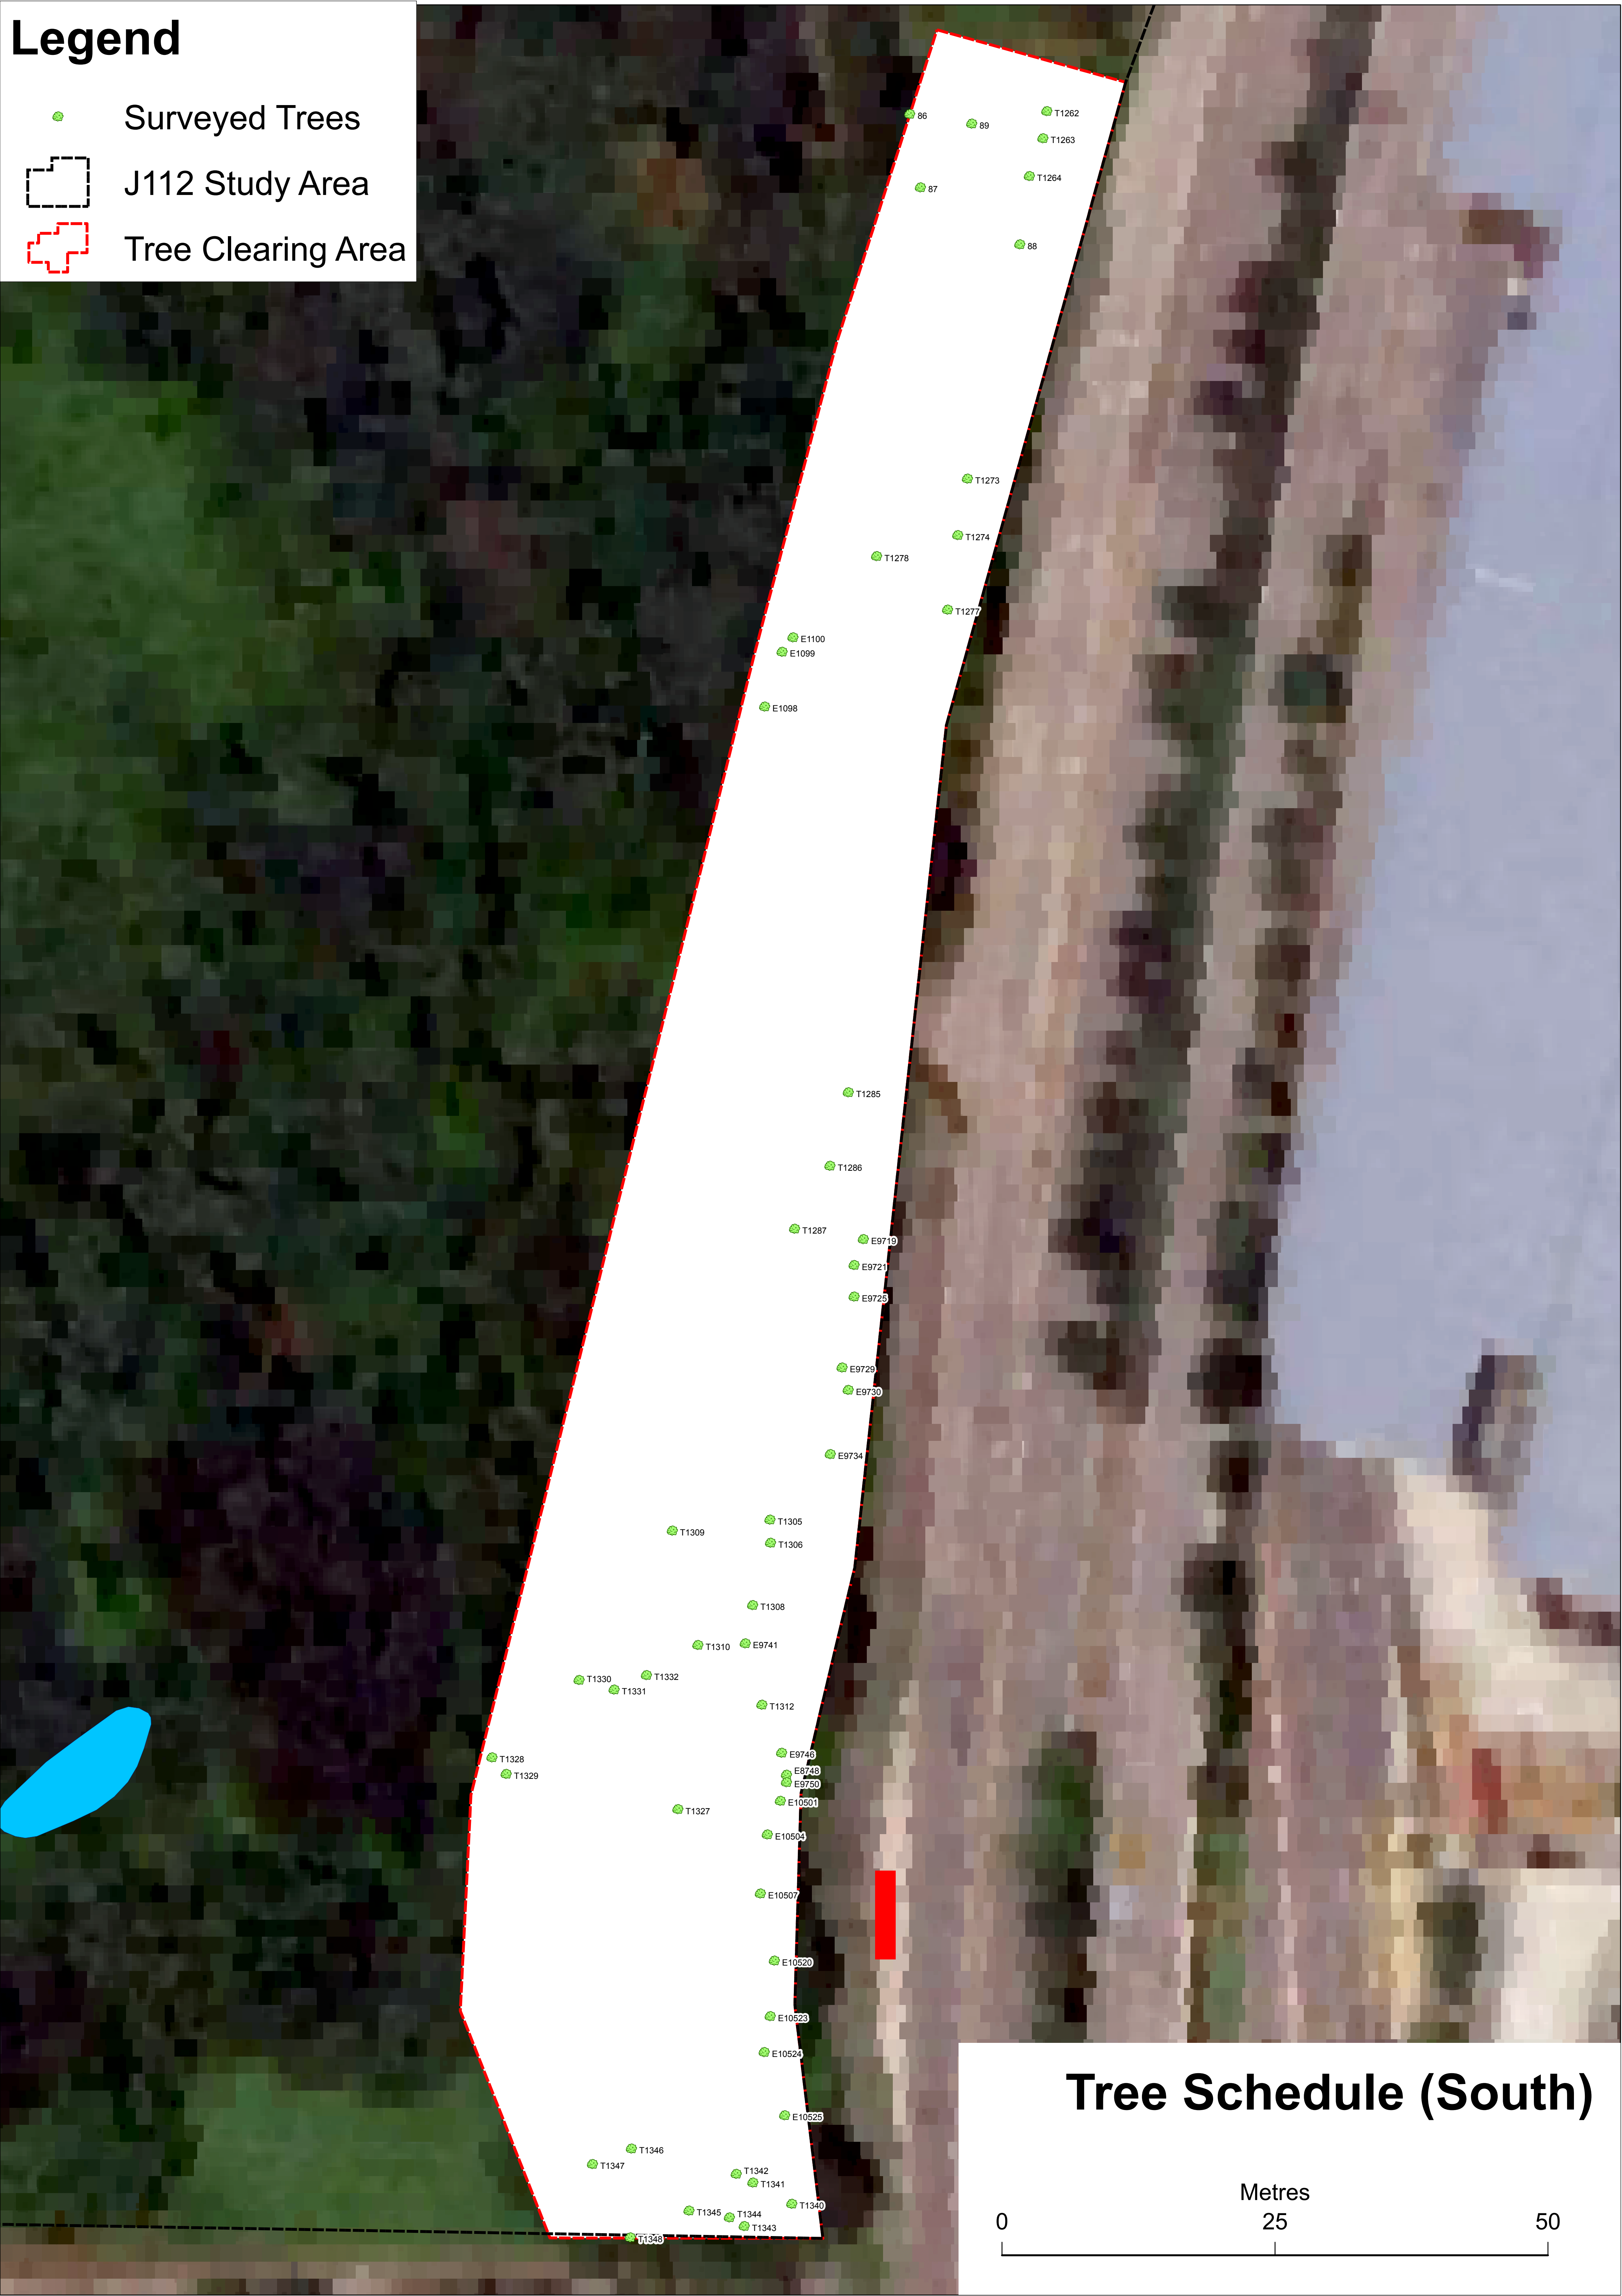
Tree Schedule (South)

J112 Study Area

Tree Clearing Area
