TAC/20005/Final EIS/RT01

April 19, 2021

N112 VIADUCT PROJECT AT SEMBAWANG ROAD

FINAL ENVIRONMENTAL IMPACT STUDY REPORT

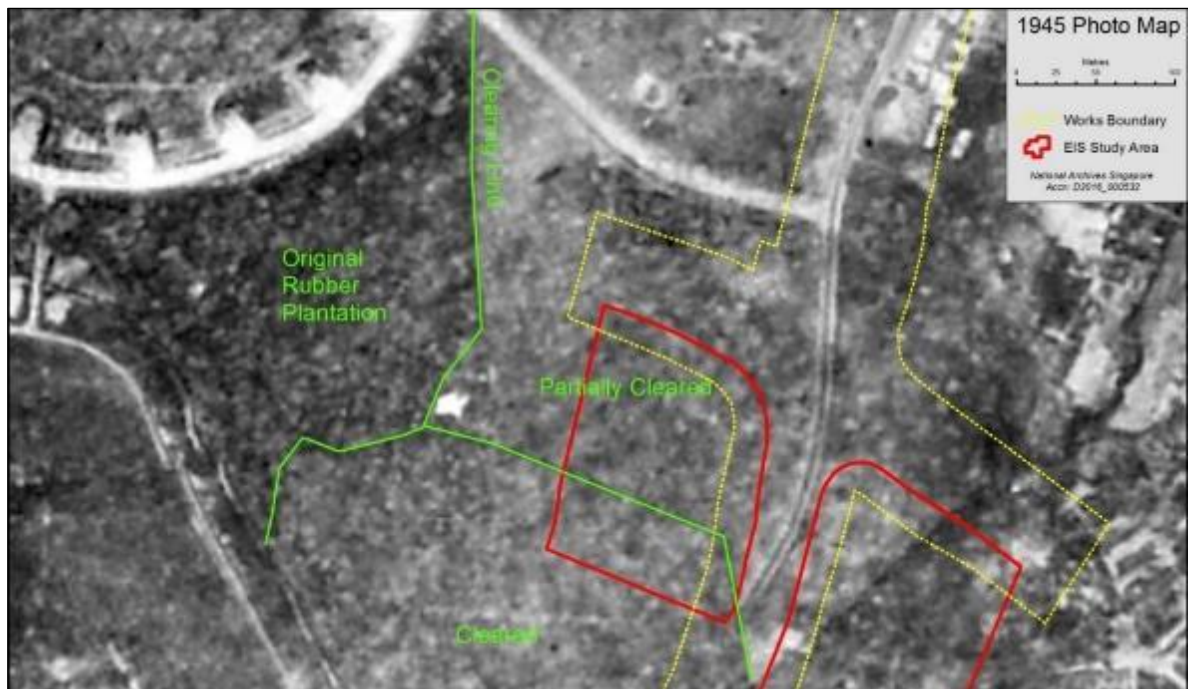
Figure 2.4. 1945 Aerial photo map showing partially cleared western section of study area

In an NAS Oral History interview³, Douglas Hiorns⁴ pointed out that after the war, many of the former rubber areas were never replanted due to the nature of crops grown during the occupation years having denuded the soils of the necessary nutrients required to support a new crop of rubber. He also mentioned that after the war much of rubber lands west of Sembawang Road were compulsorily acquired by the government for military purposes. The lack of rubber plantation in the western section of the study area is most likely due partly to wartime clearing (Figure 2.4) and subsequently to compulsory acquisition of land (for Nee Soon Army Camp).

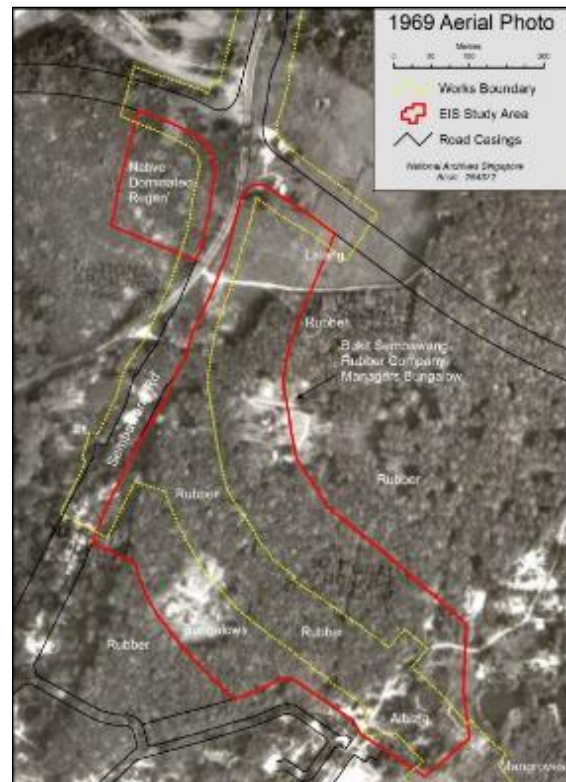
Figure 2.6. 1969 Aerial photo (NAS)

After the occupation, the POW camp was demolished and fresh rubbers were planted by the Bukit Sembawang Rubber Company as can be seen in Figure 2.5 and Figure 2.6.

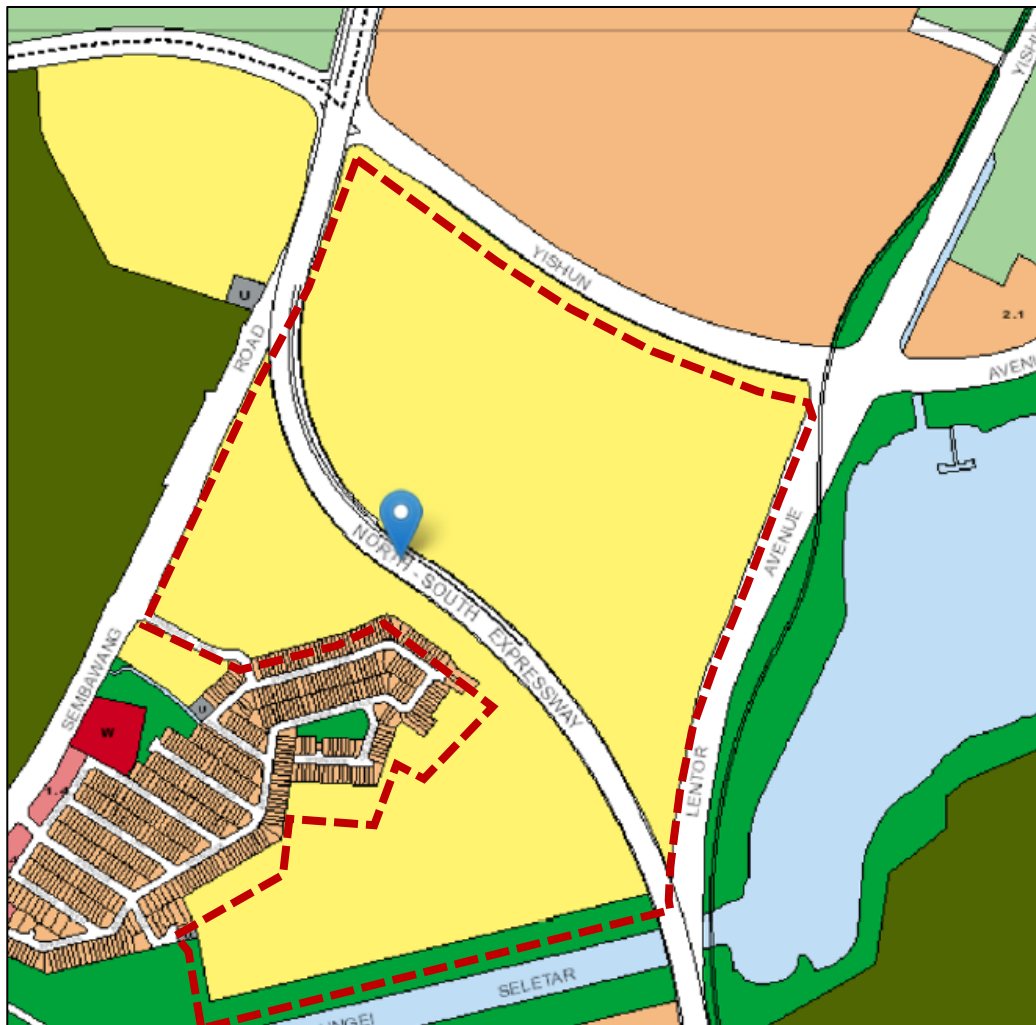
Figure 2.8. URA Master Plan detailing planned land use of project study area

The project site is located within an area that is bounded by Lentor Avenue, Yishun Ave 1 and Sembawang Road as shown in Figure 2.8. The area is currently used as a MINDEF training ground.

According to the URA Master Plan⁵, the project site is zoned as a Reserve Site and is located within the Yishun Planning Area and Springleaf Planning Sub-zone.

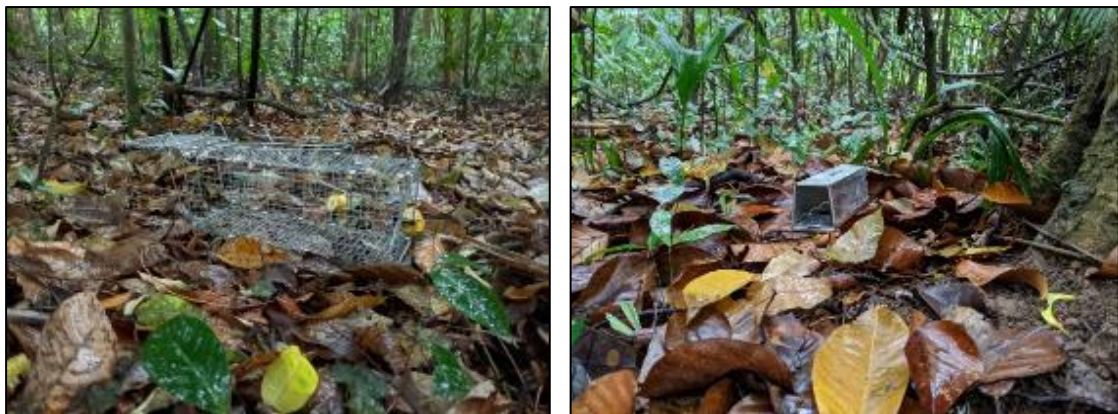
Figure 4.6. Example of cage trap (left) and Elliott trap (right) setup

Live trapping of target groups using cage and Elliott traps (see Figure 4.6 for an example of the setup) is an effective tool to capture species diversity, abundance, population structure, and distribution. It is also an effective method to capture animals that are too small to be detected and identified definitively using camera traps. Five cages and five Elliott traps were set throughout the study area (see Table 4.3 for the GPS coordinates and Figure 4.7 for the location on the map). They were checked and rebaited with bananas, peanut butter, and vanilla-scented oats for three consecutive mornings and evenings to assess the diversity, abundance, and movements of both nocturnal and diurnal mammals. Captured individuals were identified in terms of species, sex, and age class before released at the trap site.

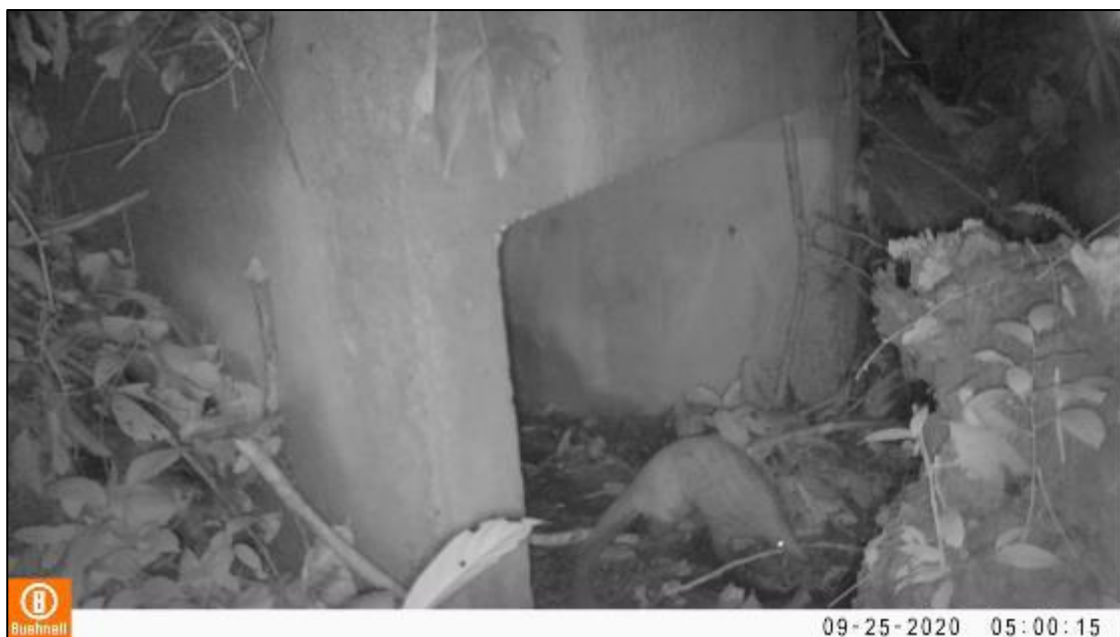
Figure 4.20. Sunda Pangolin at the entrance of the culvert, captured by Camera 6

Camera 6 was facing the stream habitat ('Sungei Botak') and the culvert which passed under Sembawang Road. Both the Sunda Pangolin and an unidentified bat species were seen within the culvert. As mentioned in the results, the culvert is likely used as a foraging area for bats and Sunda Pangolins, but there is no evidence of it being used as a roosting site or connection for the area across the road. Sungei Botak was also used by several species, including the Olive-winged Bulbul and White-crested Laughing Thrush, which were both seen with wet feathers, presumably from using the stream.

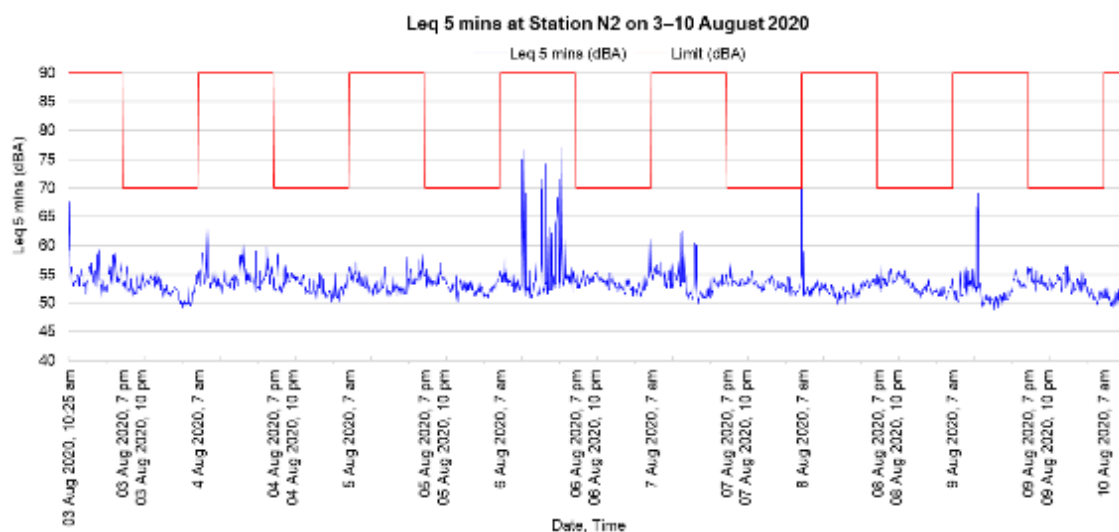
**Figure 5.4.** Baseline Leq 5 mins noise monitoring results at Station N2 over one-week period**Table 5.5.** Summary of the baseline Leq 5 mins noise monitoring results at Station N3

Date	Monitoring Period	Noise Level (dBA)			Maximum Permissible Noise Levels (dBA)
		Min. Leq 5 mins	Median Leq 5 mins	Max. Leq 5 mins	Leq 5 mins
Mon, 3/8/2020	10 am – 7 pm	51	54.2	67.6	90
	7 pm – 7 am	49.2	52.6	56.5	70
Tue, 4/2/2020	7 am – 7 pm	51.6	54.1	62.9	90
	7 pm – 7 am	50.1	52.9	58.6	70
Wed, 5/8/2020	7 am – 7 pm	51	53.2	58.5	90
	7 pm – 7 am	50.2	53.1	57	70
Thu, 6/8/2020	7 am – 7 pm	51	53.6	77.1	90
	7 pm – 7 am	51.1	53.5	61	70
Fri, 7/8/2020	7 am – 7 pm	49.9	53.7	62.6	90
	7 pm – 7 am	51.1	53.4	57.1	70
Sat, 8/8/2020	7 am – 7 pm	49.7	52.3	72.5	90
	7 pm – 7 am	50.5	52.9	57.1	70
Sun, 9/8/2020	7 am – 7 pm	48.8	51.8	69.2	90
	7 pm – 7 am	49.3	53.1	56.4	70
Mon, 10/8/2020	7 am – 10 am	49.1	50.9	53.4	90

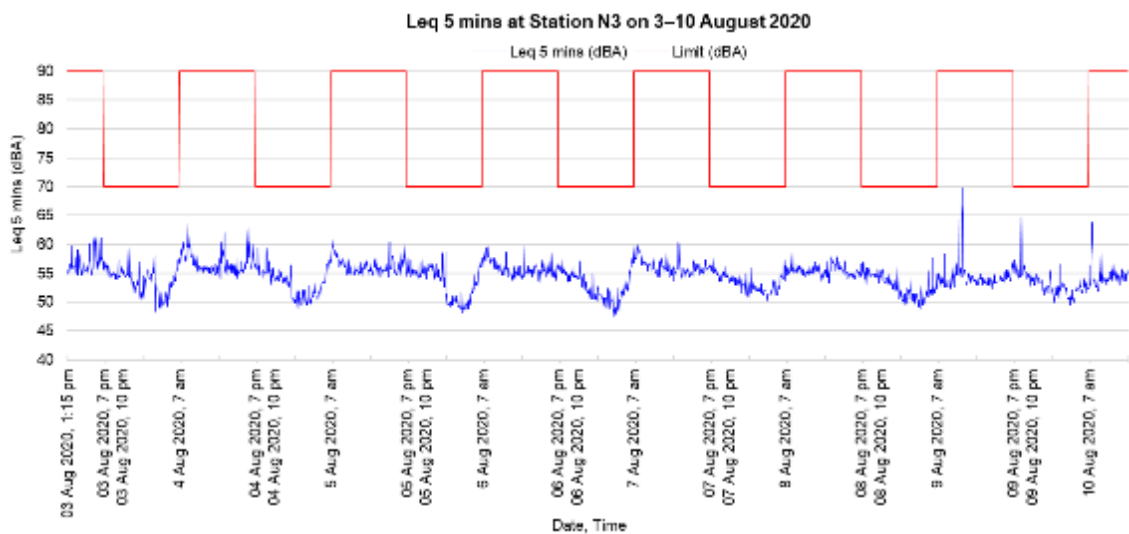
Figure 5.5. Baseline Leq 5 mins noise monitoring results at Station N3 over one-week period

Date	Monitoring Period	Noise Level (dBA)			Maximum Permissible Noise Levels (dBA)
		Min. Leq 5 mins	Median Leq 5 mins	Max. Leq 5 mins	Leq 5 mins
Tue, 4/2/2020	7 am – 7 pm	53.9	56.3	64.1	90
	7 pm – 7 am	48.8	53.6	59.4	70
Wed, 5/8/2020	7 am – 7 pm	54.1	56	60.9	90
	7 pm – 7 am	48.2	54.4	58.7	70
Thu, 6/8/2020	7 am – 7 pm	53.3	55.6	59.7	90
	7 pm – 7 am	47.5	52.5	57.6	70
Fri, 7/8/2020	7 am – 7 pm	53.7	55.9	60.3	90
	7 pm – 7 am	50.1	53.4	57.6	70
Sat, 8/8/2020	7 am – 7 pm	53.4	55.4	58.5	90
	7 pm – 7 am	48.9	52.6	57.7	70
Sun, 9/8/2020	7 am – 7 pm	52.2	54	69.8	90
	7 pm – 7 am	49.4	52.8	64.7	70
Mon, 10/8/2020	7 am – 1 pm	51.8	54.1	63.8	90

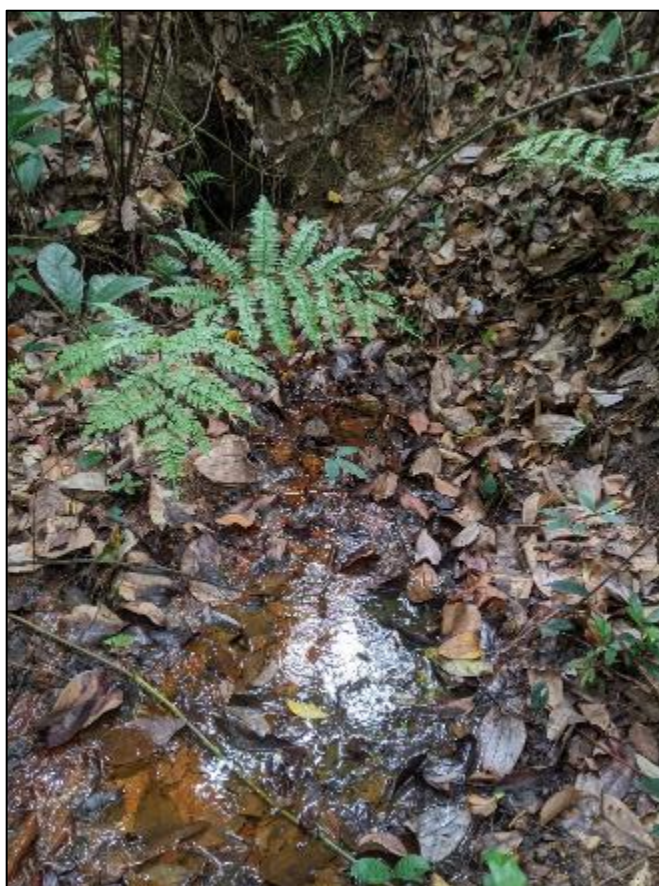
Figure 6.3. Natural stream near Sembawang Road (i.e. Sungei Botak)

Two small natural streams are identified in the project study area (Figure 6.2). The first one is located near Sembawang Road and colloquially called Sungei Botak. Figure 6.3 presents the photograph of the stream. It appears to originate in middle of project study area and feeds into a culvert built under Sembawang Road. Flow at this stream was observed to be slow. The culvert continues south-eastward along Sembawang Road before turning left after Ahmad Ibrahim Mosque. From there, the culvert goes roughly straight perpendicular to Sembawang Road and ends in an outflow perpendicular to Springside Avenue. The second stream originates from the eastern side outside project study area and ends in small ponds in MINDEF training area. Figure 6.4 presents the

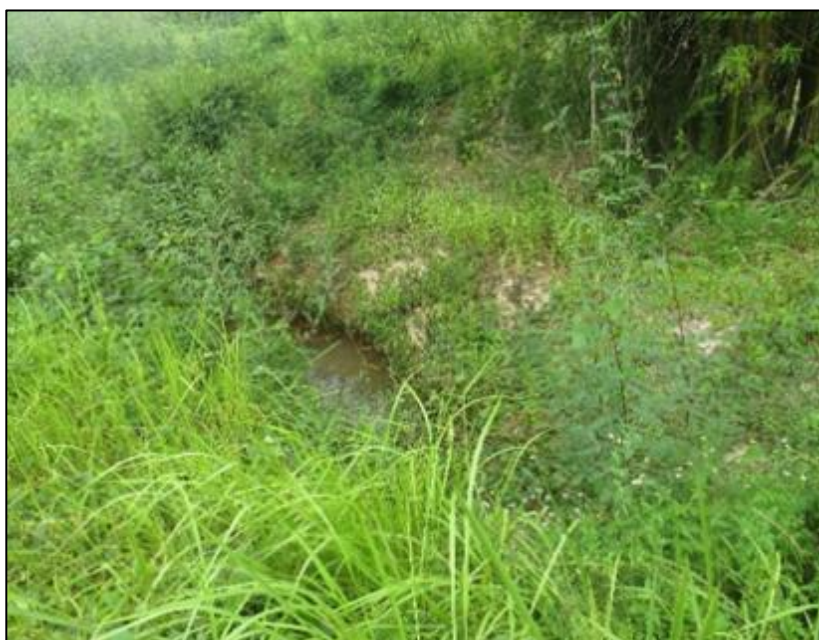
Figure 6.4. Natural stream in MINDEF training area

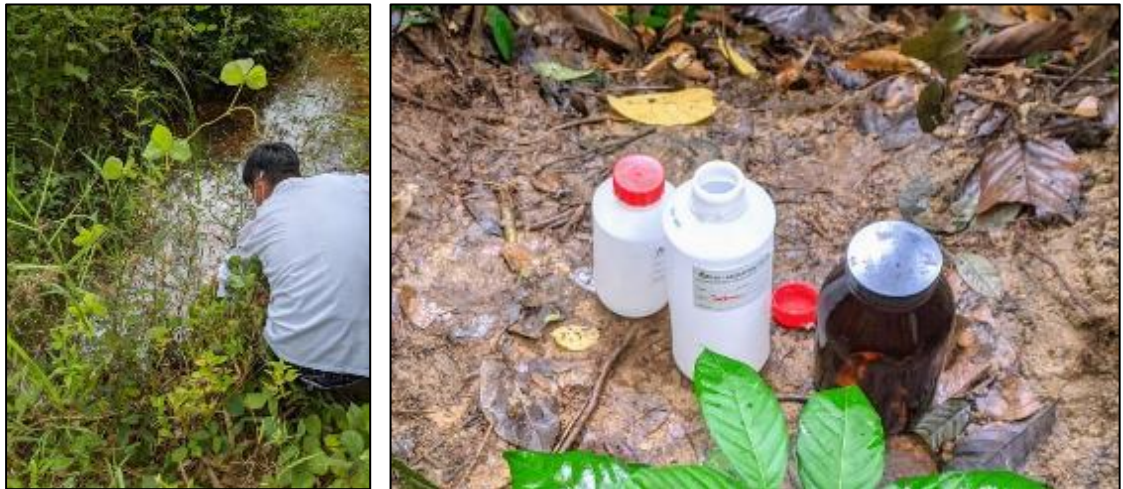
Figure 6.6. Surface water sampling activities

As noted earlier, there are two (2) natural water streams observed in project study area where surface water quality sampling was carried out. Sampling was conducted at the accessible point of these two streams (Table 6.1, Figure 6.5). Dry weather samples were collected on 3 August 2020 while the wet weather samples were collected on 12 August 2020. The SINGLAS-accredited Astar Laboratory Pte Ltd, was appointed to analyse the collected water samples. Figure 6.6 depicts the surface water sampling activities.

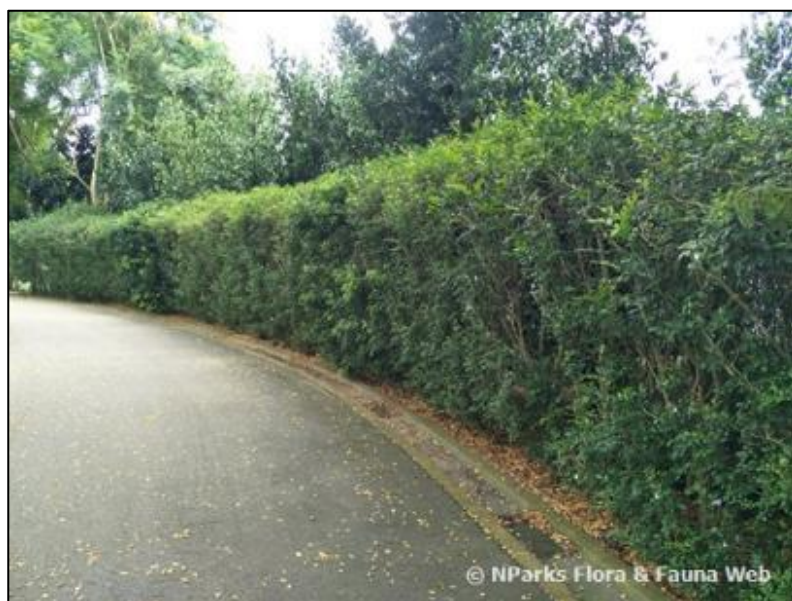
Figure 8.2. Example of hedge planting using *Murraya paniculata*

During operational phase of the project, the impacts of light on the surrounding forested areas can be mitigated through proper designing of roadside lighting system as recommended earlier. Further, the impact can be reduced through appropriate roadside buffer planting for at-grade section of slip road within forested area. The presence of thick and tall hedge plants could minimise the amount of light that enters the forested area, thus reducing its impact on sensitive flora and fauna within the forest (Figure 8.2).
