REPORT ON POWER DISRUPTION ON NORTH-SOUTH AND EAST-WEST LINES (NSEWL) AND CIRCLE LINE (CCL) ON 14 OCTOBER 2020 (“INCIDENT”)

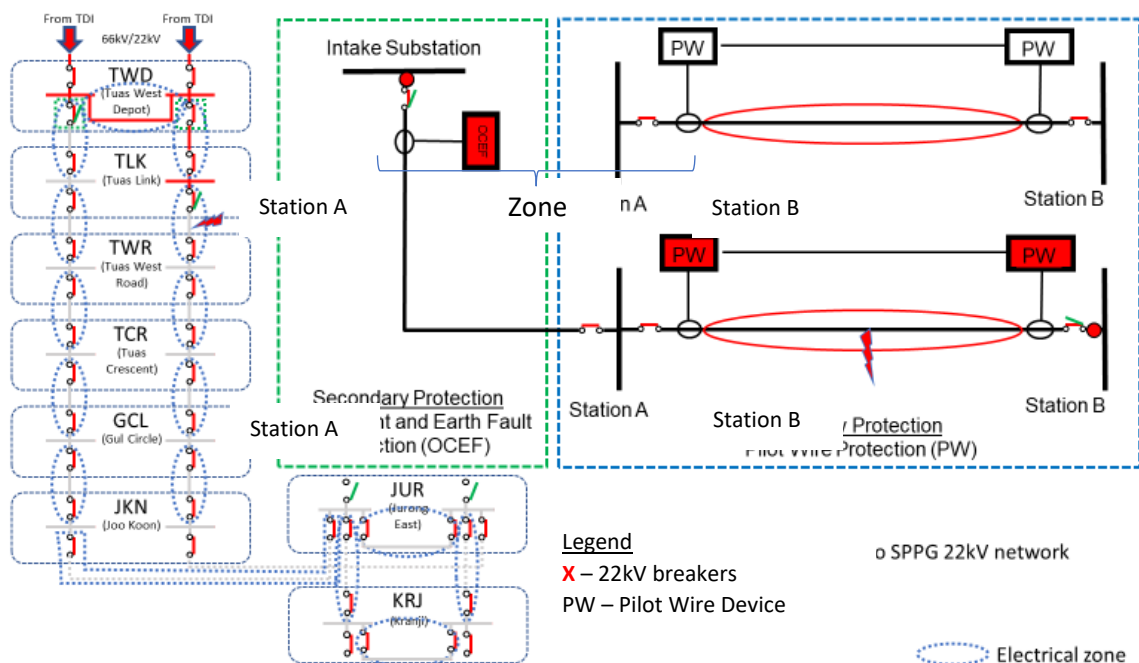
Figure 2: Typical 22kV Protection Scheme

12. The Rapid Transit System (RTS) 22kV network is designed to operate in a ring configuration as in Singapore Power Grid's (SPPG) 22kV network design. Figure 2 shows the

typical protection scheme for the RTS 22kV network. An electrical zone comprises a set of 22kV cables between stations which incorporates its own primary protection through the use of Pilot Wire (PW) protection devices. The primary protection essentially checks that the current flowing into the zone is equal to the current flowing out of the zone. In the event of an abnormal current flow (i.e. a fault), the primary protection will detect it and trigger the operation of the 22kV breakers, thereby effectively isolating the fault within the zone. With the fault isolated, the 22kV network ring configuration design will allow train service to continue.

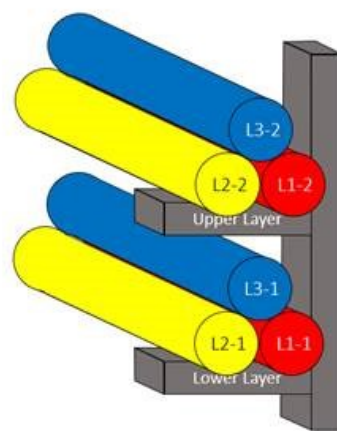
Figure 3: 3-Phase 22kV Cables Laid Out Physically on Two Layers

13. The electrical zone between the two stations comprises 3-phase 22kV cables laid out physically on two layers of brackets (See Figure 3). Collectively, these two sets of cables are designed to carry the full current required for train operations.
