## **Findings of Investigation into the Train Derailment Incident on the East-West Line (EWL) on 25 September 2024**

### **Summary of Findings**

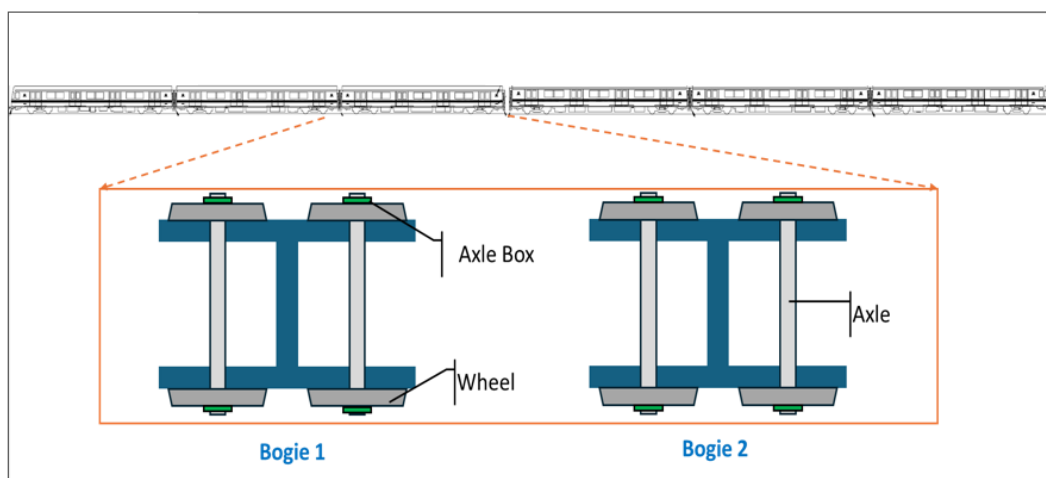
2. KHI trains have six train-cars, with each train-car having two undercarriage bogies, and each bogie holding four wheels. An axle box assembly is attached to each wheel. (Please see [Figure 1](#))

Figure 1: Schematic of the train bogie

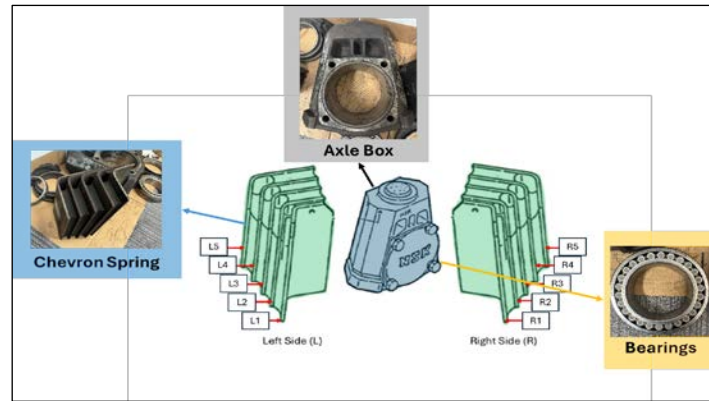
3. Axle box assemblies allow the train's wheels and axles to rotate while the weight of the train sits on the axle boxes. An axle box assembly comprises one axle box and two sets of chevron springs. The axle box holds the train wheel to the axle. Within each axle box are greased axle bearings, which allow the axle and wheel of the train to rotate smoothly during operations. The two chevron springs – metal plates interleaved with rubber – connect the axle box and the bogie frame, and absorb shock and vibration during train movement. (Please see [Figure 2](#))

Figure 2: Schematic of the axle box assembly of a KHI train.
